Construction Quality Assurance

Lee Taylor – Consulting Engr - Duke Energy
2008 IEEE T&D Conference and Exposition
April 23, 2008 - Chicago, Illinois

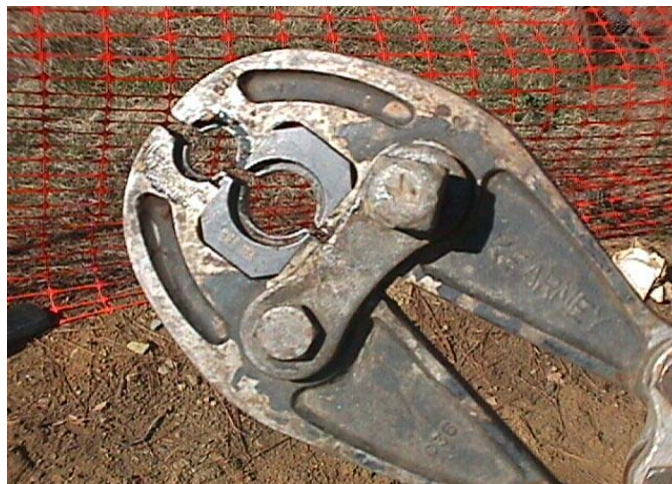
“I can fix anything with a hard
head.”

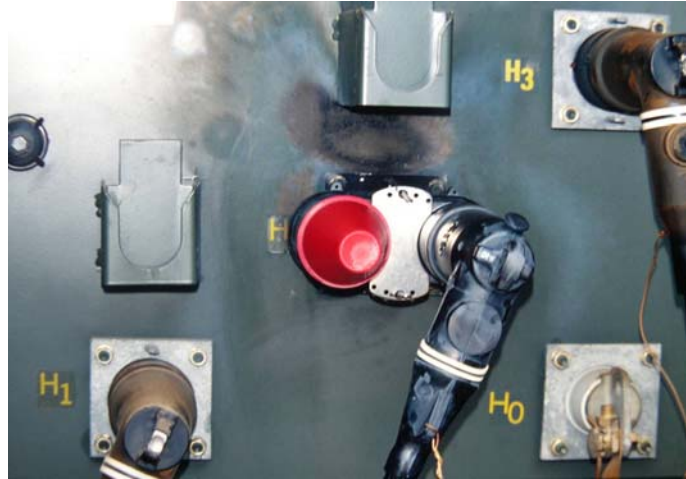
“This plastic thing they sent is a lot less expensive than an insulated plug!”

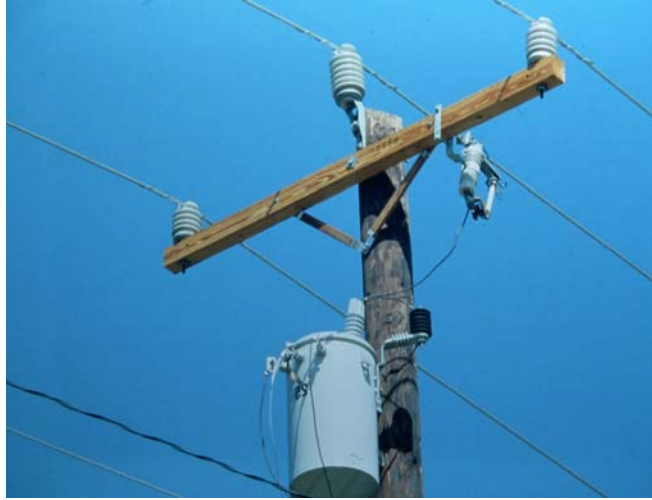
Failed to install animal guard on lightning arrester.

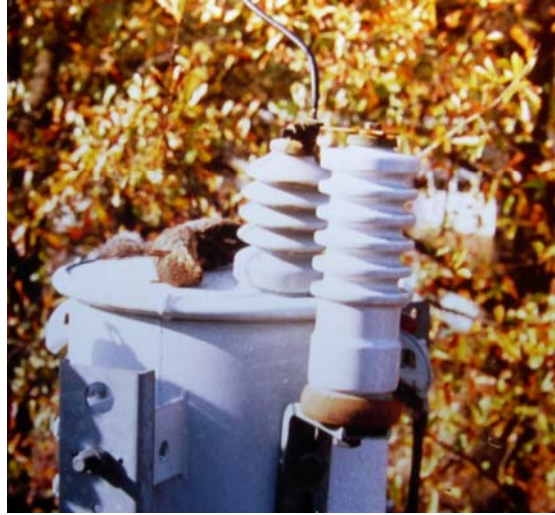
Failed to install animal guard on transformer bushing.

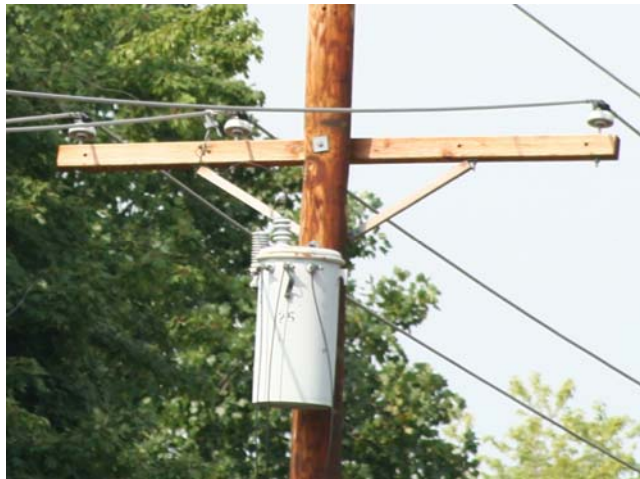
Failed to install fuse and animal guard on transformer when set up on pole.

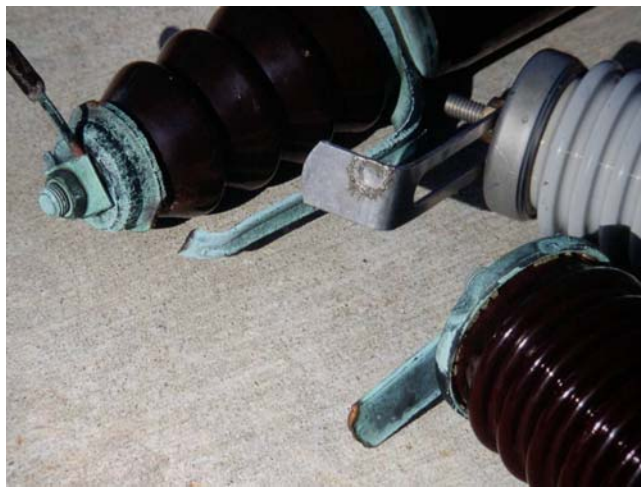
Melted metal means power follow arcs.
These arresters have joined the other side!

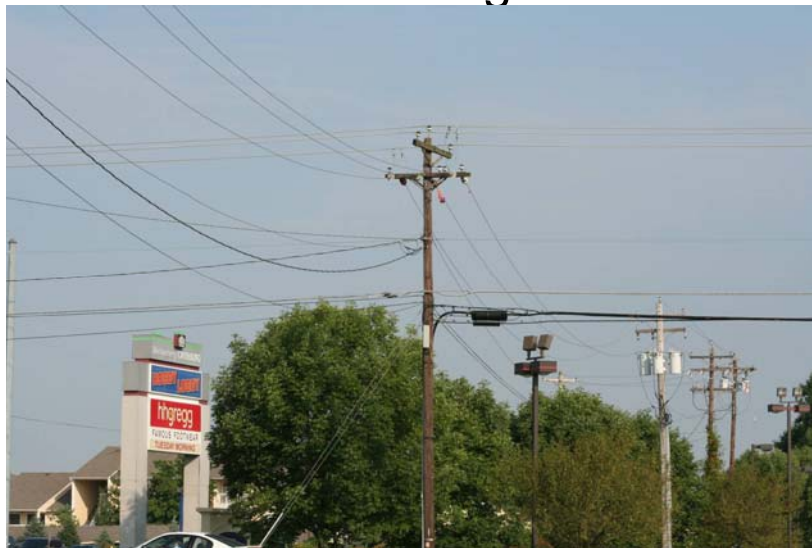
Unfused taps are a common cause of circuit lockouts. Engineer error.

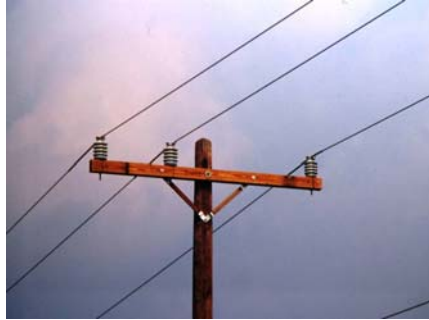
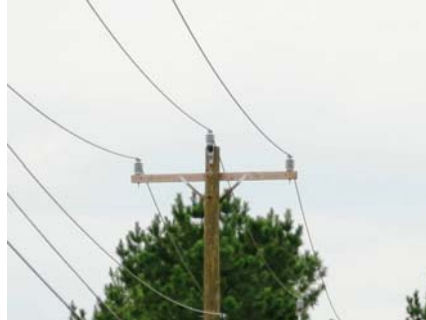
Installing middle phase on crossarm.

- Lowers BIL (CFO) by 40%
- Increases mid span faults by magnetically induced subsequent faults (MISFAULT)
- Increases line to line tree faults.
- Mandatory 3 point deduction

Avoid placing close conductors in the same horizontal plane.

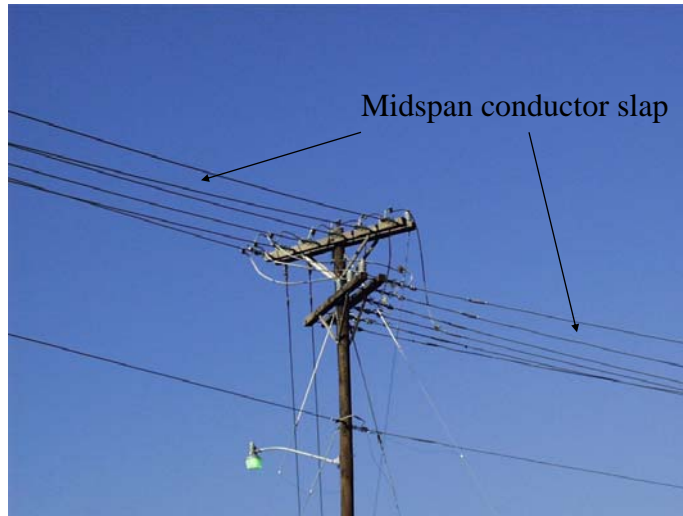
Two circuits on one ten foot arm often results in mid-span conductor faults.

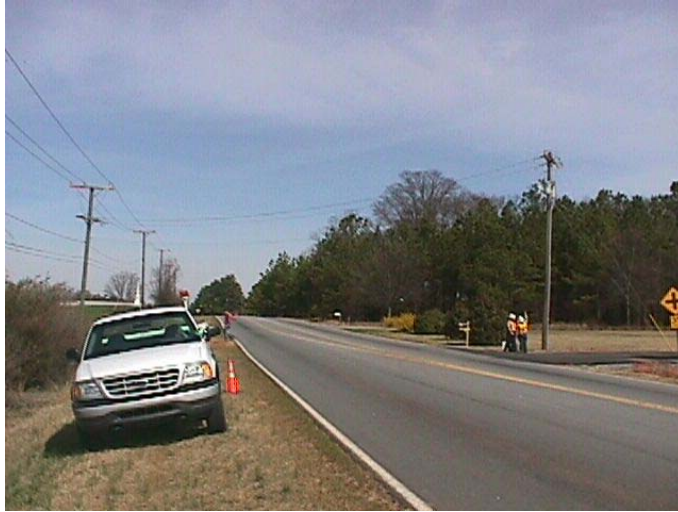
Guyed on one end and not on the other.

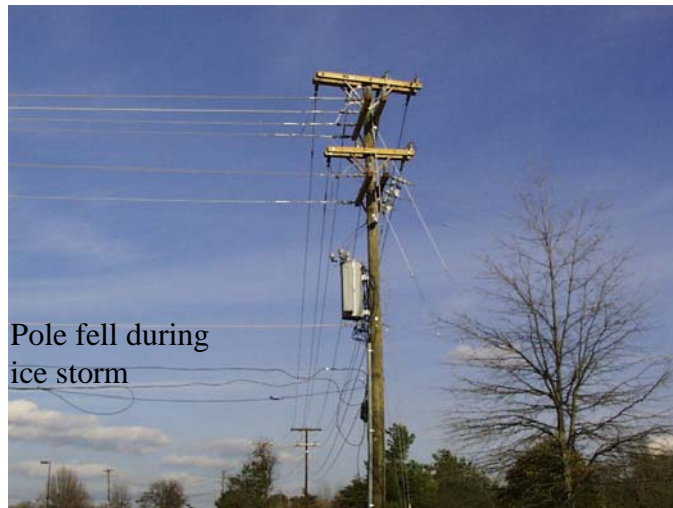
The original guy lead was too short,
and the pole fell on Jan. 3 1999.

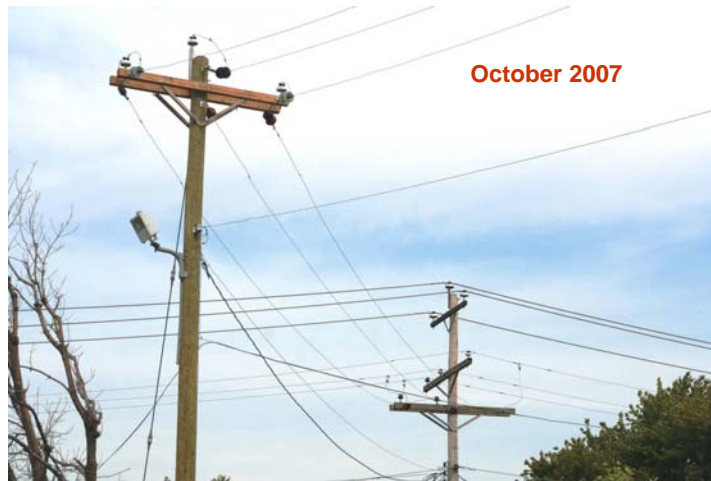
Pole hit on 3 span tap feeding one customer – 1,951 Customers Out

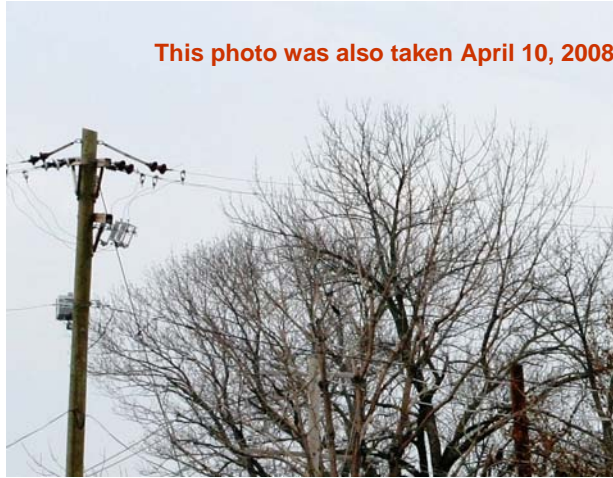
Side view of pole hit by truck last year.

This photo was also taken April 10, 2008.
