Construction Quality Assurance

Lee Taylor – Consulting Engr - Duke Energy
2008 IEEE T&D Conference and Exposition
April 23, 2008 - Chicago, Illinois

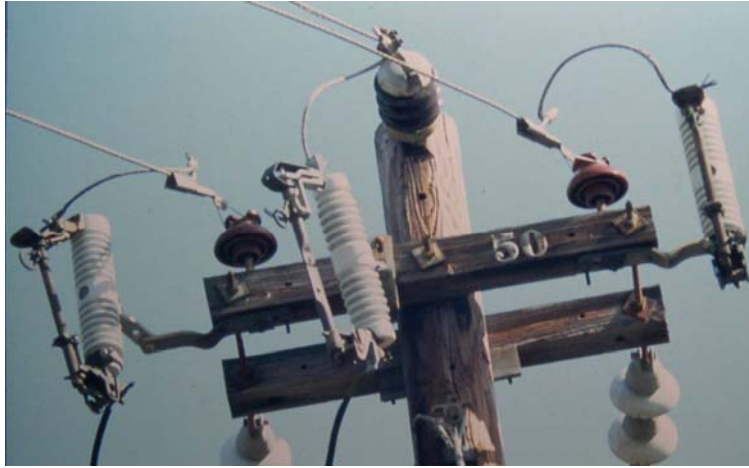
“How do you like these low cost, primary dead-ends?”

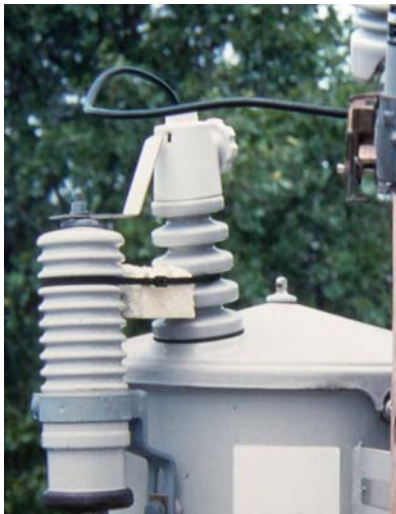
“Here’s a time saver – just leave the packing material and keep going.”

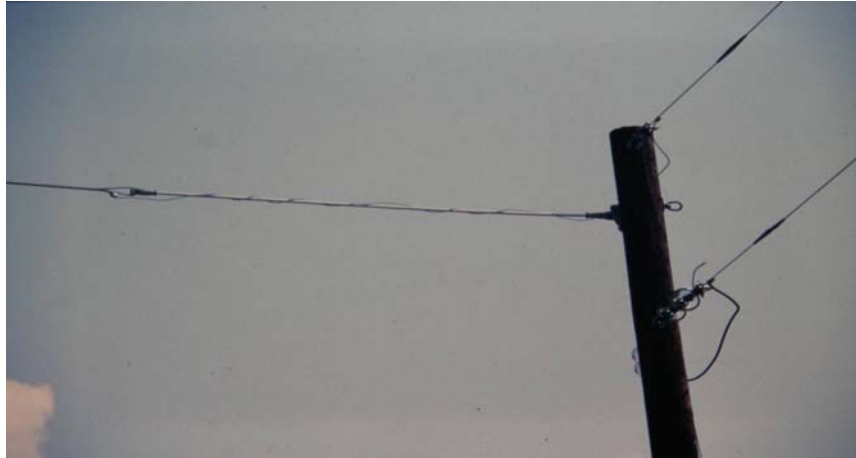
“I’m going to bond that guy wire,
no matter what.”

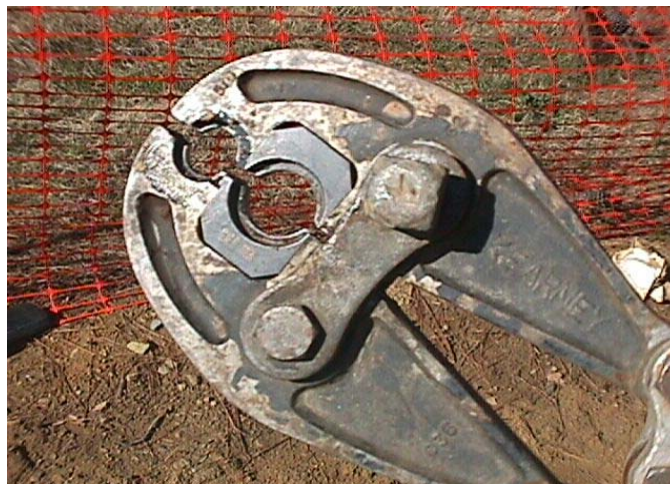
“I can fix anything with a hard
head.”

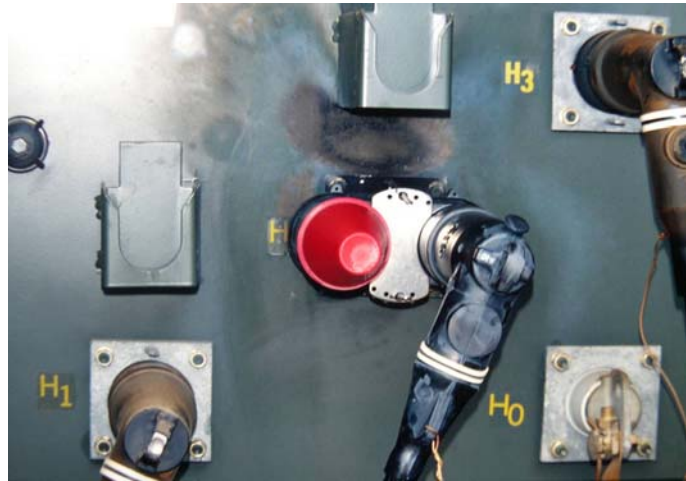
“This plastic thing they sent is a lot less expensive than an insulated plug!”

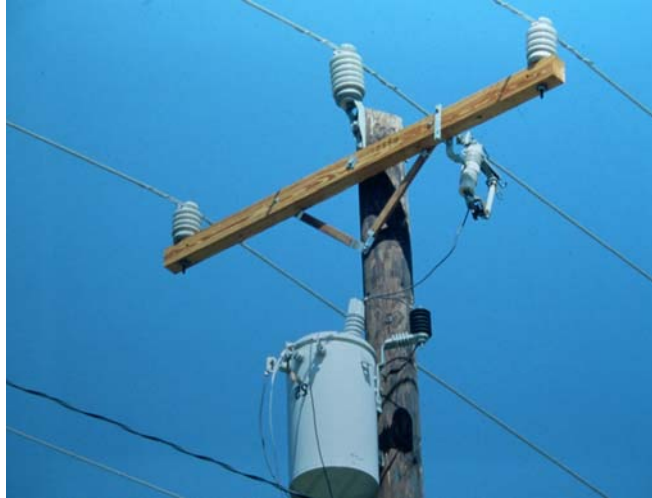
Failed to install animal guard on lightning arrester.

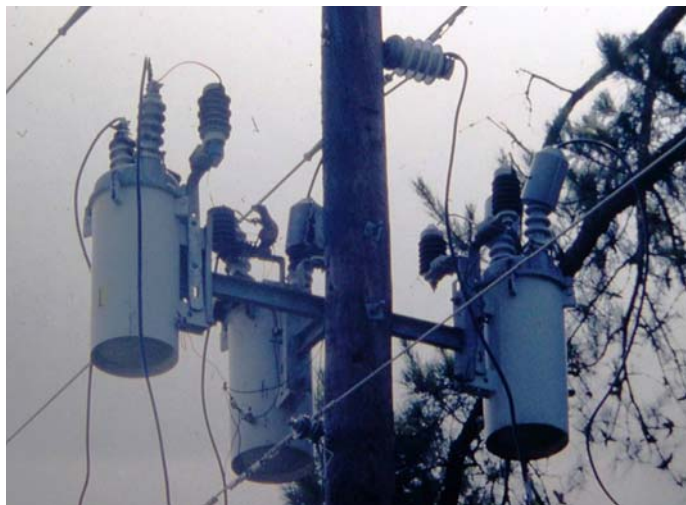
The same error causes and outage on an entire feeder.

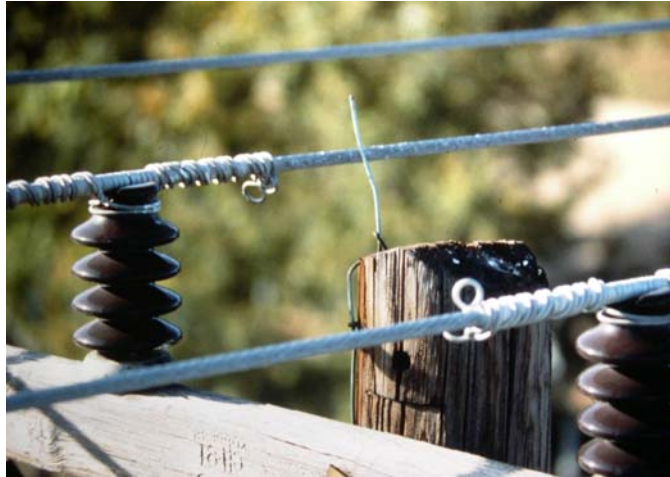
Failed to remove bonded ground wire at top of pole.

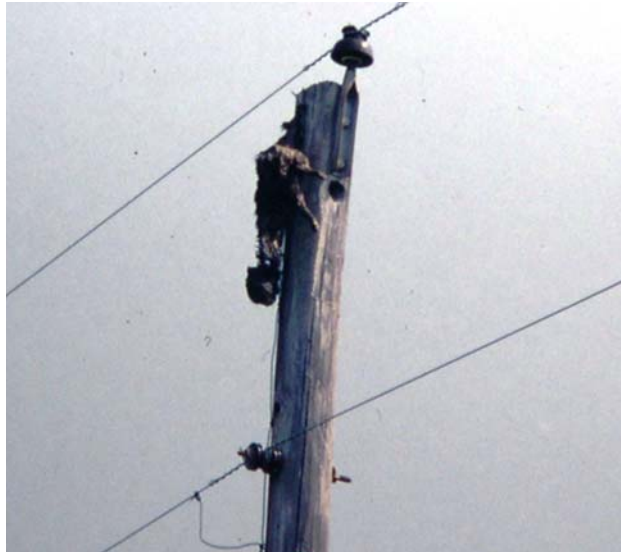
Same error killed this cat.

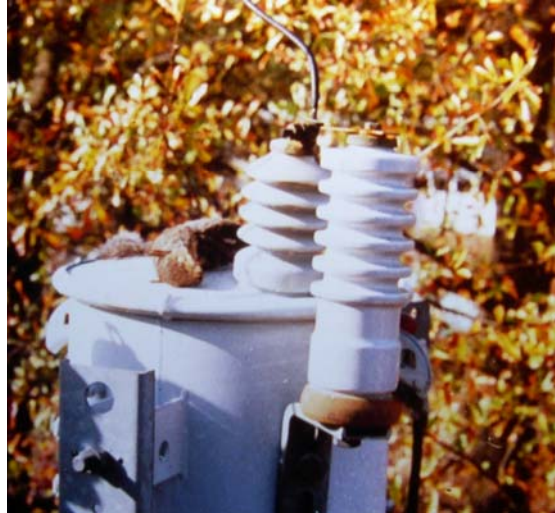
Failed to install animal guard on transformer bushing.

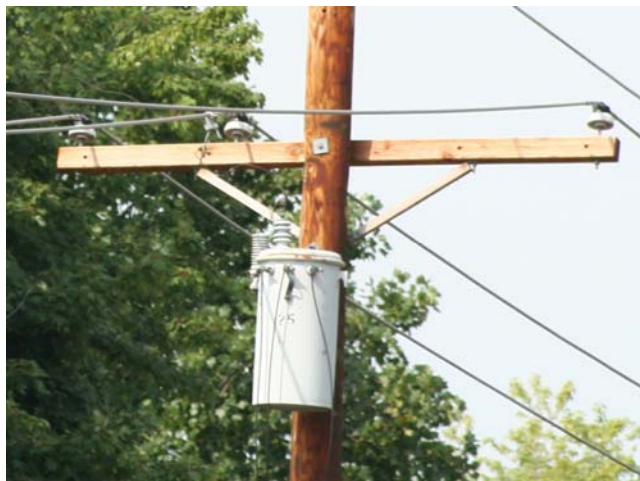
Failed to install fuse and animal guard on transformer when set up on pole.

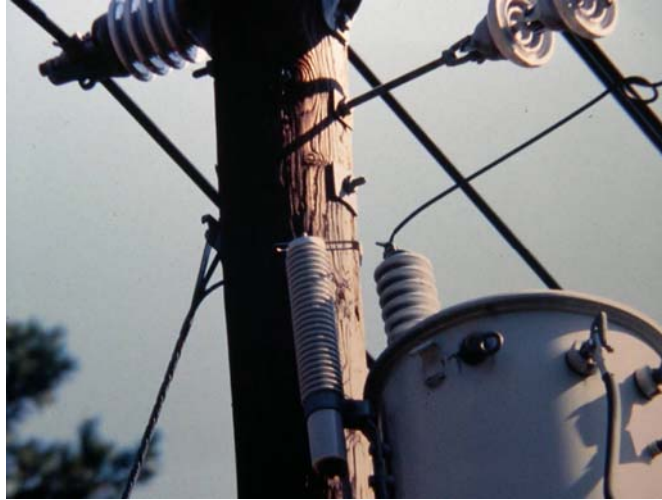
Before: Bonded guy plate near gapped arrester – no animal guards.

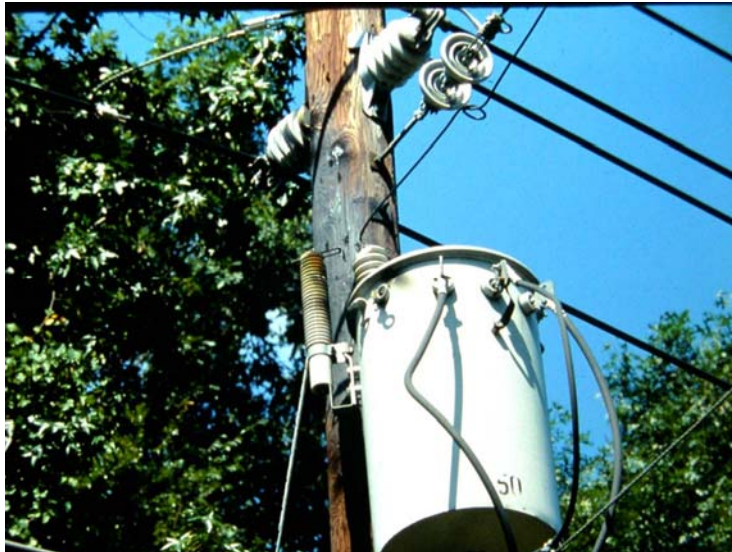
Six months later: Same pole, arrester, and bushing have been in a bad flash.

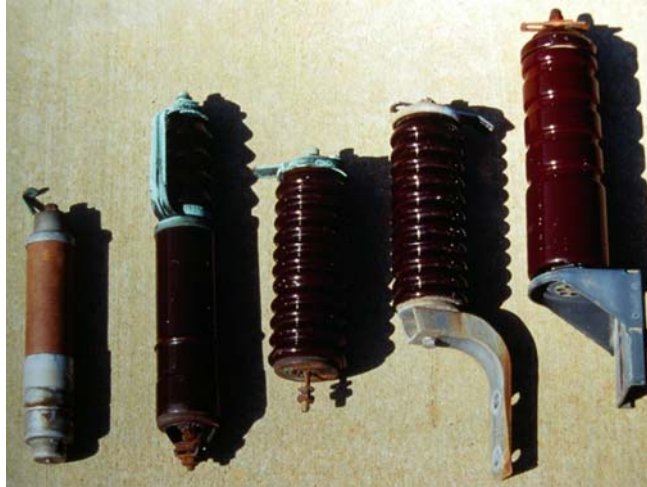
Technology from the 1930's – expulsion arresters allow power follow arcs.

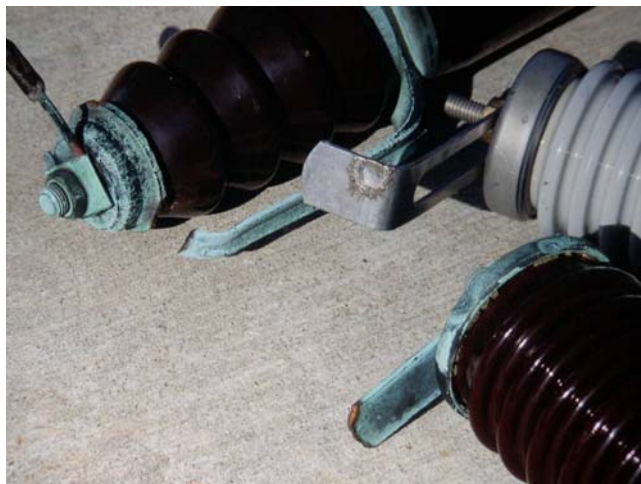
Melted metal means power follow arcs.
These arresters have joined the other side!

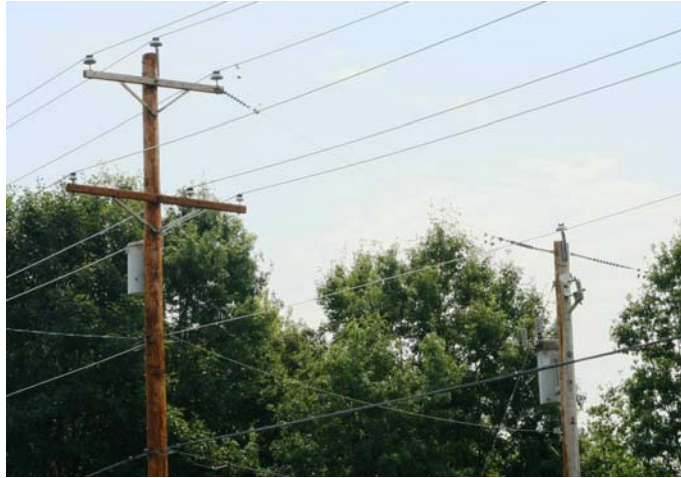
Overdutied Wire feeding 140 Amp Line Recloser

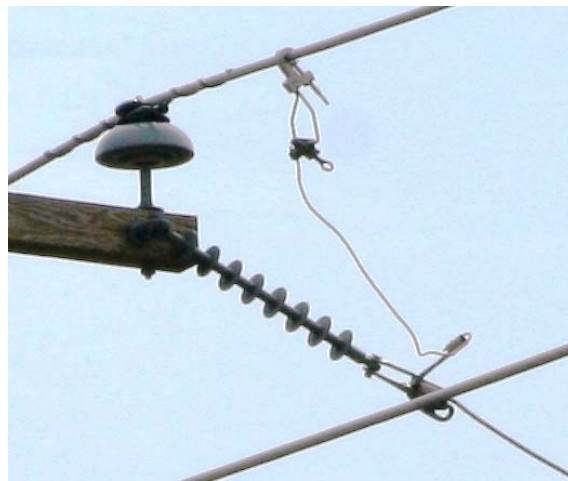
Overdutied Wire feeding 140 Amp Line Recloser

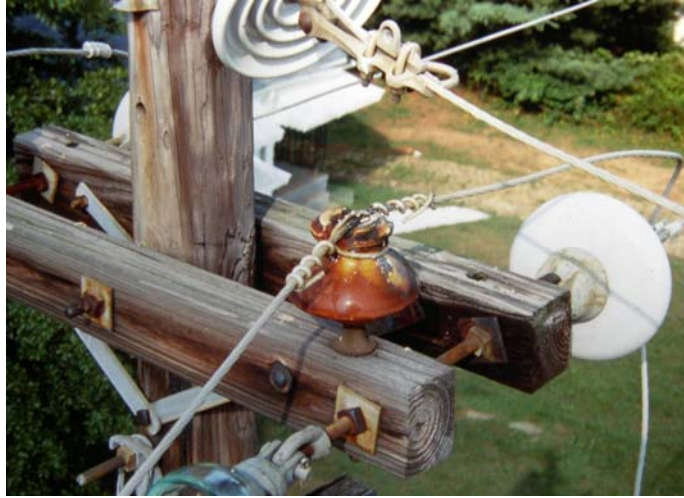
Construction error causing birds to “connect phases” = 50 trips per year on this circuit.

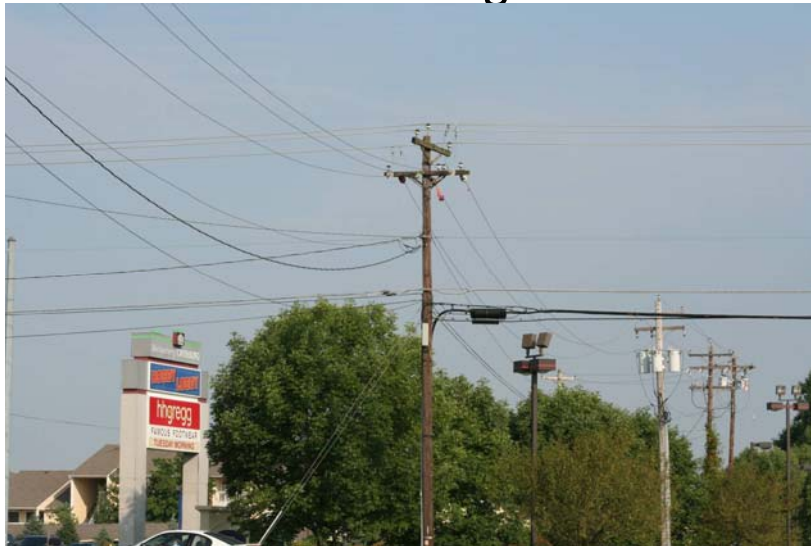
Unfused taps are a common cause of circuit lockouts. Engineer error.

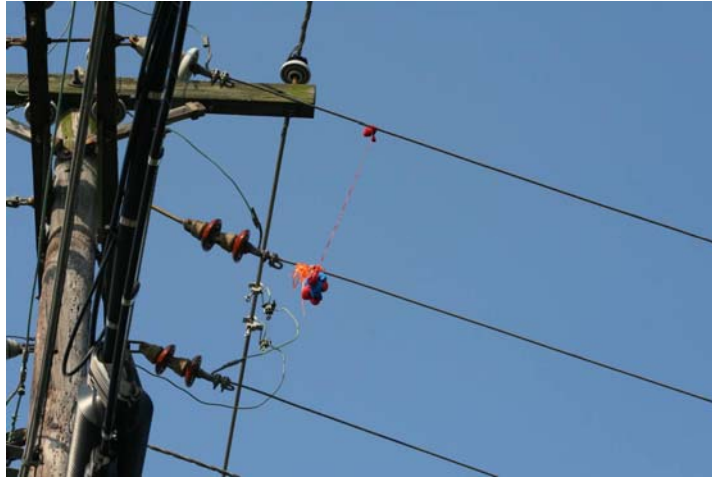
Remains of Balloon on Tap

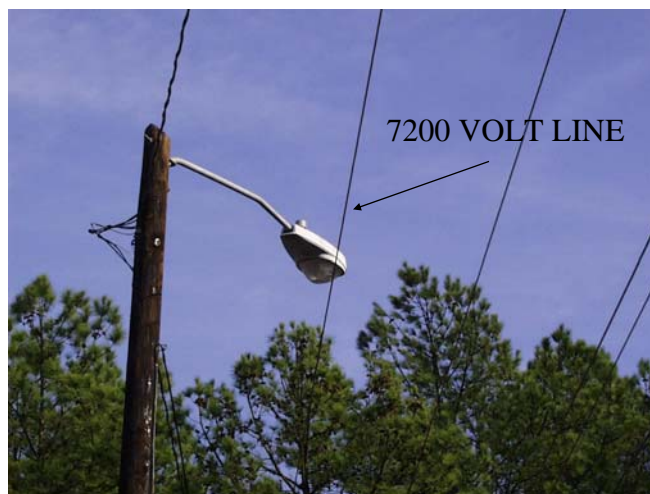
Street light installed above primary.

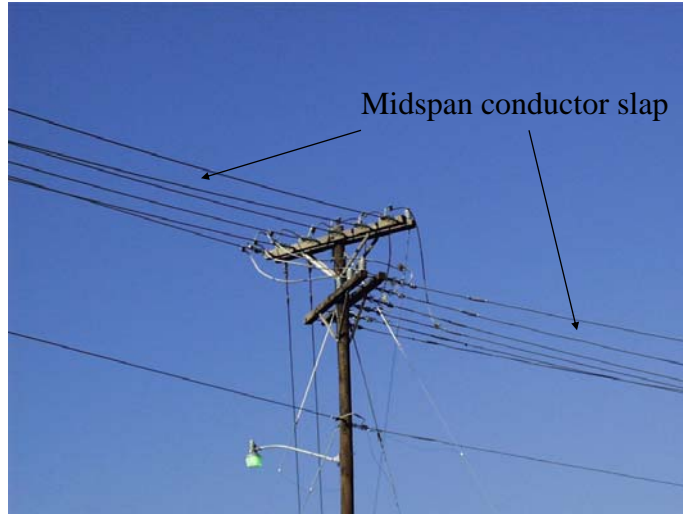
Two circuits on one ten foot arm often results in mid-span conductor faults.

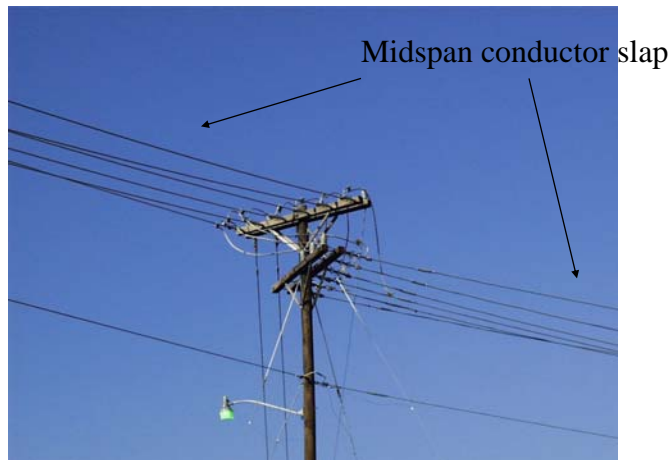
Two circuits on one ten foot arm
ALWAYS
results in mid-span conductor faults.

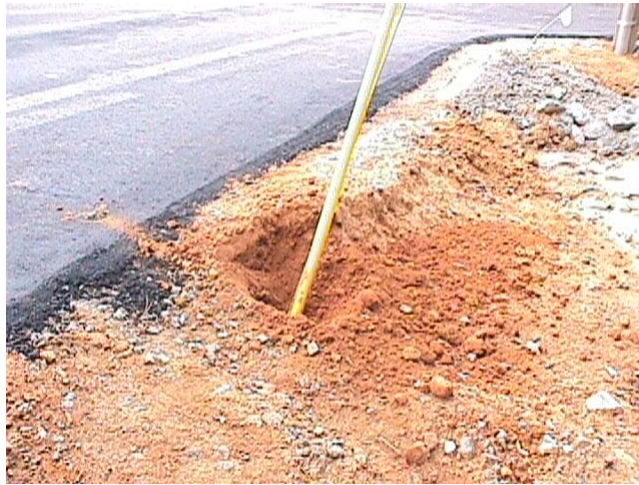
Buried guy preforms rust off and often result in broken poles.

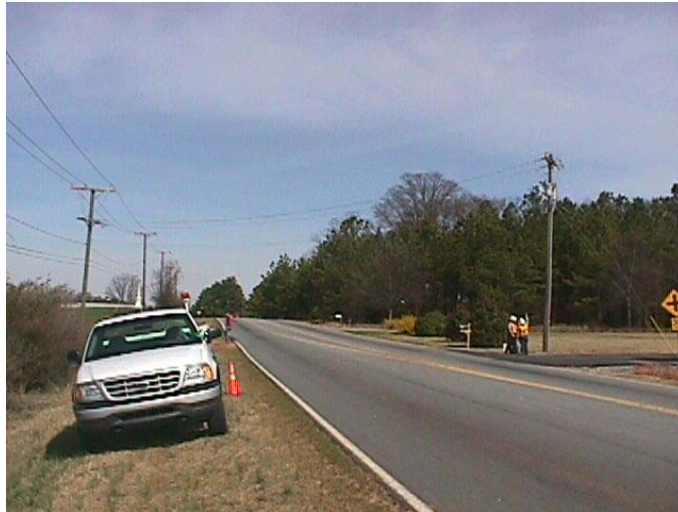
Guyed on one end and not on the other.

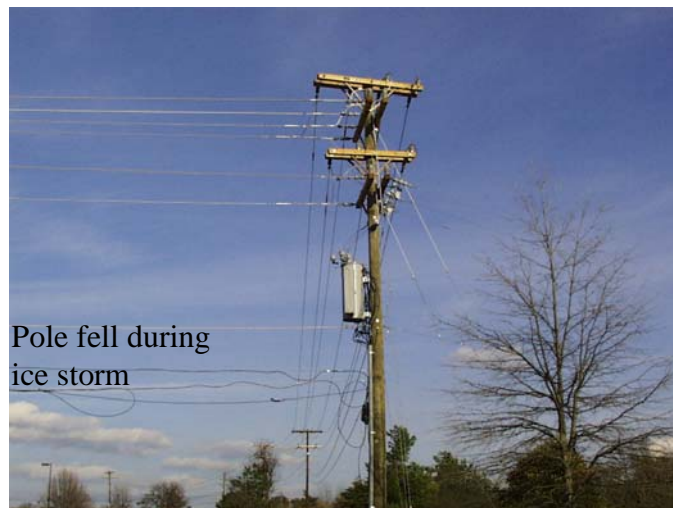
The original guy lead was too short,
and the pole fell on Jan. 3 1999.

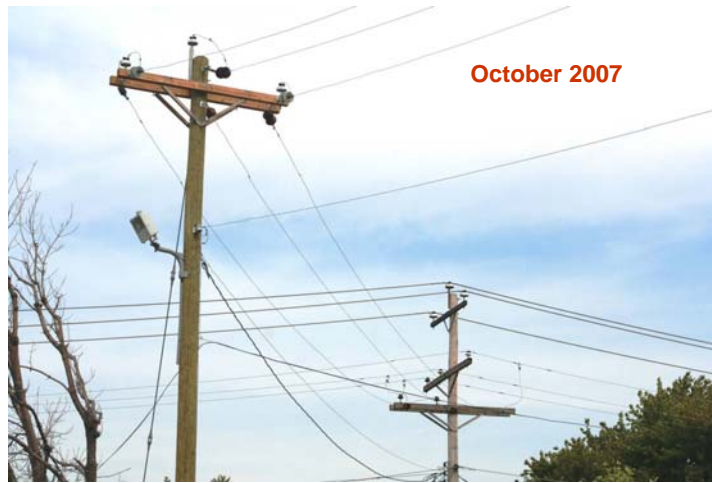
Pole hit on 3 span tap feeding one customer – 1,951 Customers Out

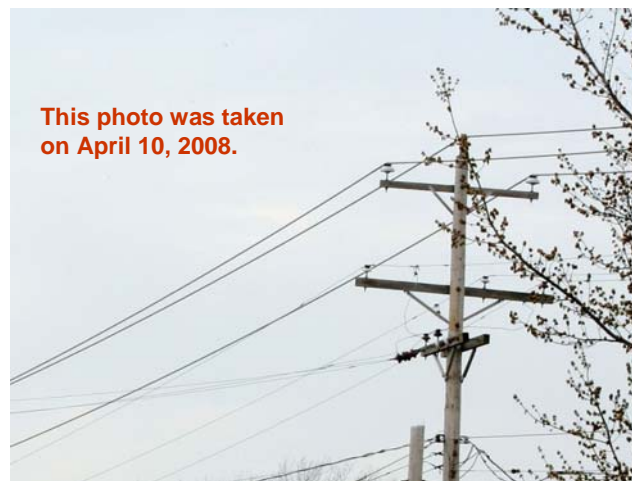
Side view - pole where follow-up engineer specified fused cutouts to be placed.

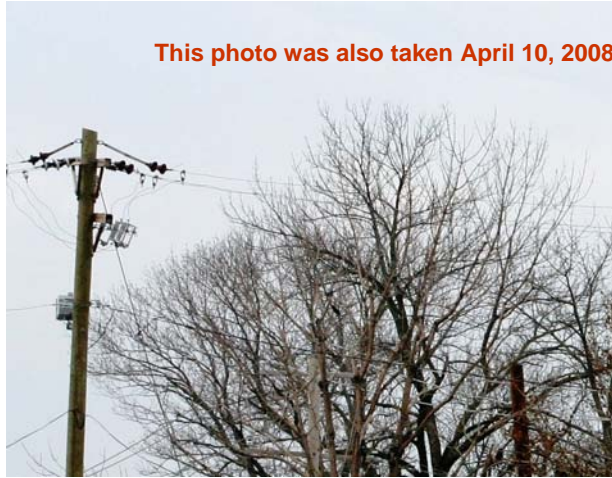
Side view of pole hit by truck last year.

This photo was also taken April 10, 2008.

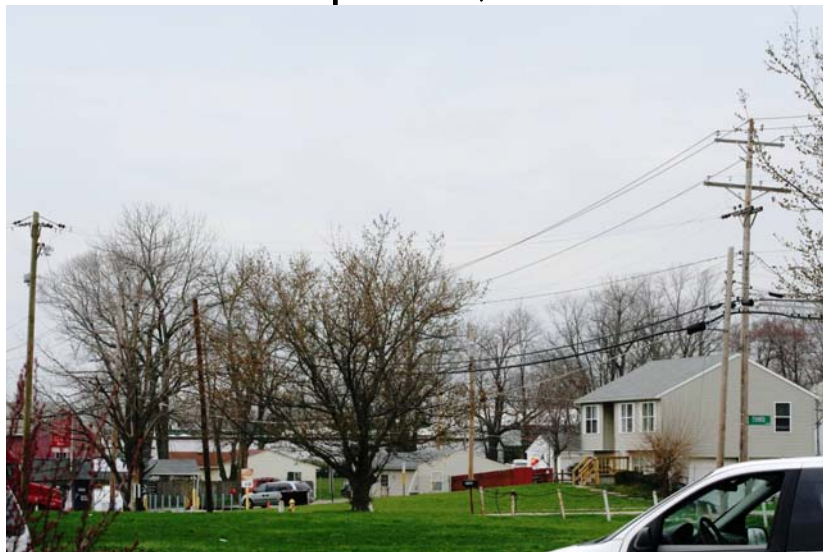
Full view of unfused span
on April 10, 2008
