Construction Quality Assurance

Lee Taylor – Consulting Engr - Duke Energy
2008 IEEE T&D Conference and Exposition
April 23, 2008 - Chicago, Illinois

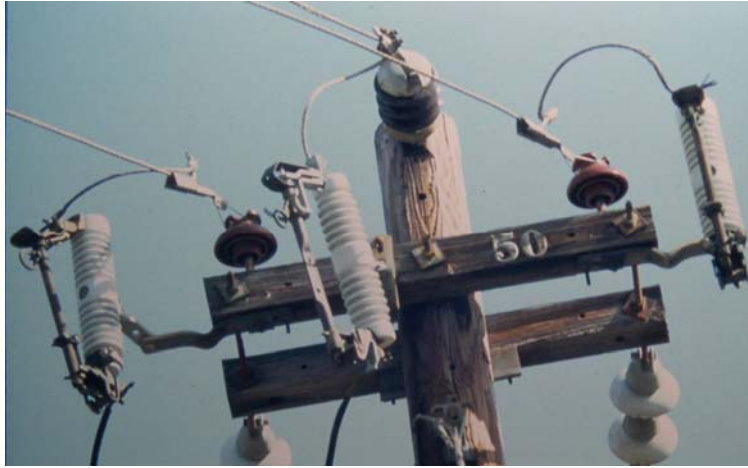
“How do you like these low cost, primary dead-ends?”

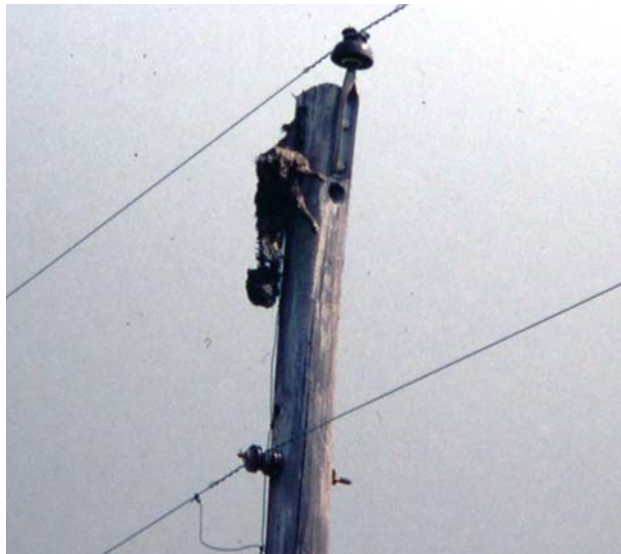
Same error killed this cat.

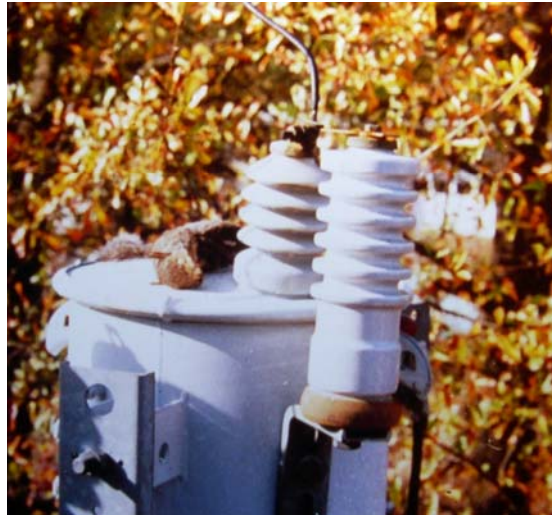
Failed to install animal guard on transformer bushing.

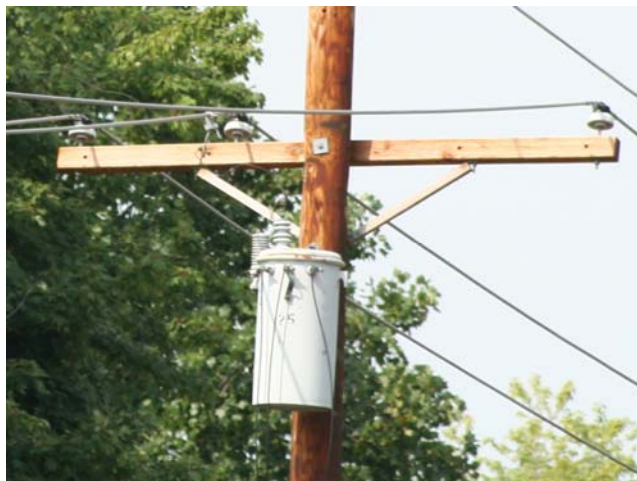
Failed to install fuse and animal guard on transformer when set up on pole.

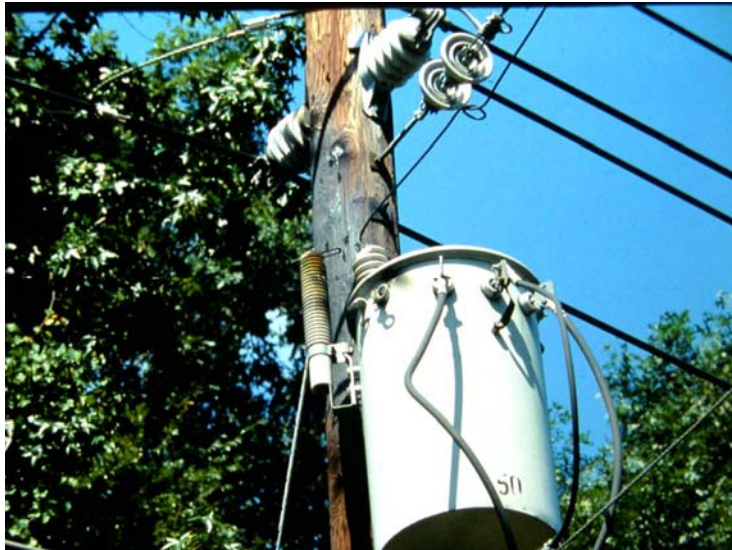
Six months later: Same pole, arrester, and bushing have been in a bad flash.

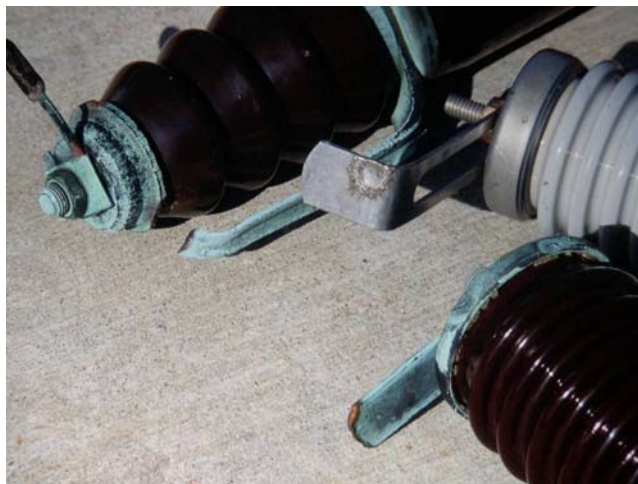
Melted metal means power follow arcs.
These arresters have joined the other side!

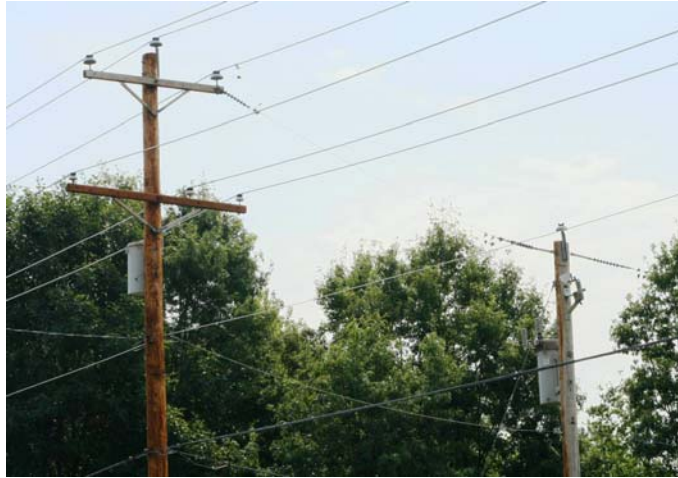
Overdutied Wire feeding 140 Amp Line Recloser

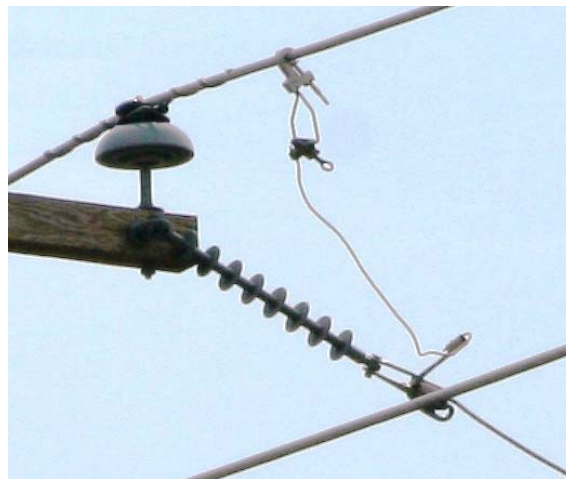
Overdutied Wire feeding 140 Amp Line Recloser

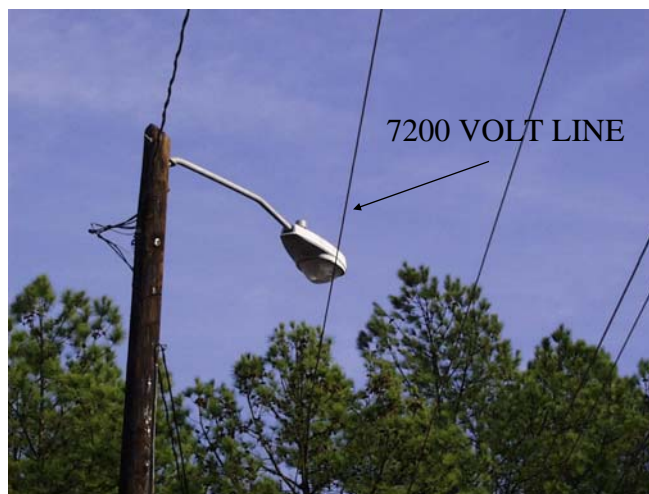
Street light installed above primary.

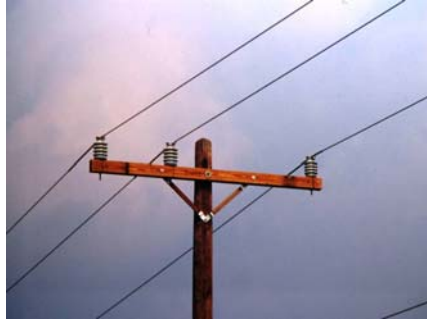
Avoid placing close conductors in the same horizontal plane.

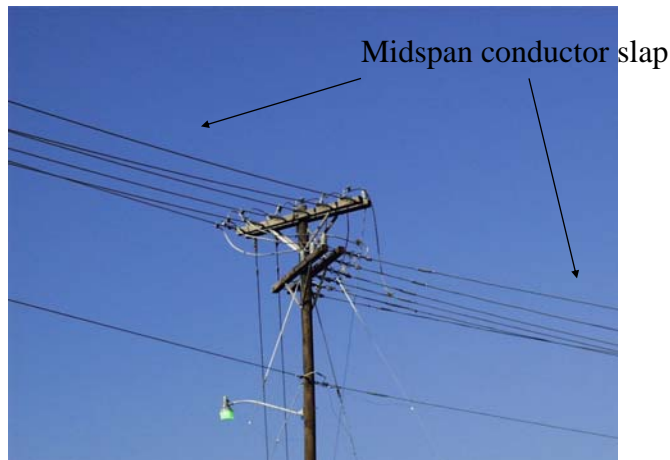
Two circuits on one ten foot arm
ALWAYS
results in mid-span conductor faults.

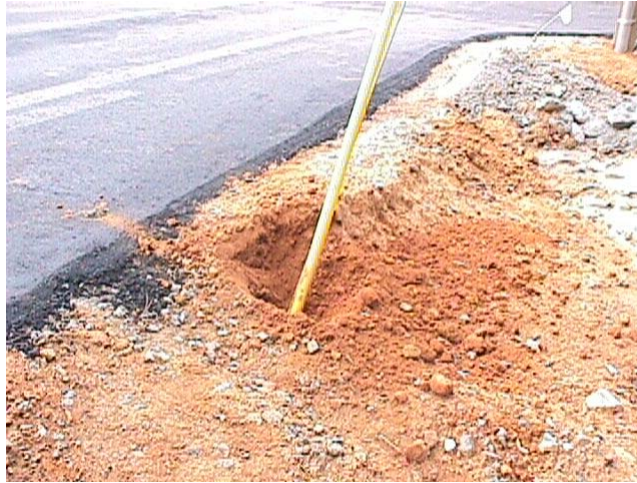
Buried guy preforms rust off and often result in broken poles.

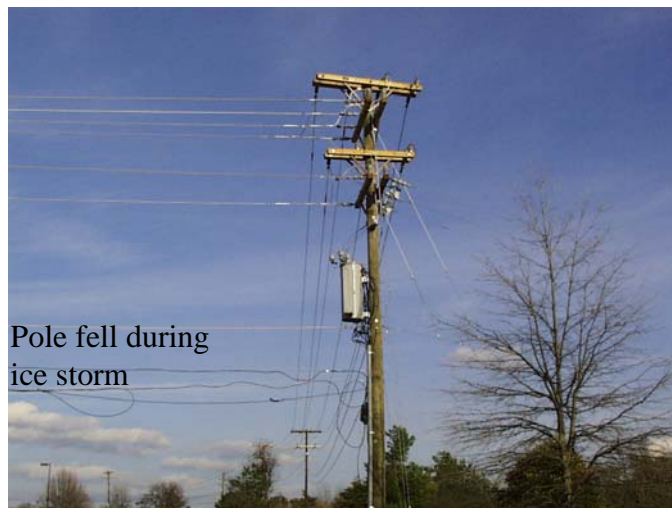
The original guy lead was too short,
and the pole fell on Jan. 3 1999.

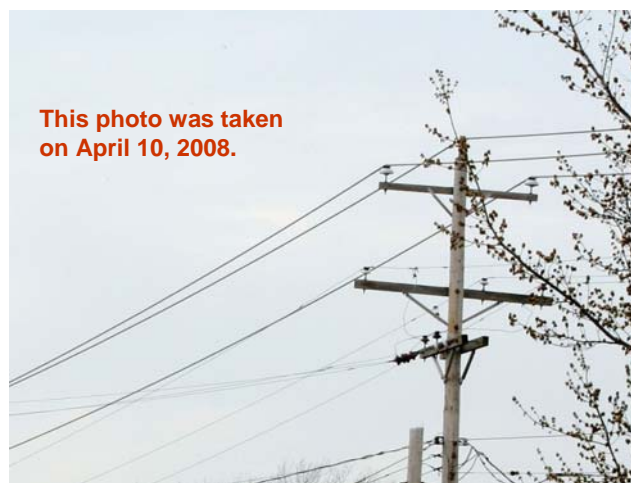
Side view - pole where follow-up engineer specified fused cutouts to be placed.

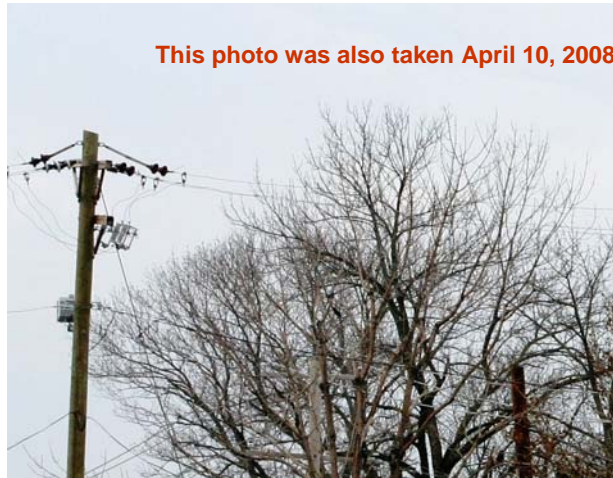
Side view of pole hit by truck last year.

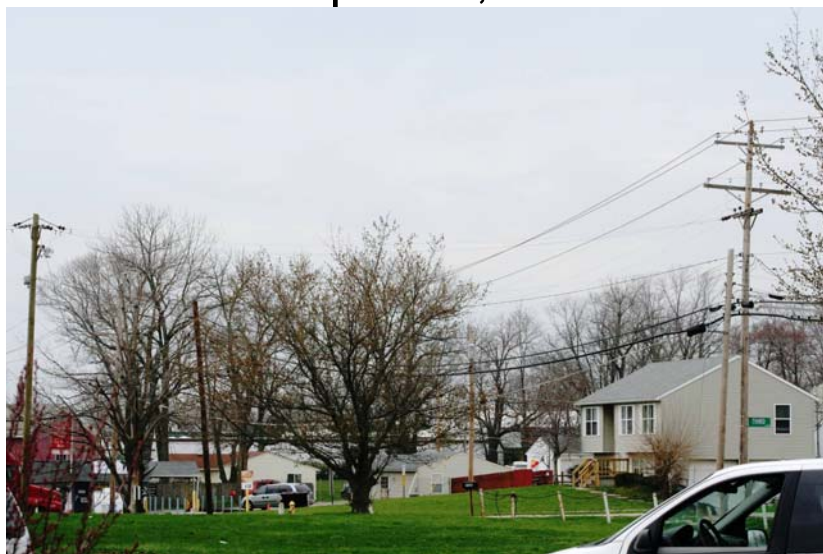
Full view of unfused span
on April 10, 2008
