Class 0 & Reliability ESD Case Studies

Ted Dangelmayer www.dangelmayer.com

Outline

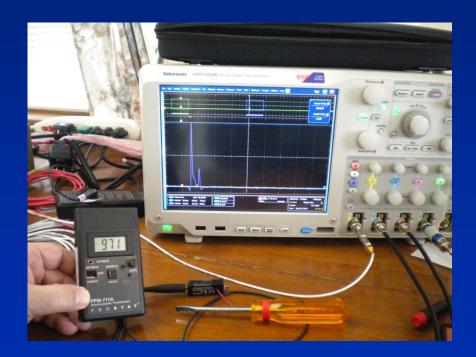
Root Cause of Factory Failures Screwdriver Discharge Current Test – 6.7 Amps

- Military ESD Requirements 40 Years Out Dated
 - Minimal CDM Controls In Place
- Compliance Verification
 Inadequate
- Charged Screwdriver
 - Used At Multiple Manufacturing Sites
 - Generated Discharge
 Currents up to 6.7 Amps!!!

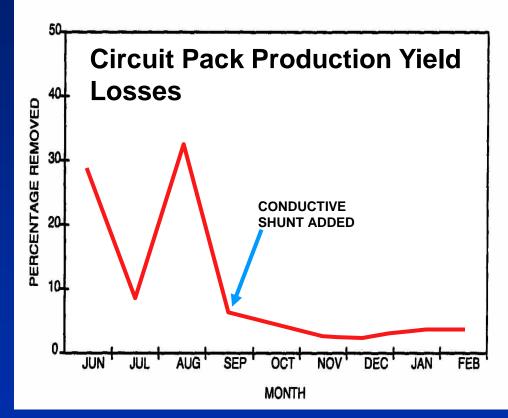
Customized Solutions Are Essential Circuit Board - Class 000 Case Study:

- Design Transfer
 - No ESD Data
- 15 Volt CDM Threshold
- 100% Failure Rate: Some Lots
- \$1.2B Sales Jeopardy
- \$1K Invested in Shunt
- \$6.2M/yr Savings Documented

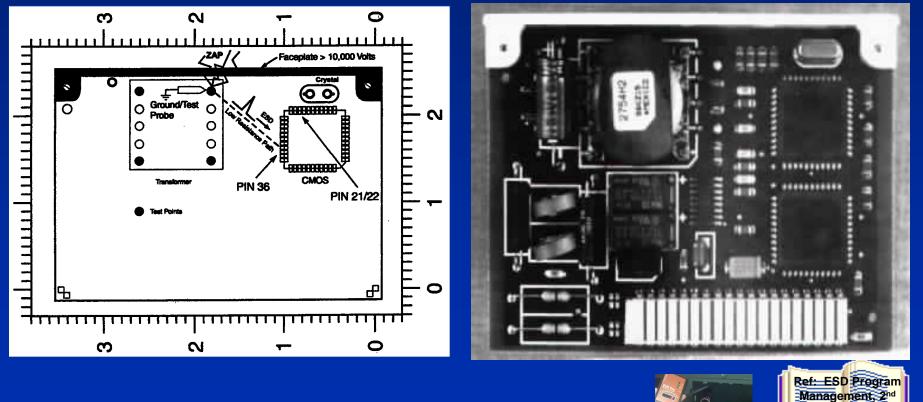
Faceplate Field- Induced CBE Failure

Established Code - New Faceplate Supplier

40% Failure Rate - 1.5KV CDM Threshold

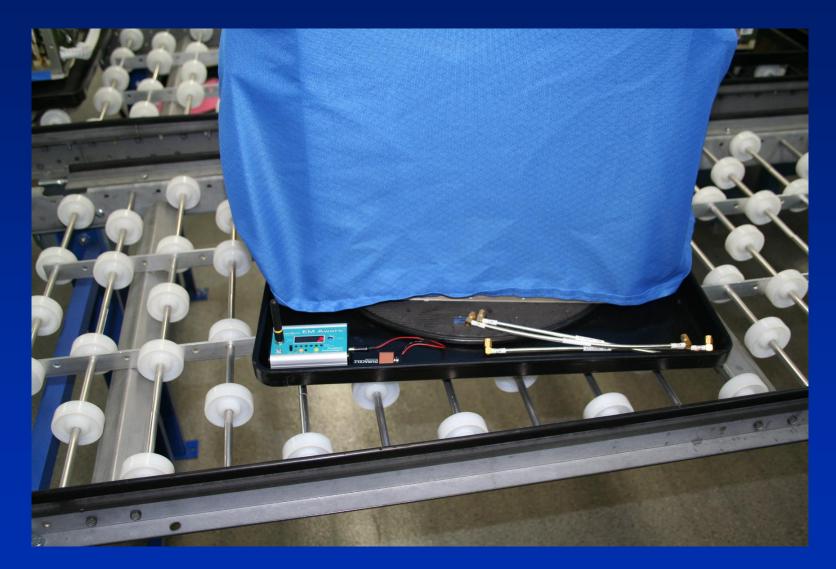
- Background Subsystem Assembly Operation
 - 12% Circuit Board EOS Failure Rates
 - FA Determination by IC Supplier was EOS
 - Ungrounded Conveyor System
 - Static Generating Carts
 - Strong & Persistent ESD Discharge Events
 - During Assembly Operations
 - Installing Coax Cables
- ESD CBE & CDE Countermeasures Reduced Failures by 80%

Strong ESD Events During Assembly *Charged Product and Cables*

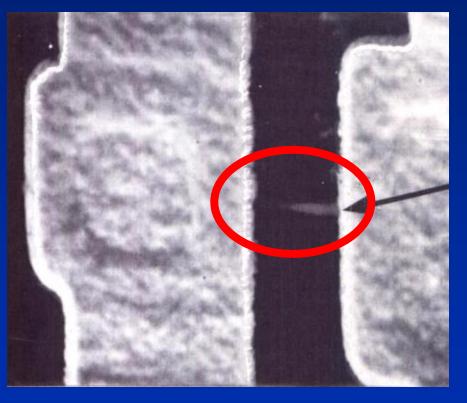
- Bipolar Junction
- 450 Volt HBM Withstand Voltage
- 3 of 15 Failed QA Tests
- 5 of 24 Circuit Boards
 Failed after Five Days
- Customer Failures: 17 of 31 Circuit Boards Failed after two Weeks

Latent Failure

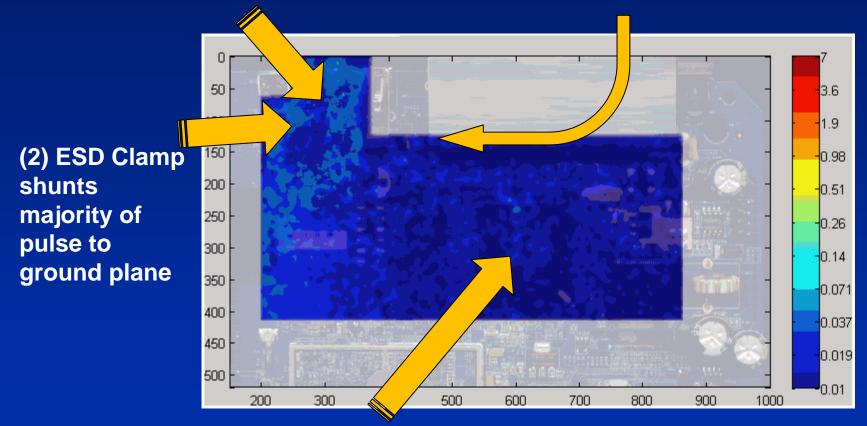
Example of USB strike causing Ethernet soft error...

(1) ESD pulse is injected into USB port (Units in A/m)

(4) Some energy coupled into nearby nodes (Ethernet port) causing upset

(3) Residual Current shunted by clamps inside ASIC

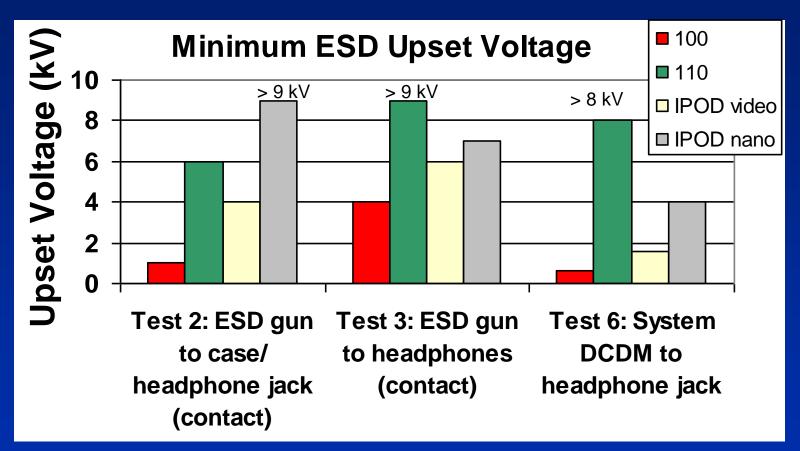
Tinnitus Unit vs. IPOD Comparison

- Significant improvements in 110 processor
- Passes Level 2 (>4kV failure level)

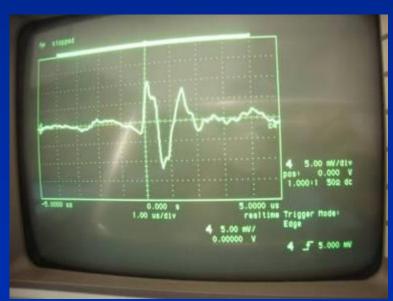
Maximum current: 2mA Horizontal: 1us/div Vertical: 5mV/div Trigger: 5mV

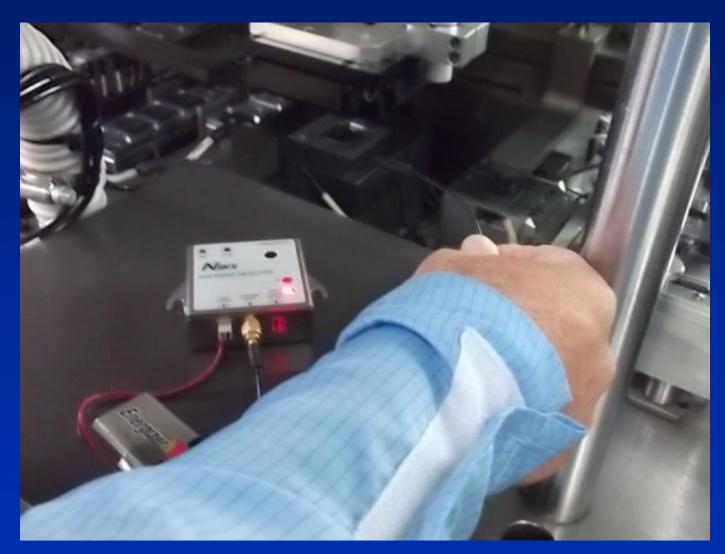
30 Volts on Device ESD Events Detected – Must Determine Source!

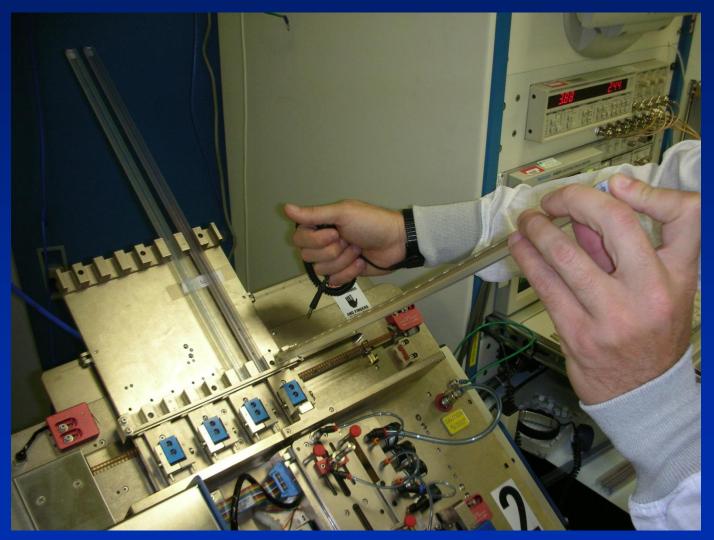
Test Handler – Multiple ESD Events Including Double Jeopardy & Class 0A Devices

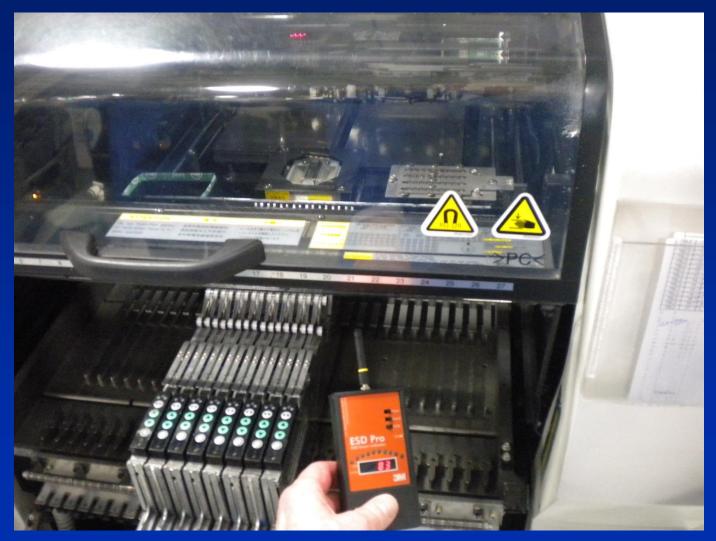
SMT ESD Events Common Issue *Must Locate & Eliminate Risk for Class 0*

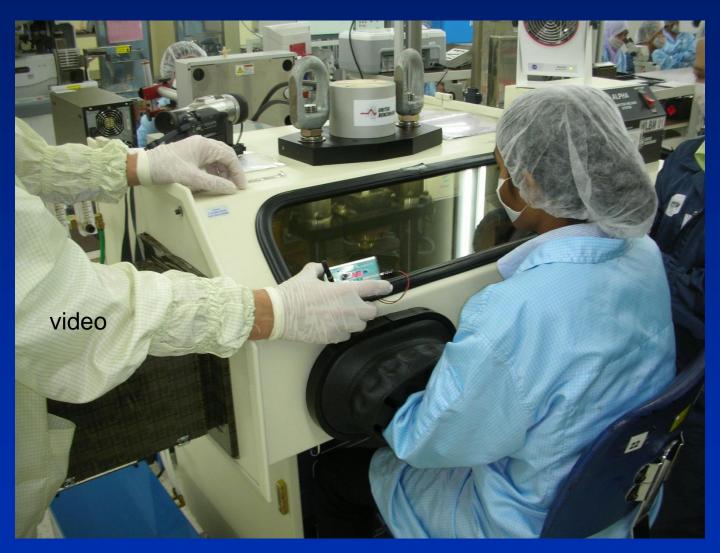
ESD Events in Glove Box Common Issue High Risk For Class 0A

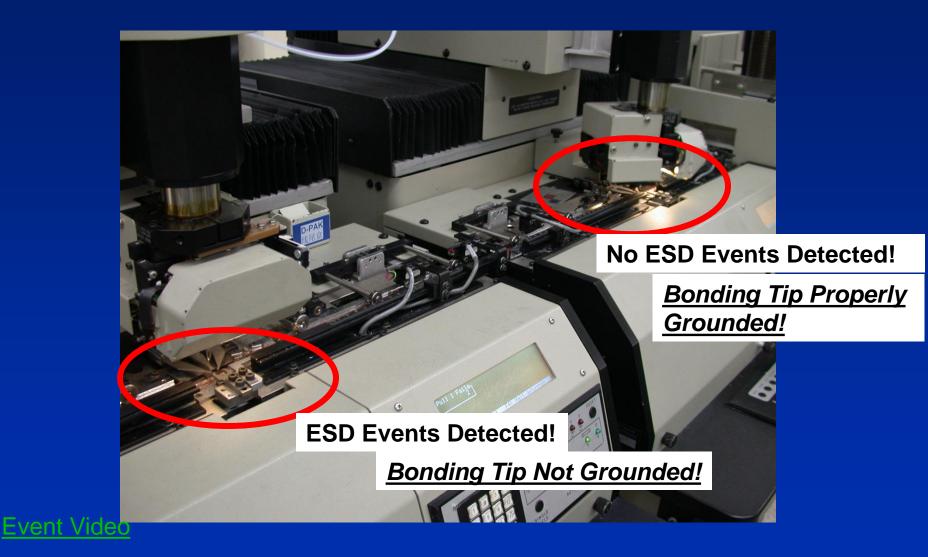
Proper Grounding Essential ESD Event Detection Good Analytical Tool

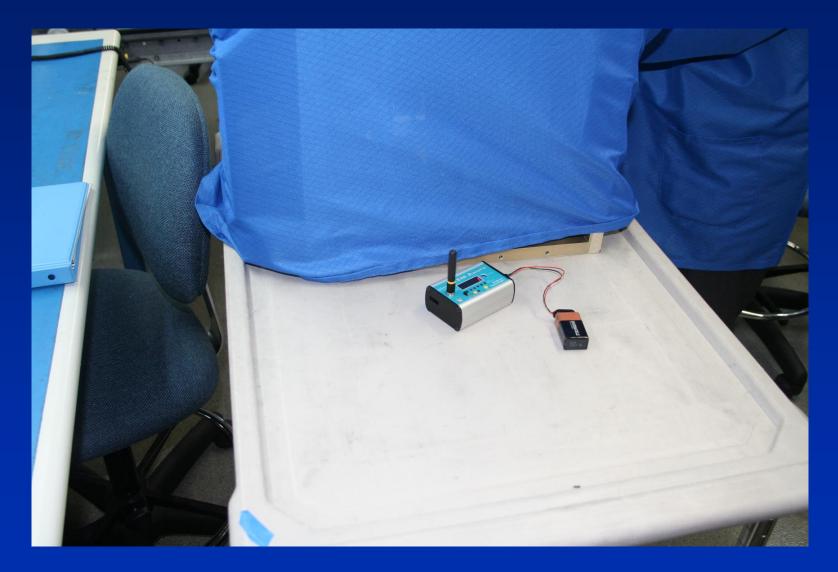
ESD Events Due to High Charging Carts
