Troubleshooting and Lessons Learned Using Protective Relay Event Analysis

GE Digital Energy Multilin

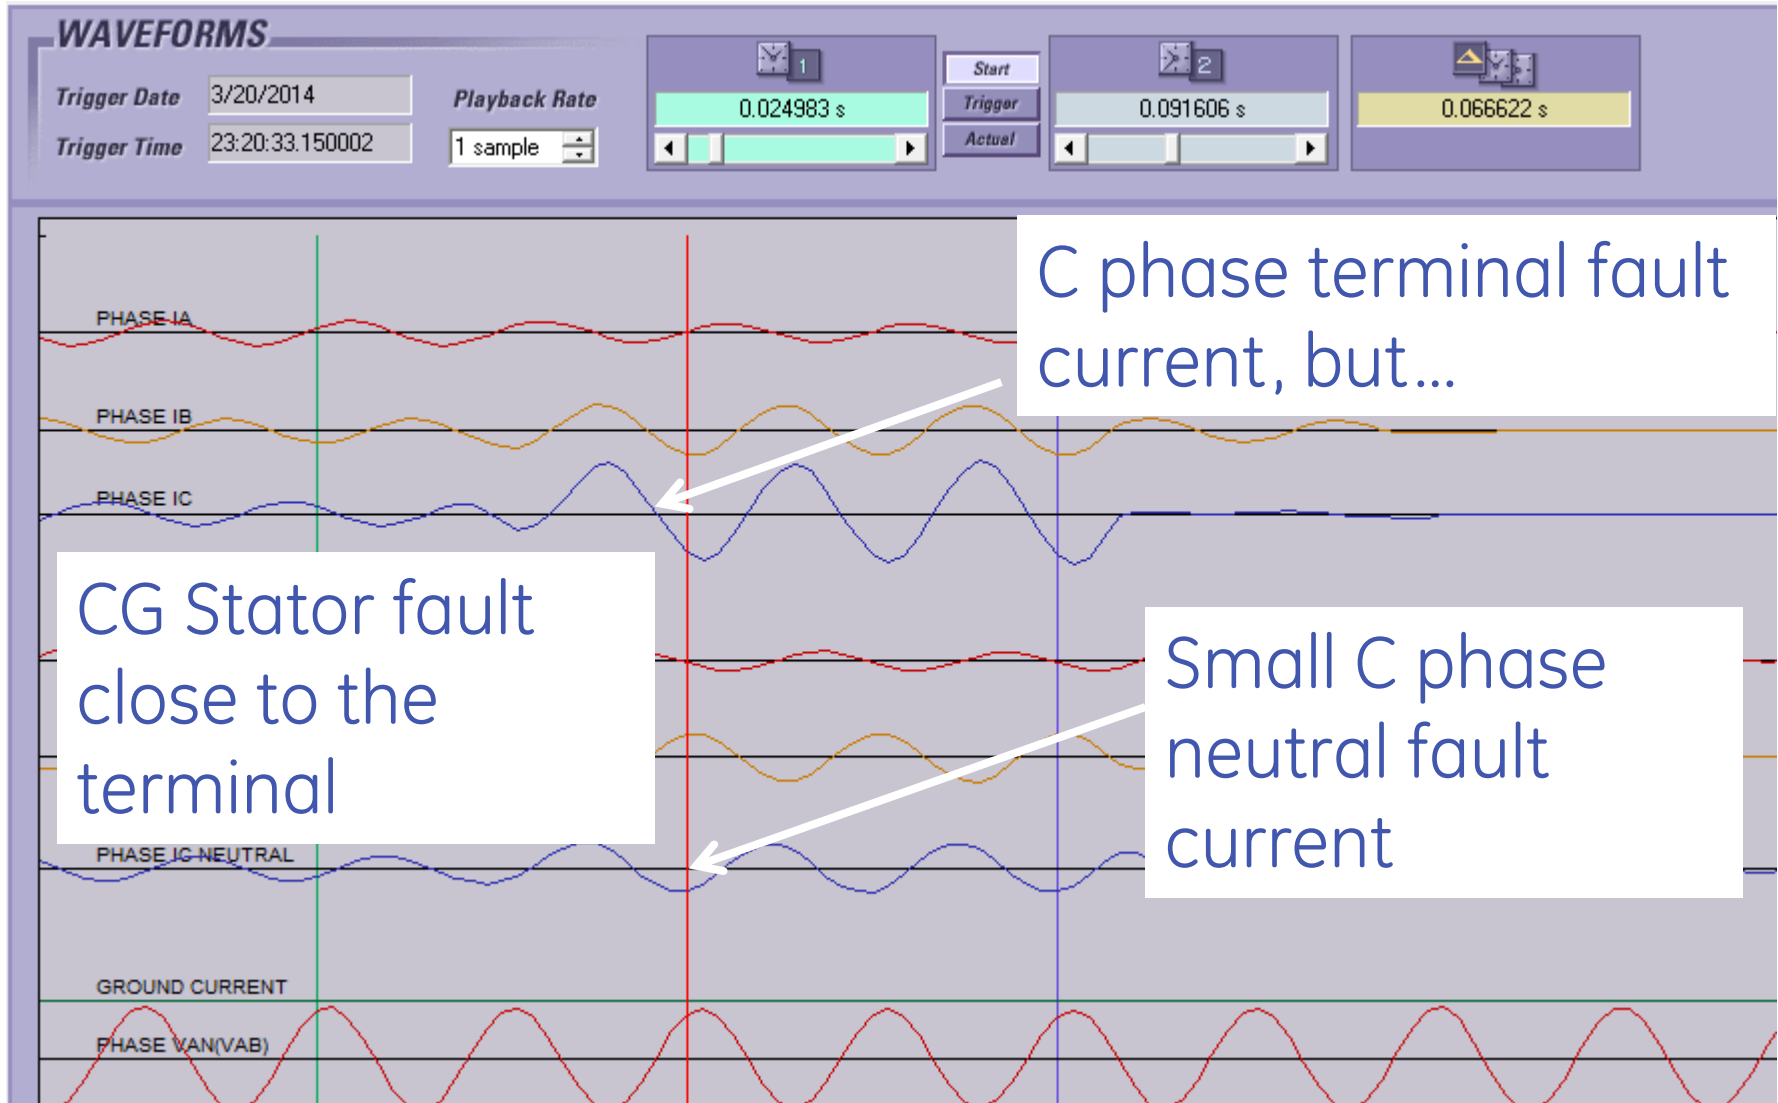
What about the Generator???

What happened here??

- C phase to ground fault because of the snake
- Zone interlocking scheme failed because of a settings error
- Generator failed due to the extra stress caused by the fault.
- Biggest Challenge was synchronizing the time differences in the relays.

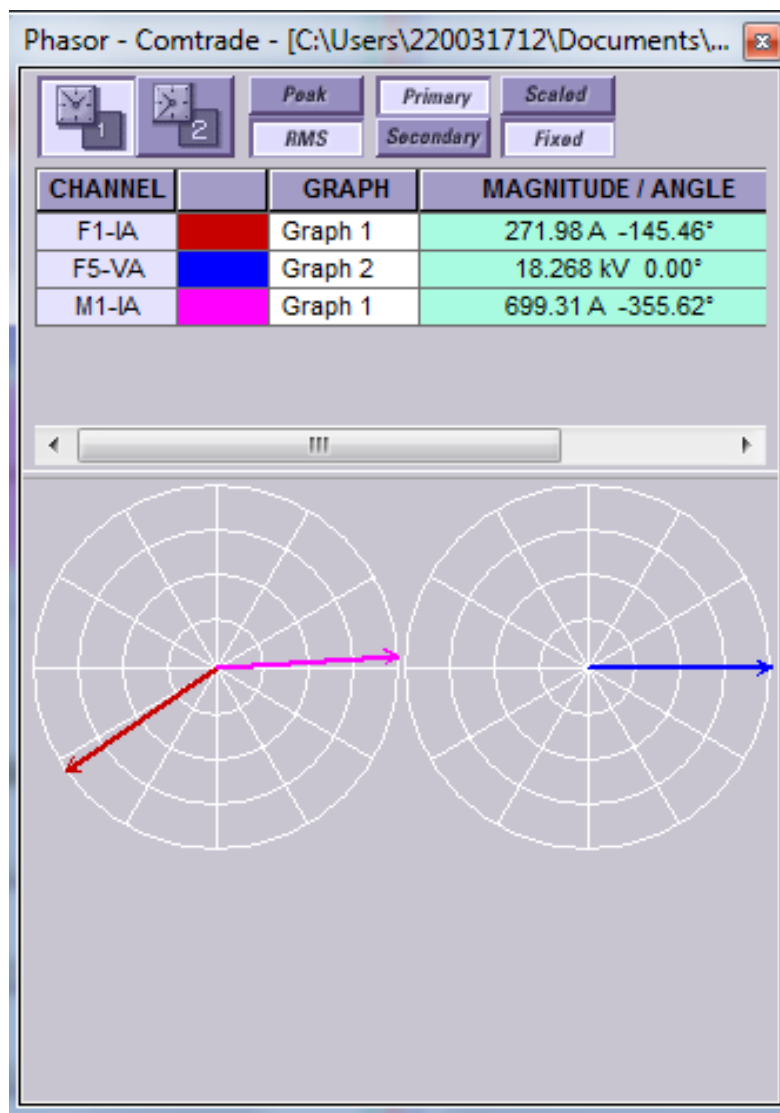
**Something with your current
is not right !**

**Ok, then why don't I trip on
Differential?**

Once I account for transformer, currents sum to zero

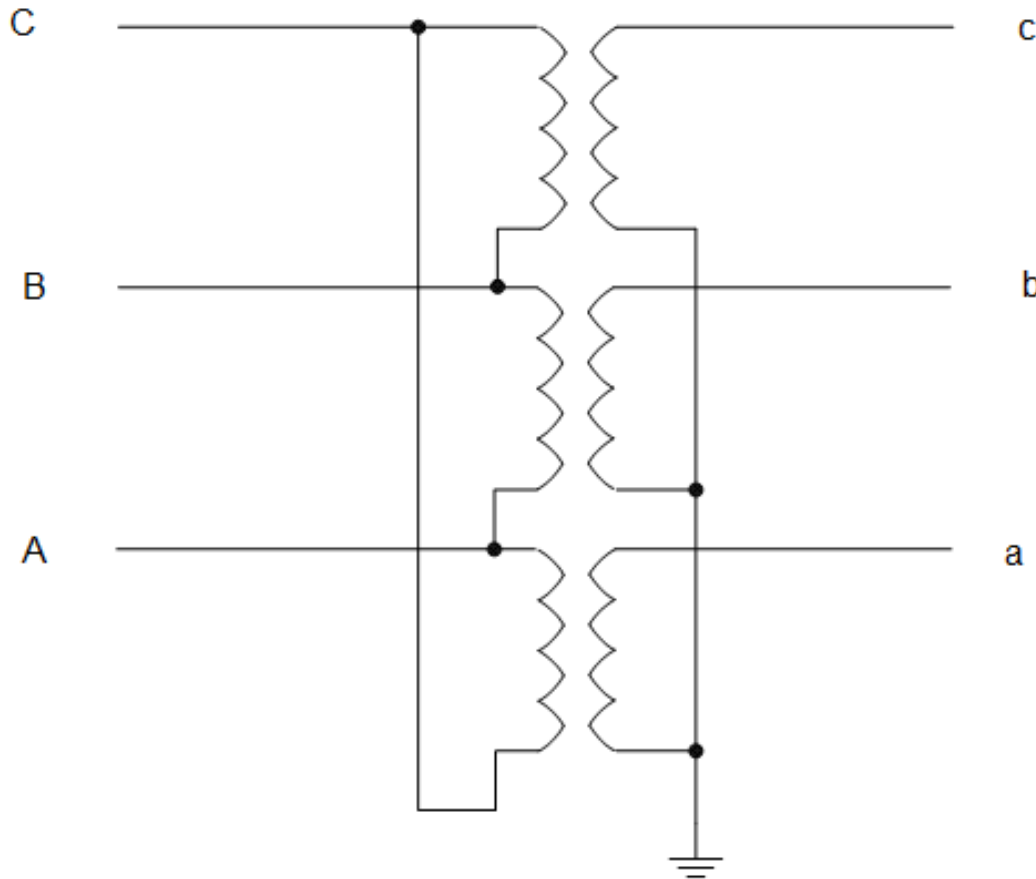
But this isn't ABC rotation:

Typically H Winding lags X winding by 30 degrees on ACB rotation

Trip occurred because of setting

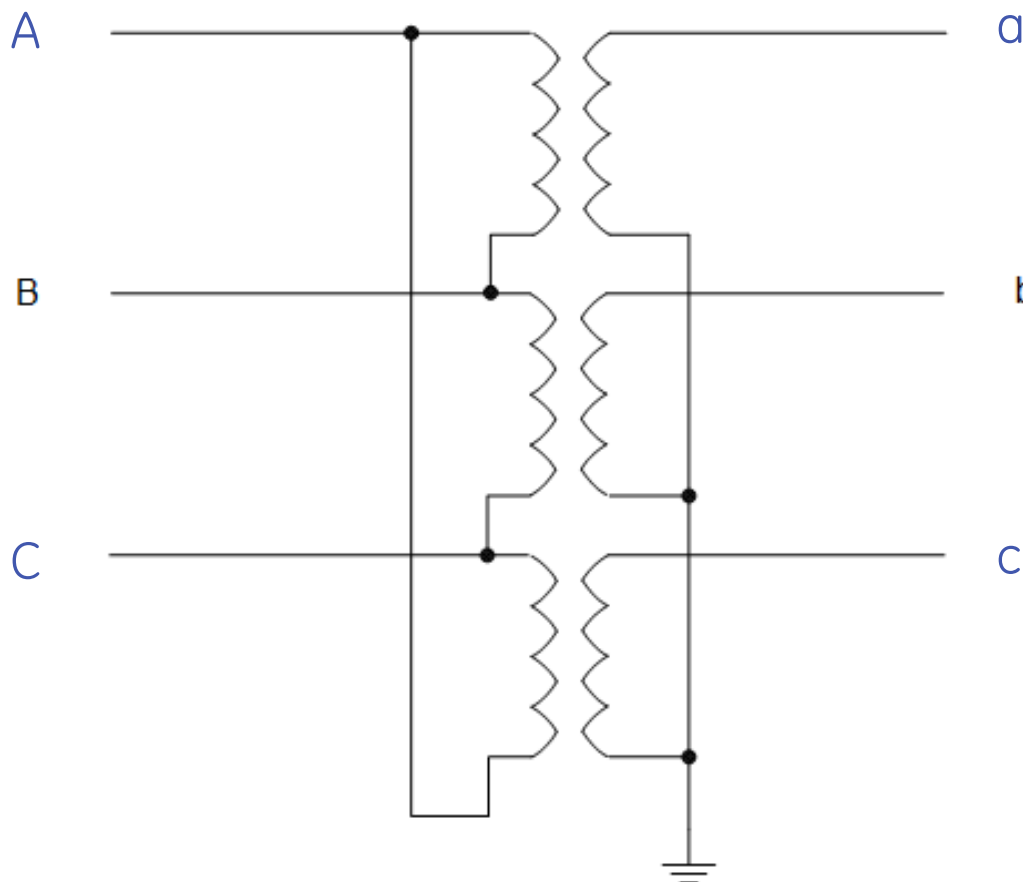
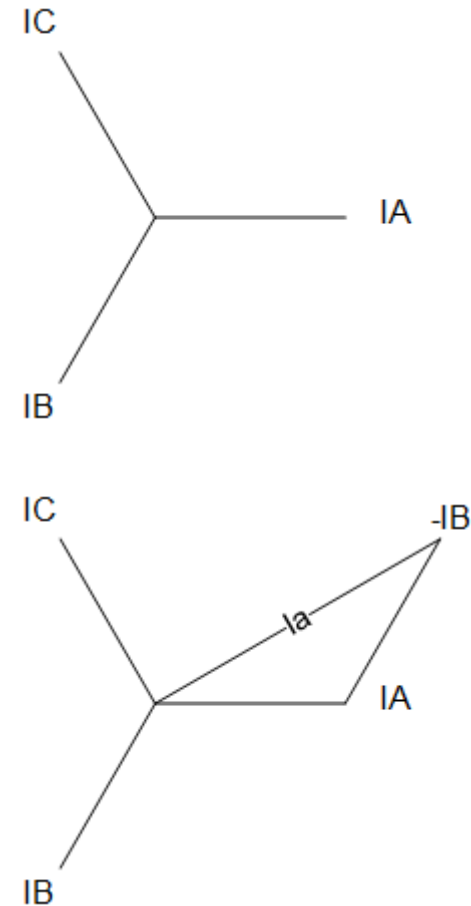
What happens if I swap phases on my H winding:

Swapping phases on the High side changes my transformer from 30 lag to 30 lead

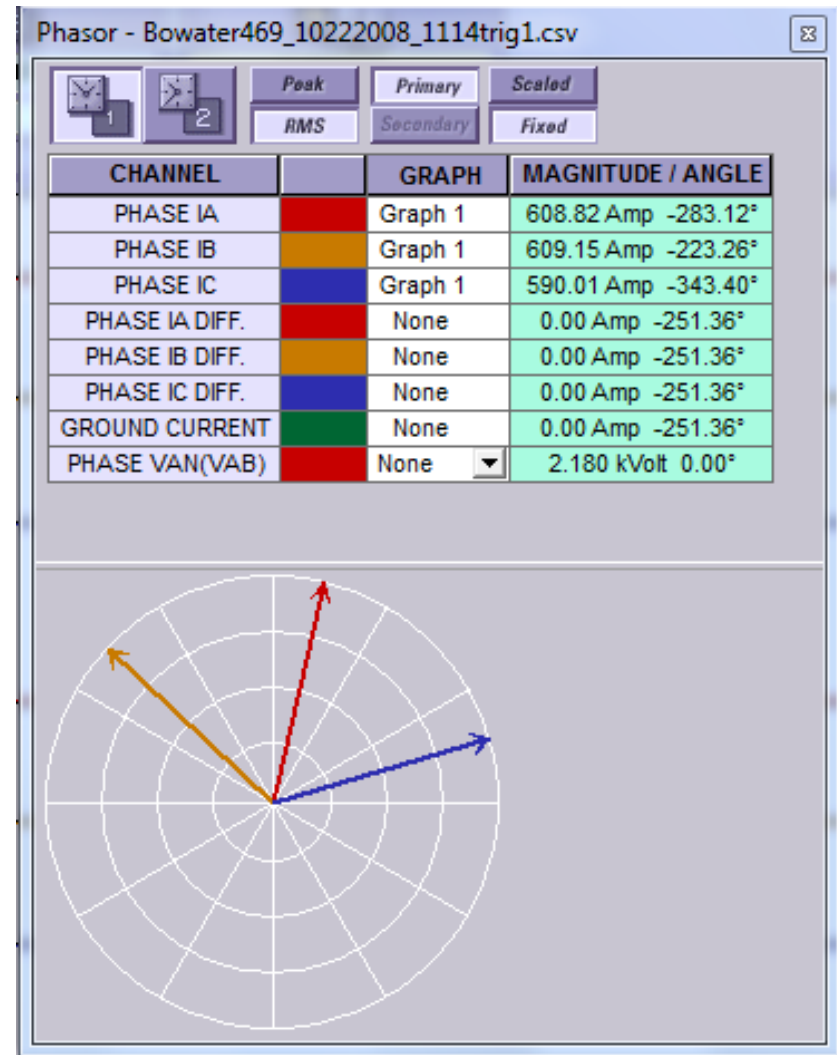
- This relay had a rolled phase, but also a lot of other issues
- During start up, verify metered values
 - Negative sequence voltage and current should be small relative to positive sequence quantities
 - Power factor should be as expected 80-90% lagging for induction machines and loads.
 - Phase relationships should be as expected (across transformers)

How to fix

- Move wire from B to A and roll 180 degrees
- Move wire from C to B and roll 180 degrees
- Move wire from A to C and don't roll.

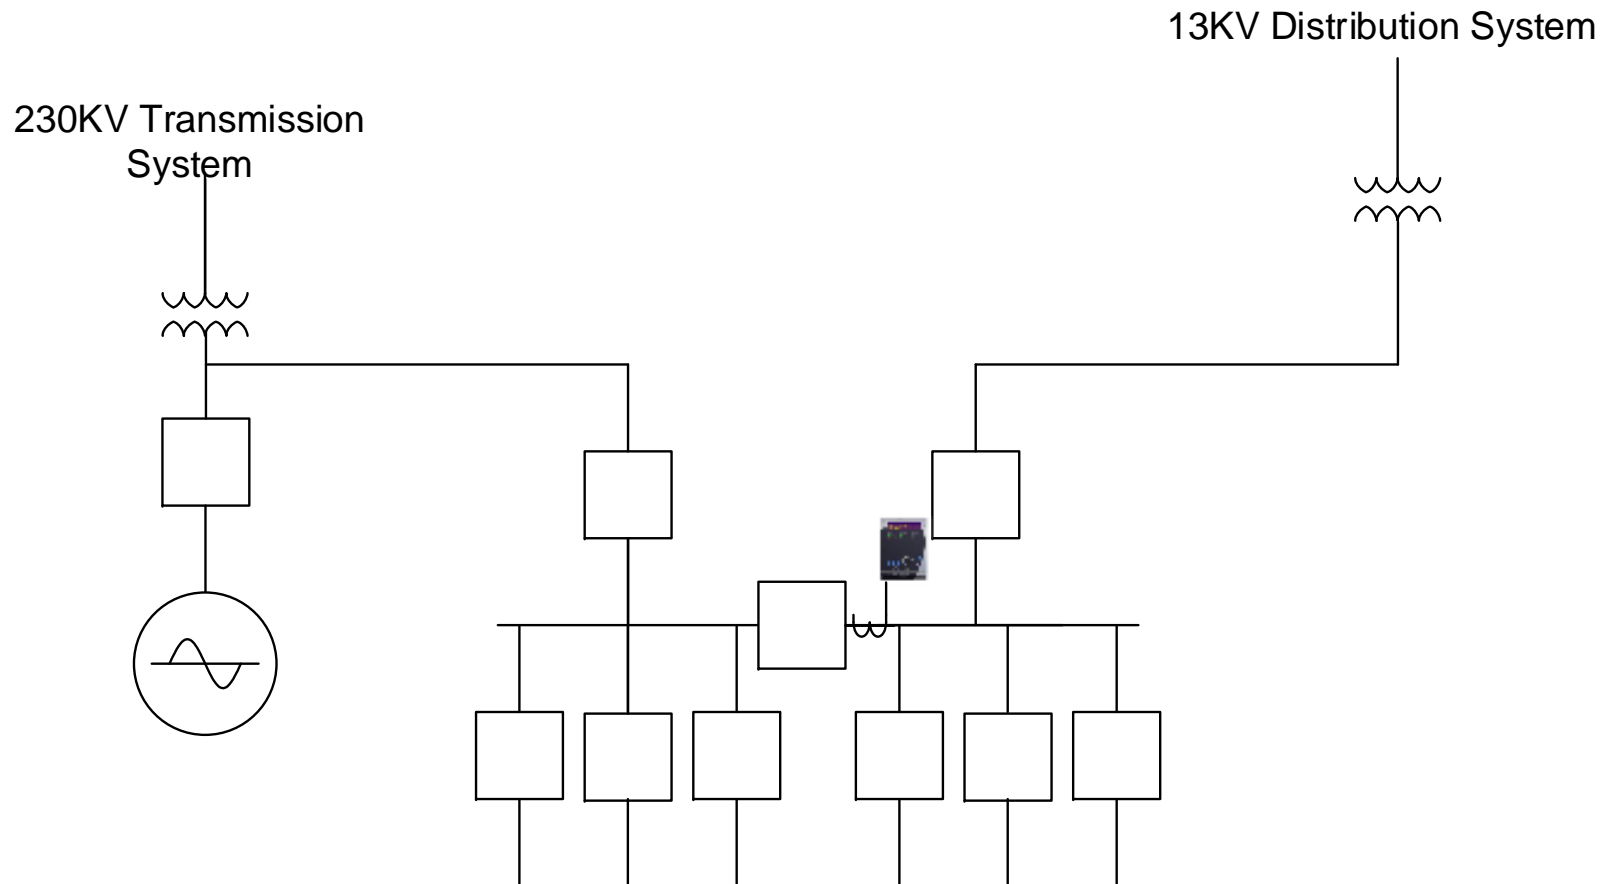
So what are you actually paralleling?

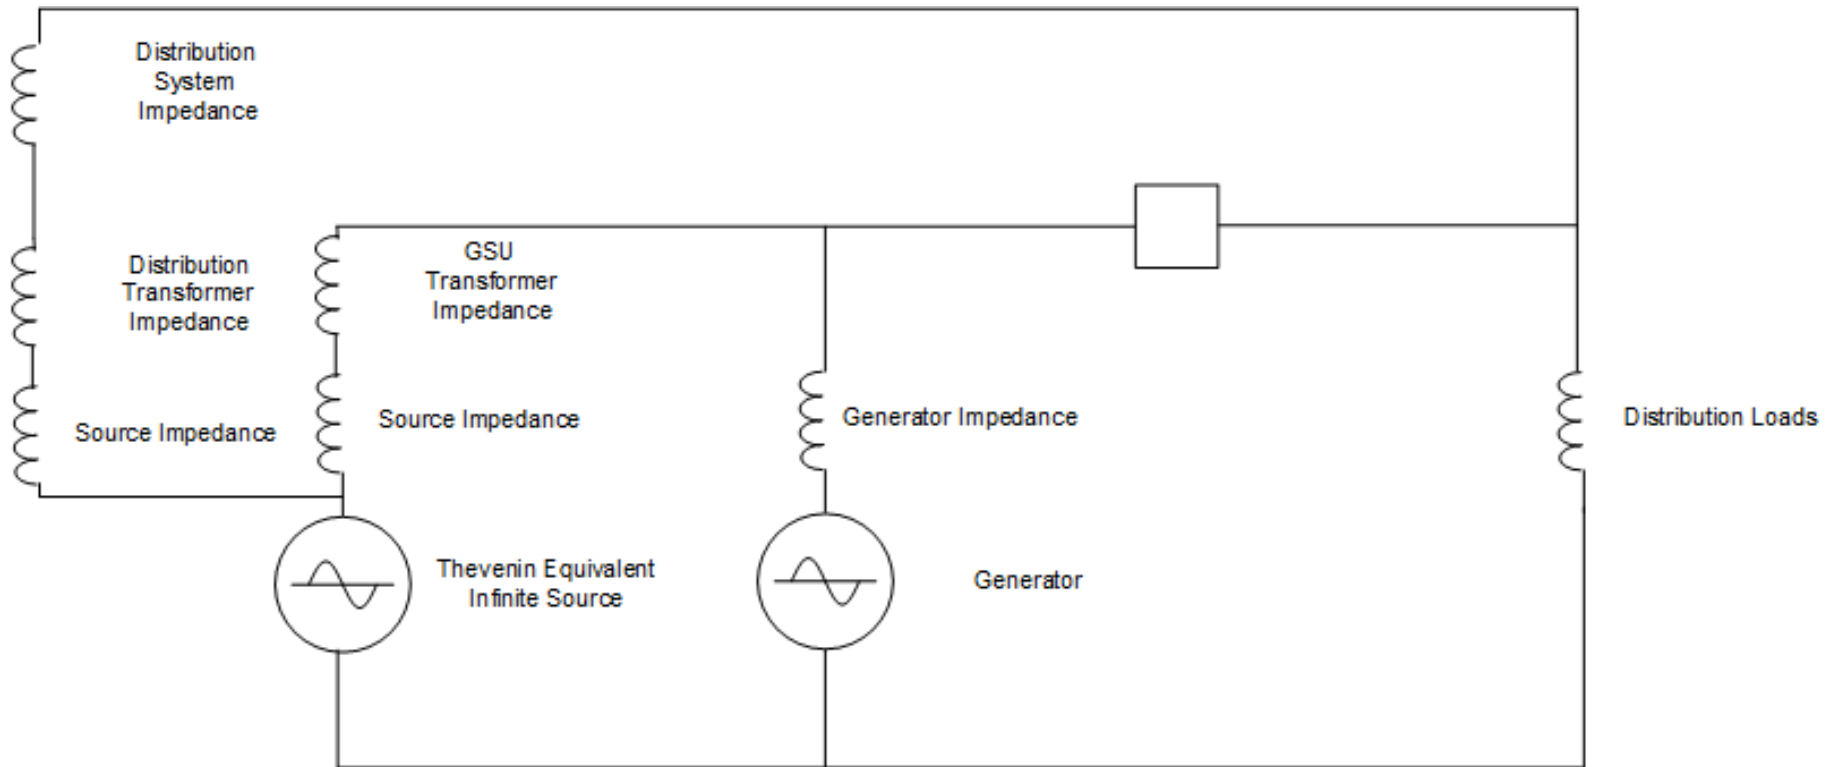
Equivalent Circuit

Since Parallel:

$$Z_{dist} I_{dist} = Z_{tran} I_{tran}$$

$$Z_{dist} / Z_{tran} = I_{tran} / I_{dist}$$

If $Z_{dist} \gg Z_{tran}$

Then $I_{tran} \gg I_{dist}$

Possible Solutions

- Can't really raise the TOC pickup setting on the tie breaker 750 and can't really make the time delay longer
- Could add controls to trip a selected breaker after all three are closed.
- Never parallel these two sources. Add mechanical interlocks to prevent parallel of all three sources.

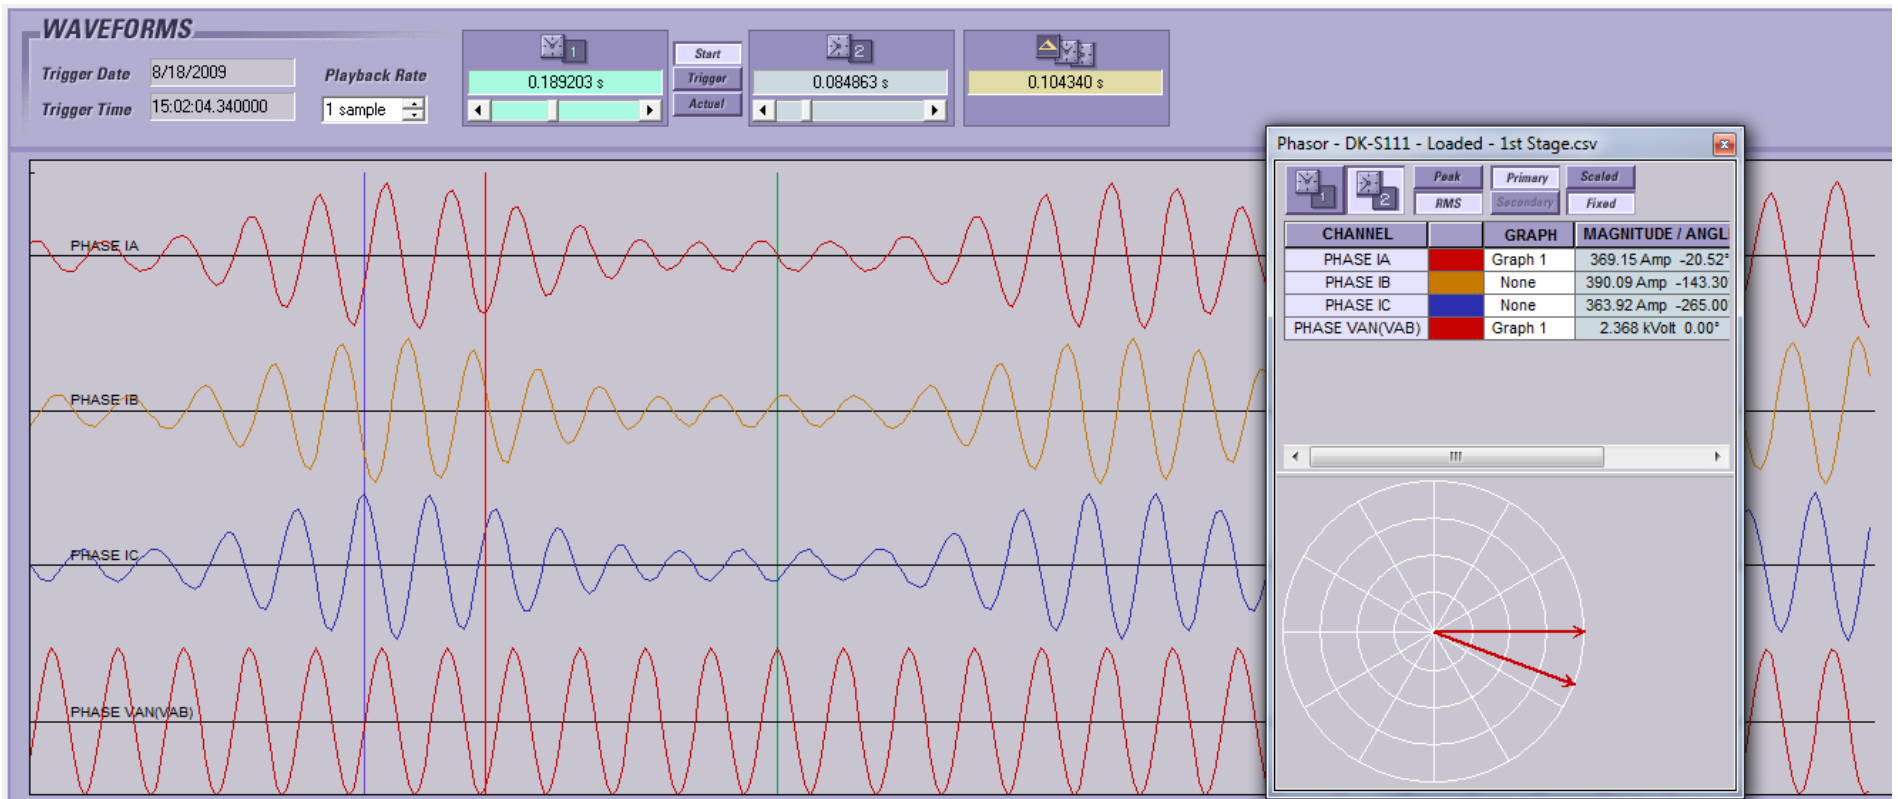
The Problem Compressor – Loaded Cycle

- This cannot be fixed with relay settings.
- Must talk to motor manufacture about why this compressor behaves this way.
- A mechanical problem was causing the issue.

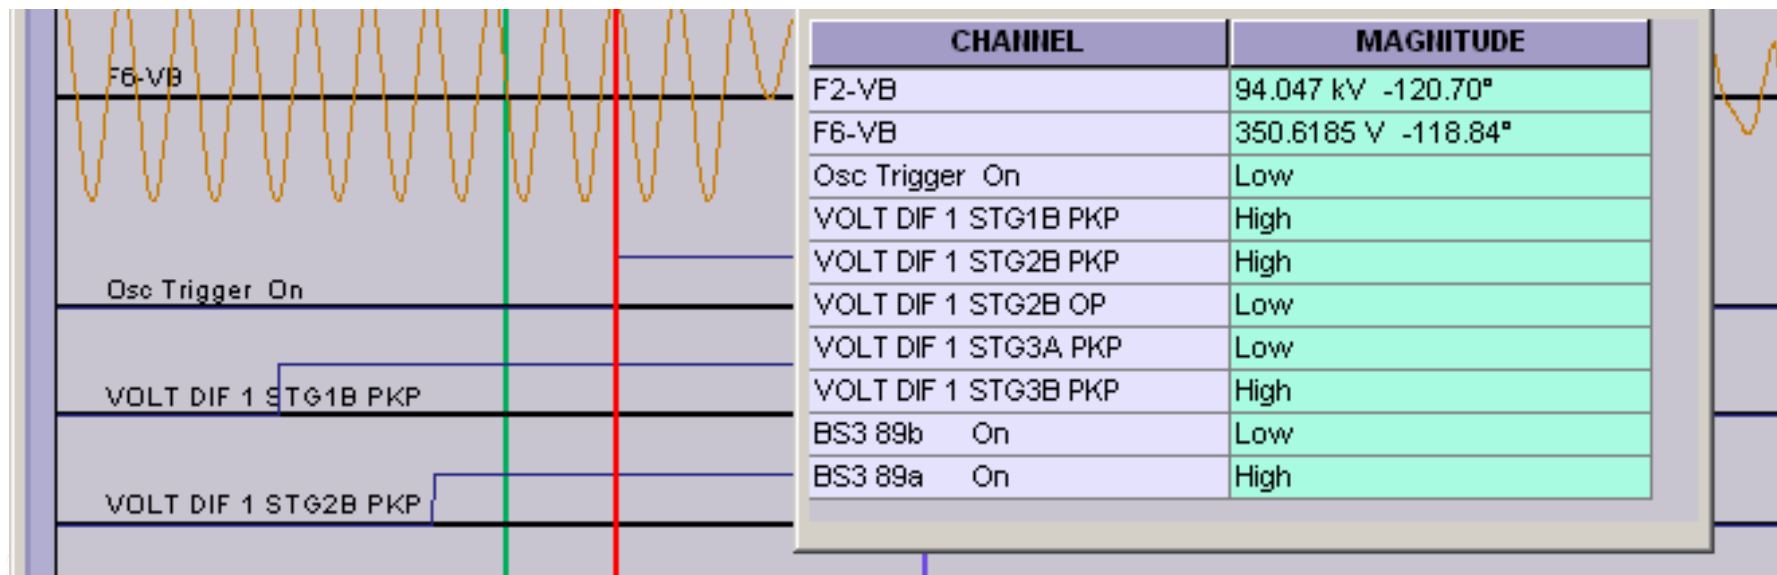
Fault Values of the Trip

Trip is set to 0.02 with a 50ms Delay
