Guide 5, 2003

**Guide for Visual Identification
of
Deterioration & Damages
on
Suspension Composite Insulators**

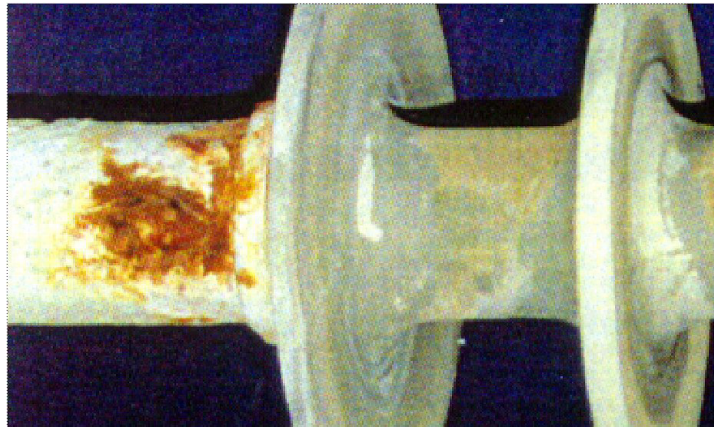
Deterioration due to a chemical reaction with the environment (rusting), see **fig. 1**.

fig 1 Example of deterioration affecting the metal end-fitting: **Flange Corrosion**[11].

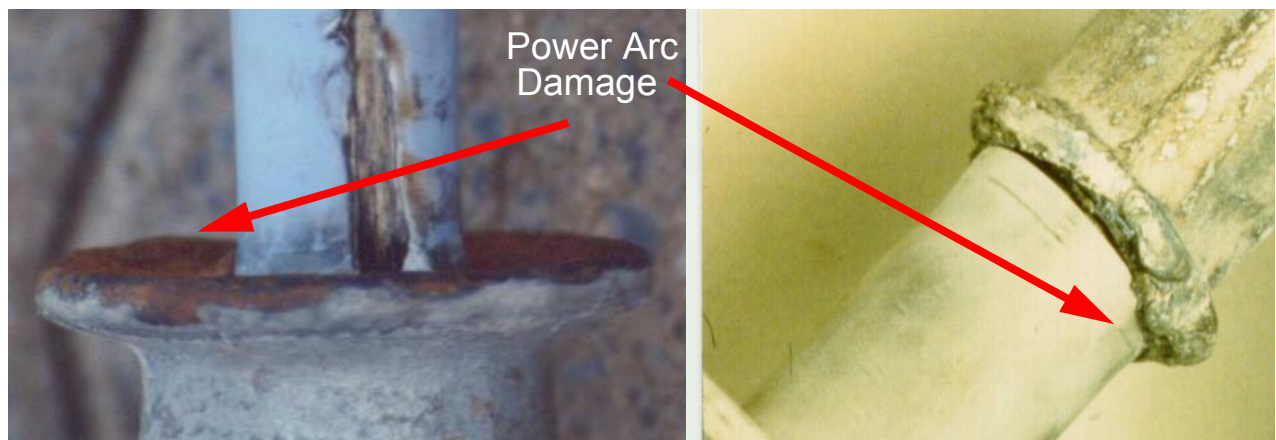
Damage sustained from a high current and temperature concentration at the metal fitting caused by an electrical flashover. See [fig. 2](#).

fig 2 Examples of damage occurring on the metal fitting: **Power Arc Damage**. Right photo [11].

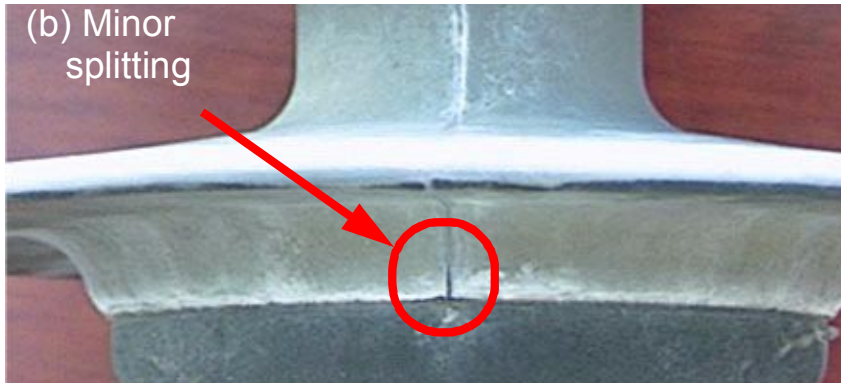
fig 3 Example of **Minor Splitting/Cutting** (deterioration) at the polymer housing/end-fitting interface (seal).

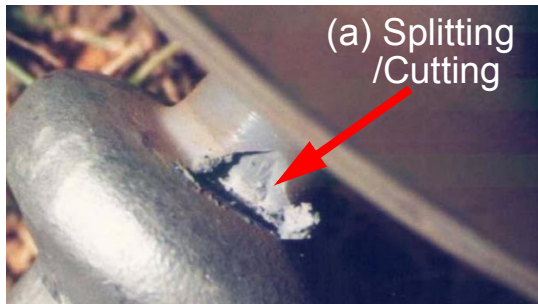
Uncovering of the core to the environment (e.g. due to erosion, tracking, splitting, puncture or careless handling). See [fig. 4\(a\)](#) and [fig. 8\(a\)](#).

fig 4 Examples of damage at the polymer/fitting interface (seal): (a) **Core Exposure** due to **Splitting/Cutting**[14], and (b) **Erosion**[8].

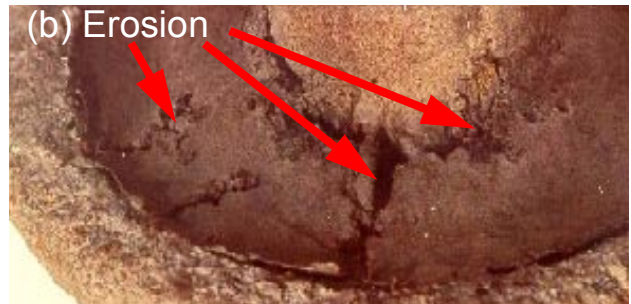
Irreversible and non-conducting degradation of the surface of the insulator that occurs by major loss of material[1], which significantly reduces the thickness of the polymer sheath that prevents moisture ingress to the core rod (i.e. by more than 1mm). This can be uniform or localised. See [fig. 4\(b\)](#) and [fig. 9](#).

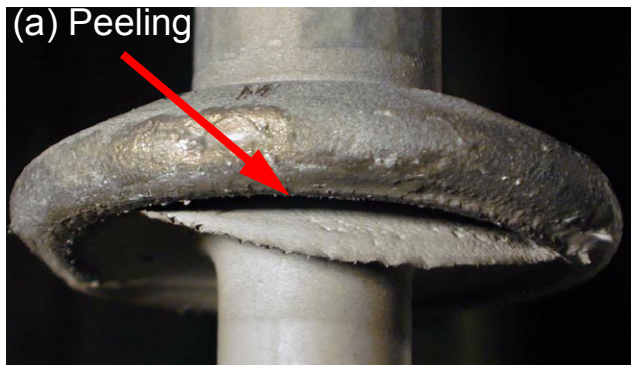
Loss of adhesion of the seal from the metal fitting². See [fig. 5\(a\)](#).

fig 5 Examples of damage at the polymer sheath/fitting interface (seal): (a) **Peeling**, and (b) **Puncture** of the seal [8].

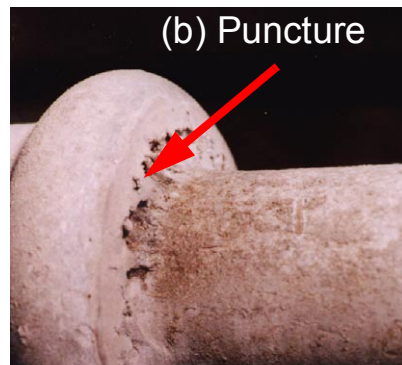
Hole in the insulator sheath/shank or shed. See [fig. 5\(b\)](#) and [fig. 10\(b\)](#).

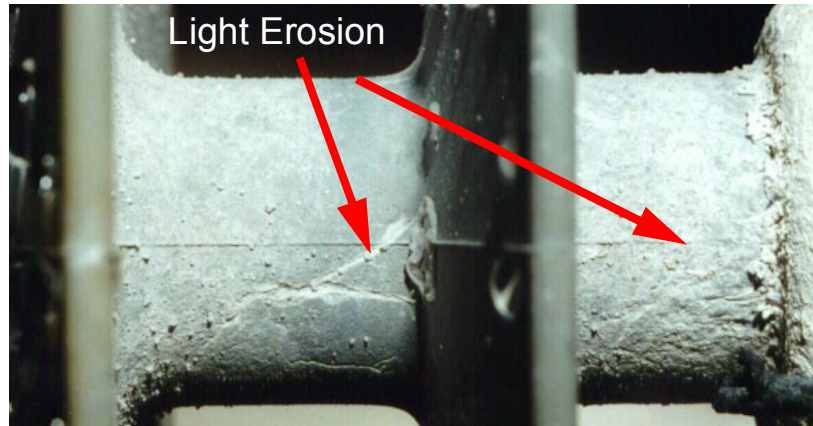
Superficial, irreversible and non-conducting degradation of the surface of the insulator that occurs by loss of material[1], which does not penetrate deeper than 1 mm. This can be uniform or localised. See **fig. 6**.

fig 6 Example of deterioration on the sheath/shank: **Light Erosion.**

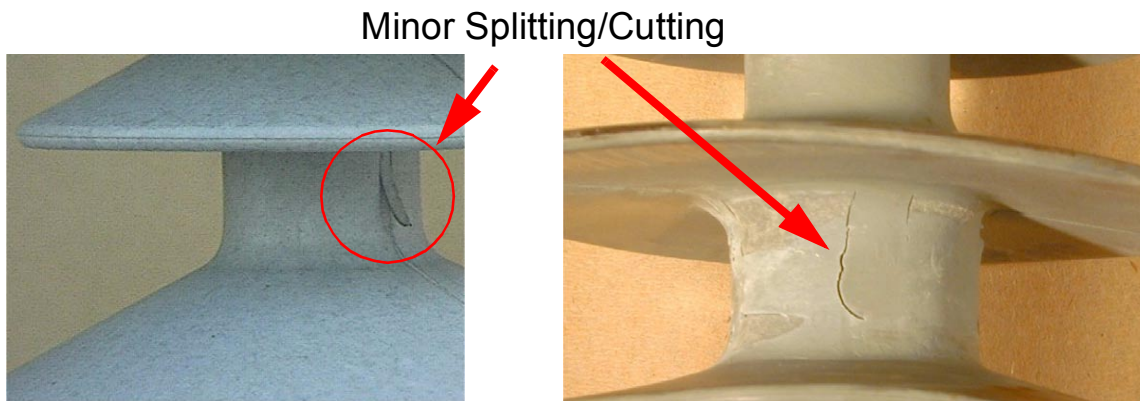
fig 7 Examples of deterioration on the sheath/shank: **Minor Splitting/Cutting.**

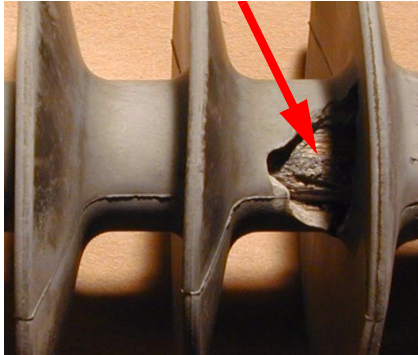
(a) Core Exposure

fig 8 Examples of damage on the polymer sheath/shank: (a) **Core Exposure** due to **Splitting/Cutting**, (b) **Debonding**.

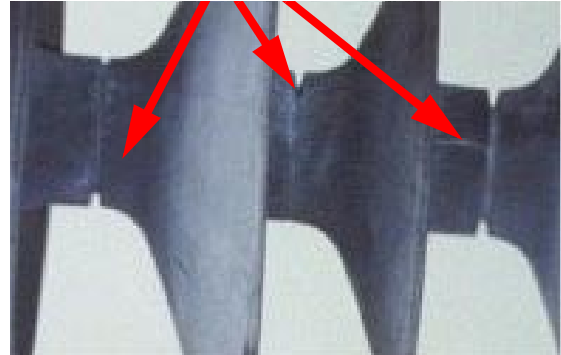
(b) Debonding

Separation of different parts of a composite insulator which significantly reduces the creepage distance (i.e. by more than about 10%), or the thickness of material that prevents moisture ingress to the core rod (i.e. by more than 1mm). See [fig. 8\(b\)](#).

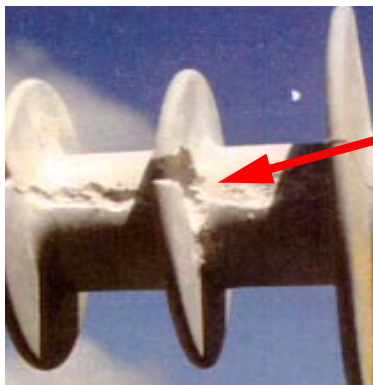
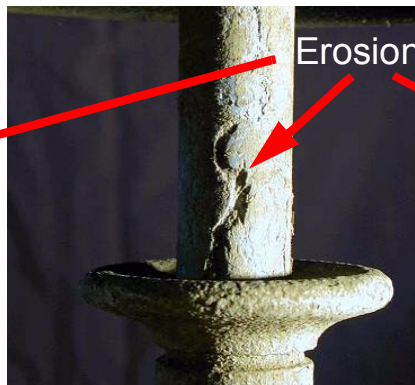
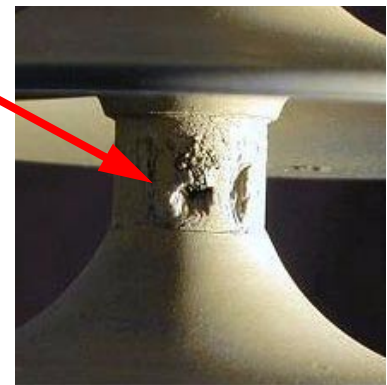
fig 9 Examples of damage on the sheath/shank: **Erosion** (Left hand photo [9]).

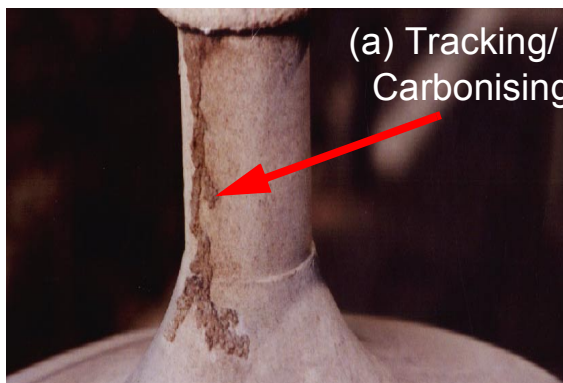
(a) Tracking/
Carbonising

Irreversible degradation by formation of conductive paths starting and developing on the surface of an insulating material [1]. These tracks have the appearance of carbon tracks which cannot be easily removed and are conductive even when dry. See [fig. 10\(a\)](#) and [fig. 15\(b\)](#) [8][9].

fig 10 Examples of damage on sheath/shank: (a) **Tracking/Carbonising**[8], (b) **Puncture**[11].

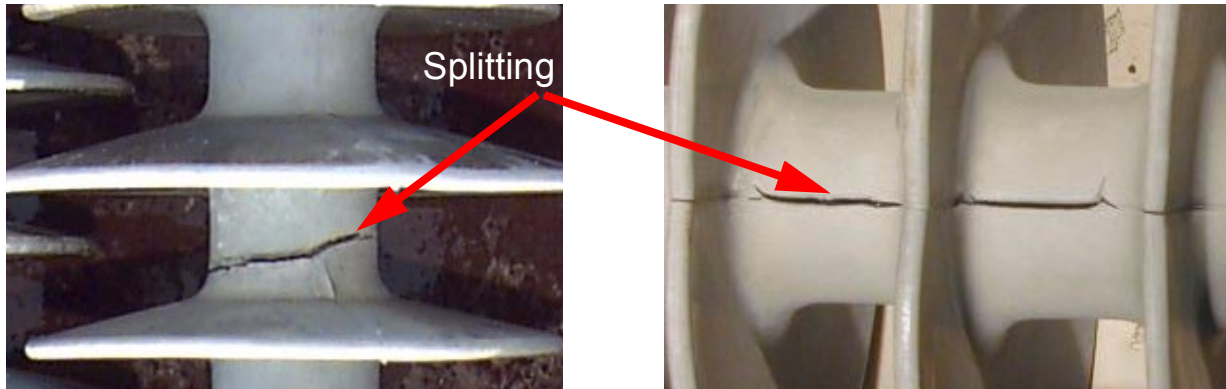
Break, tear or crack in polymer housing (e.g. shed, sheath) which may have resulted in removal of material, and which significantly reduces the creepage distance (i.e. by more than about 10%), or the thickness of the polymer sheath blocking moisture ingress to the core rod (i.e. by more than 1mm). See [fig. 4\(a\)](#), [fig. 8\(a\)](#), [fig. 11](#), and [fig. 15\(a\)](#).

fig 11 Examples of damage on the sheath/shank: ***Splitting/Cutting.***

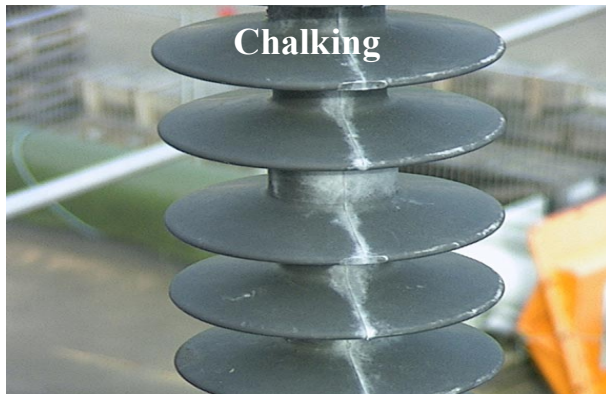
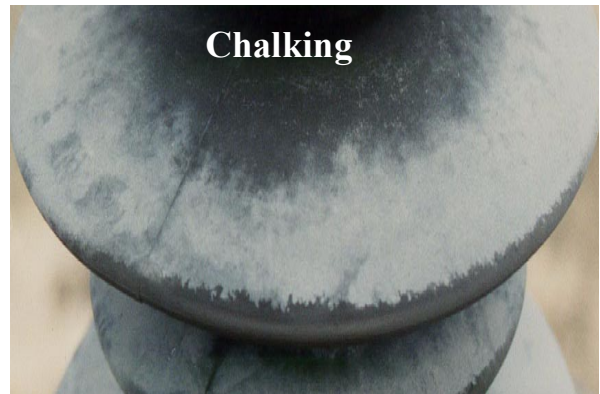
Appearance a rough or powdery surface due to the exposure of filler particles from the housing material [1][12]. See **fig. 12**.

fig 12 Examples of deterioration affecting the sheds, **Chalking**; Right picture [11].

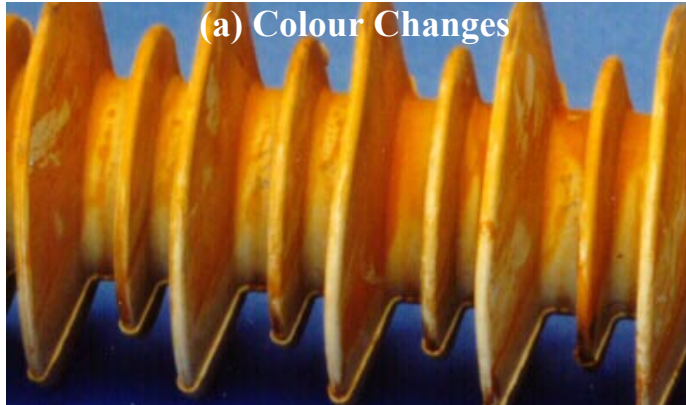
Change in the colour of the housing material of the composite insulator. See **fig. 13(a)**.

fig 13 Examples of deterioration of the sheds, (a) **Colour Changes** [11], & (b) **Crazing**[8].

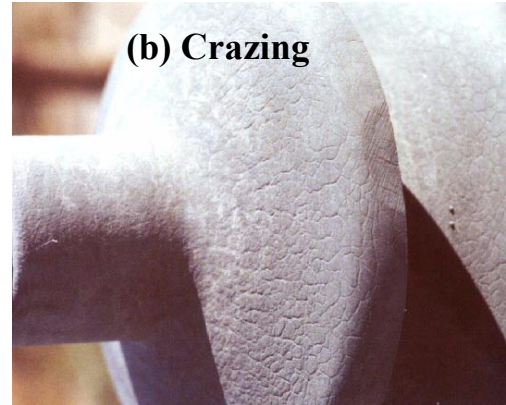
Consists of surface micro-fractures of depths approximately 0.01 to 0.1 mm [1][12]. See **fig. 13(b)**.

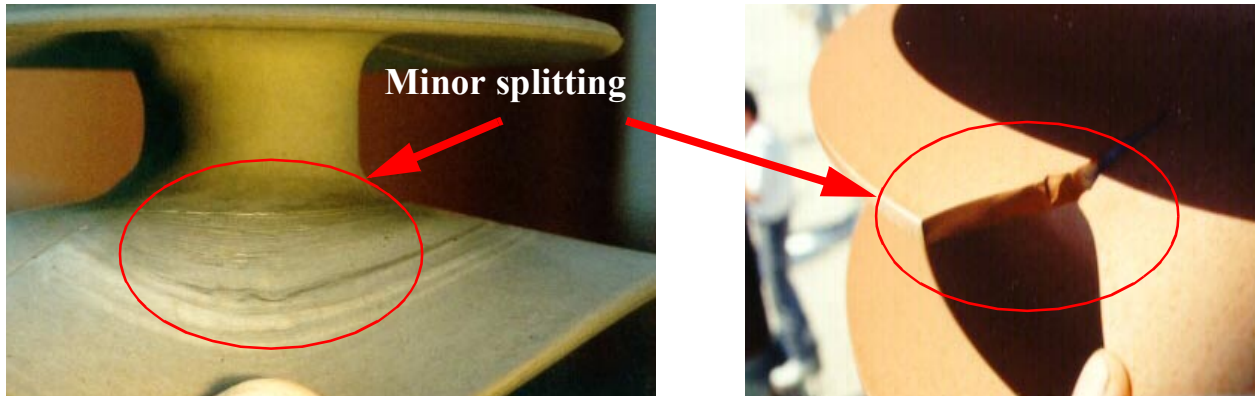
fig 14 Examples of deterioration affecting the sheds: **Minor Splitting/Cutting**. N.b in the right hand picture only one shed of 10 is affected so that the observed changes can be regarded as deterioration, i.e. not reducing the creepage distance by more than 10%.

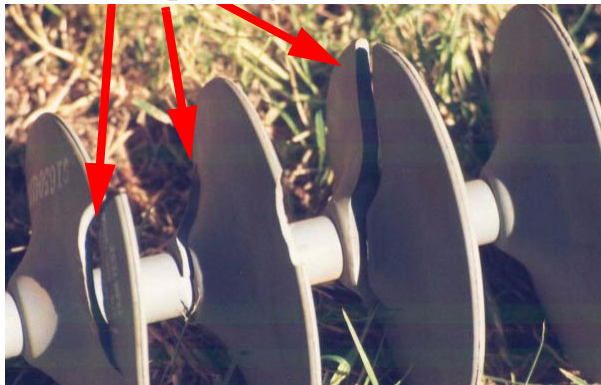
(a) Splitting

fig 15 Examples of damage to sheds: (a) **Splitting/Cutting** which reduces the creepage distance by >10%[14], and (b) **Tracking/Carbonising** on insulator sheds.

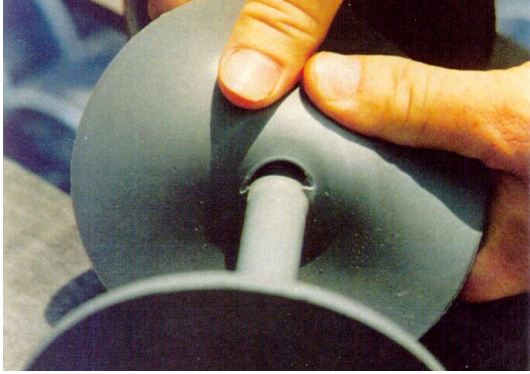
(a) Minor Debonding

Debonding occurring between different components of the insulator which can be regarded as deterioration¹ rather than damage. See [fig. 16\(a\)](#).

fig 16 Deterioration at the shed/sheath interface (a) **Minor Debonding**, & (b) **Grease Leakage**.

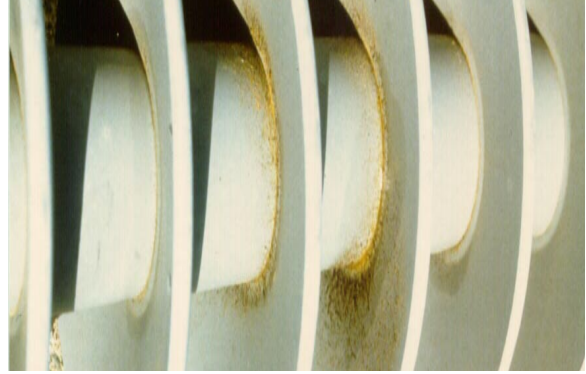
(b) Grease Leakage

Escape of grease from shed/sheath or sheath/sheath (e.g. joiner ring) interface onto the sheath or shed surface. See **fig. 16 (b)**.

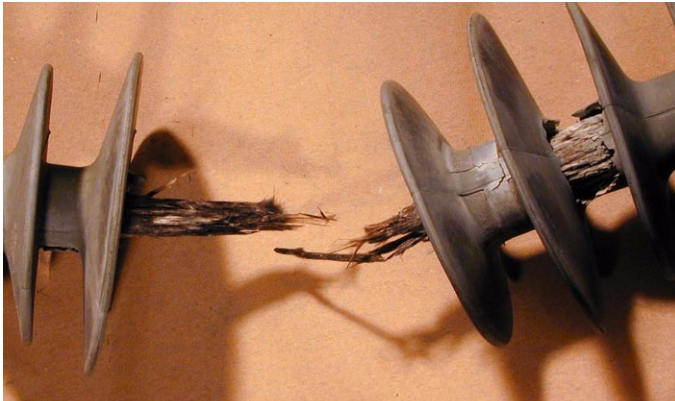
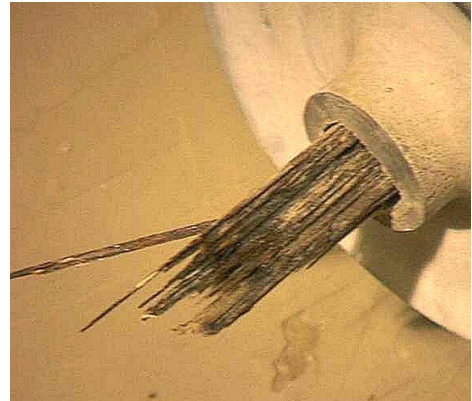
Breakage of an insulators core rod so that the mechanical load can no longer be supported. See [fig. 17](#) for a photograph of a mechanical failure **not** due to Brittle Fracture (see below).

fig 17 Examples of **Mechanical Failure** of the fibreglass core which is **not** due to brittle fracture, but rather resulting from erosion and tracking damage to the core.

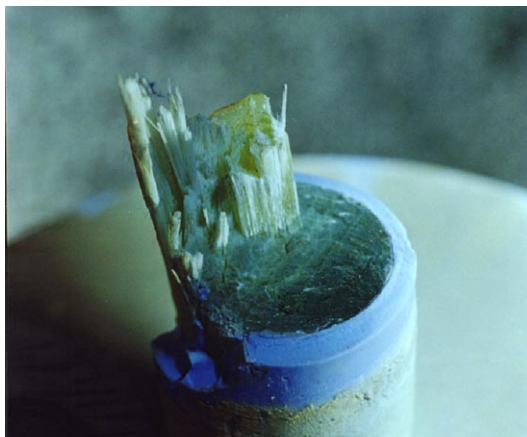
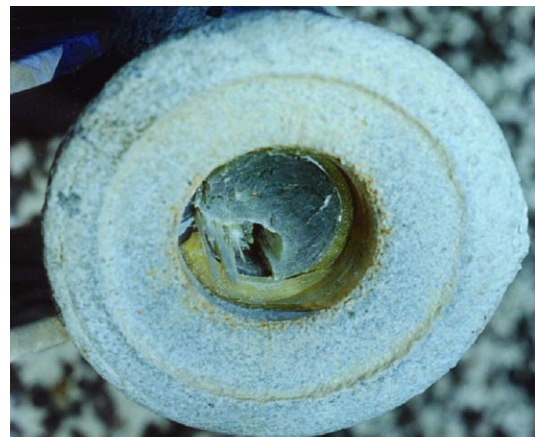
Brittle Fracture (Mechanical Failure) A type of mechanical failure of the fibre reinforced plastic (FRP) core rod characterized by one or more of the following [7]:

- smooth fracture surfaces mostly running perpendicular to the rod axis
- sometimes stepwise formations of smooth surfaces
- fibres and resin break on the same plane
- clean fracture surface (no fine glass and/or resin particles), or normally a small residual fracture section which is generally fibrous.

fig 18 **Brittle Fracture - Mechanical Failure** of the fibreglass core; photos [8].
