UPS CASE STUDY SERVER INCOMPATIBILITY

PRESENTED AT IEEE / MCPQG MEETING NOVEMBER 28, 2012

BY MIKE PUCKETT, PE

LIGHTNING CASE STUDY

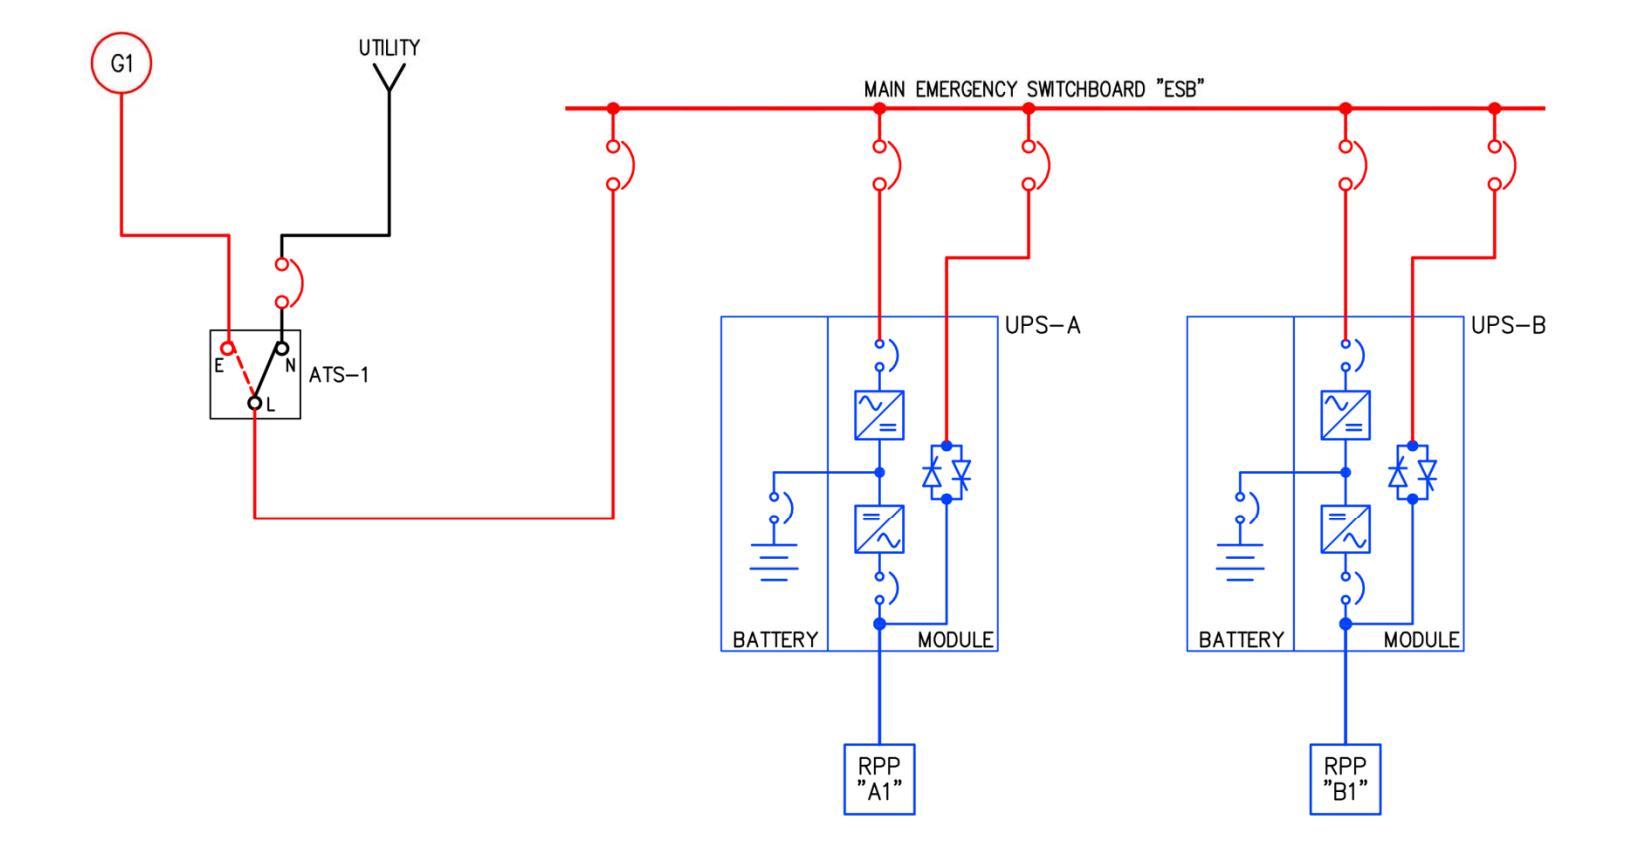
ONE-LINE DIAGRAM

- Initial Load on UPS Systems was about 13% each
- Initial Maximum Heat Gain in the UPS Room about 90% of the A/C rating based on each UPS being 25% loaded

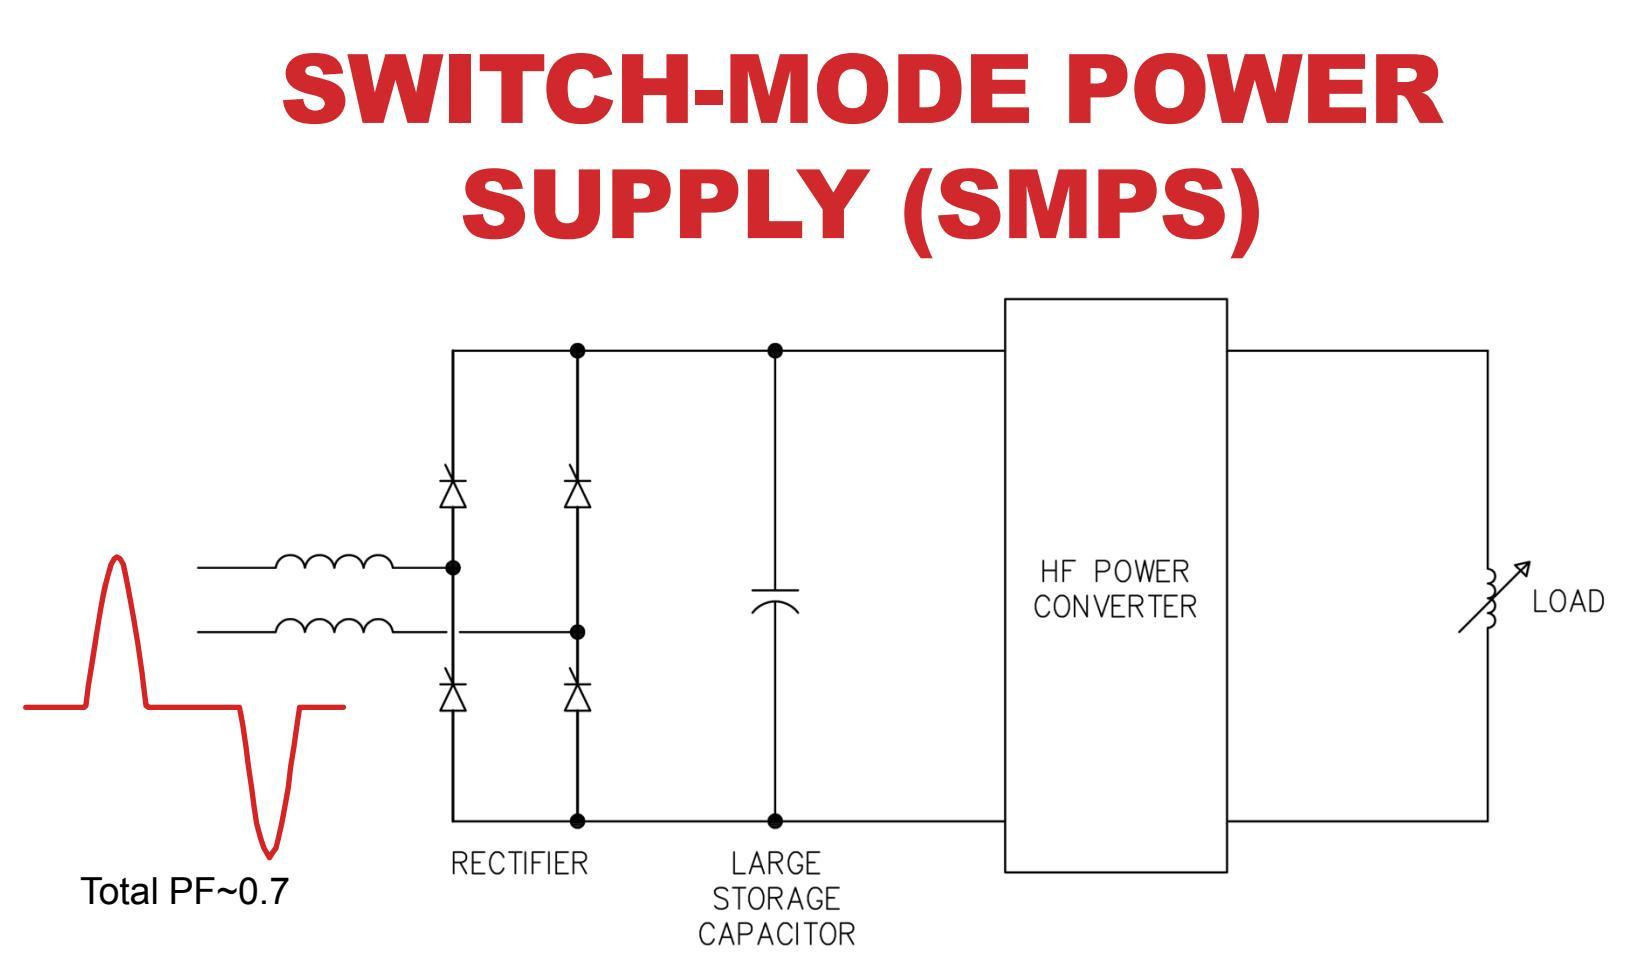
- SMPS prior to the European mandate and those currently not in compliance.
- It seems most non-Data Center equipment in U.S. does not comply with the European mandate and thus uses this SMPS

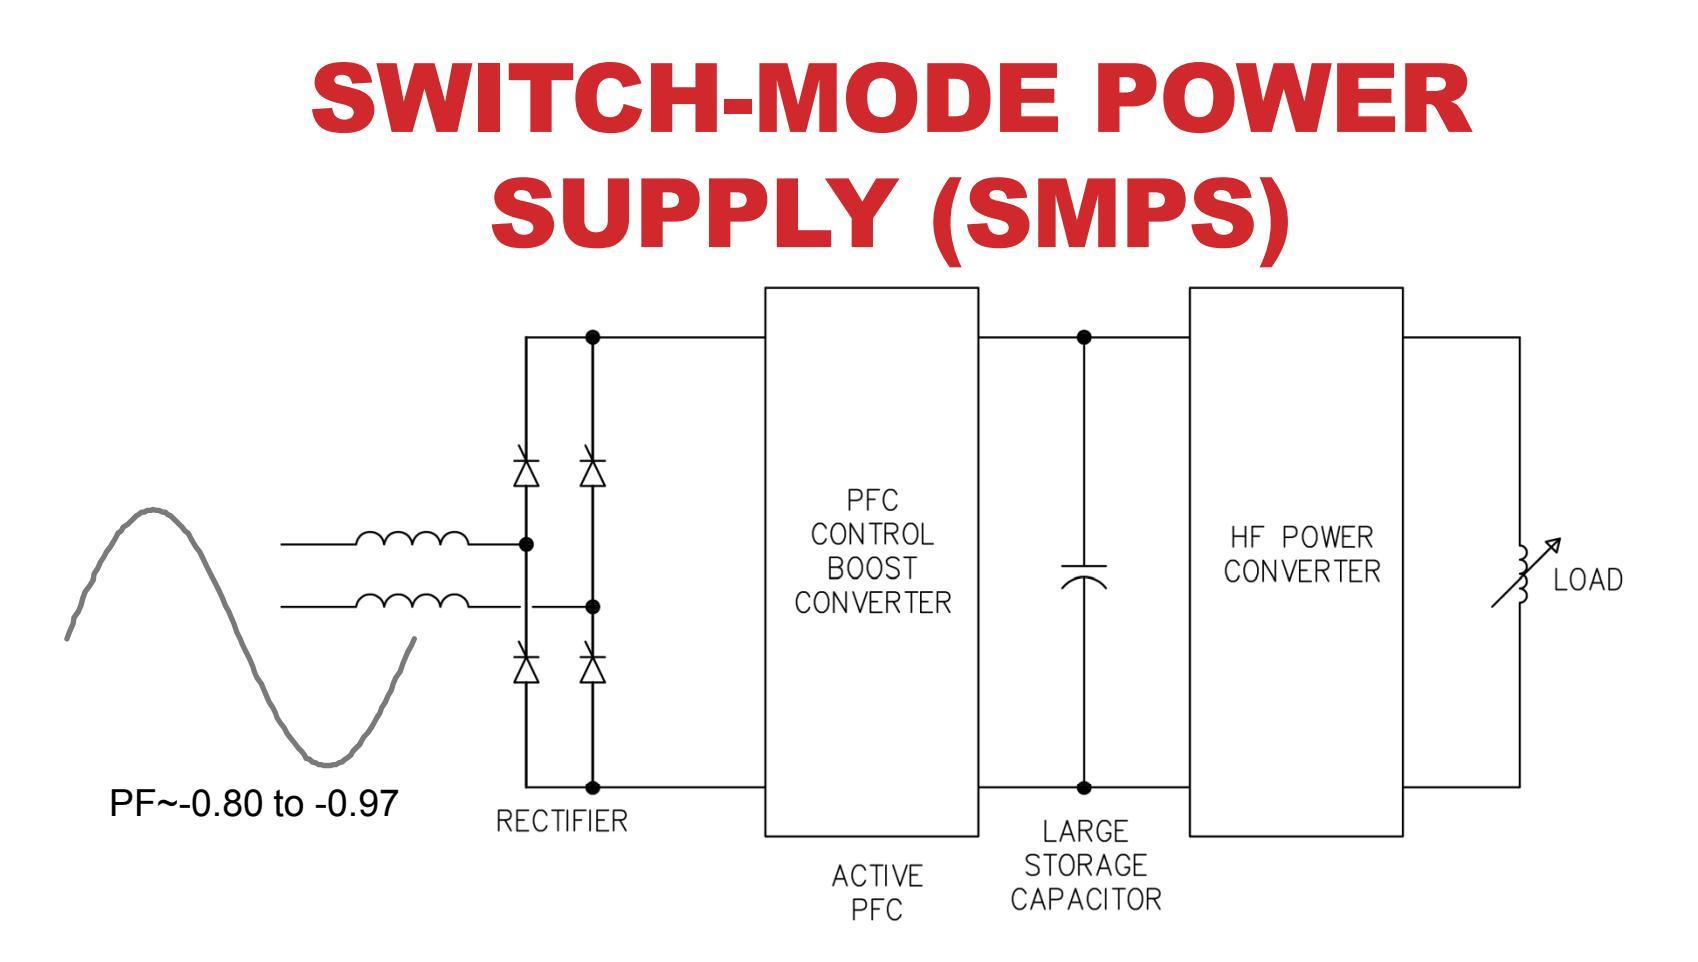
- Power Factor Corrected (PFC) SMPS after the 2001 European mandate.
- Includes leading PF at low loads.

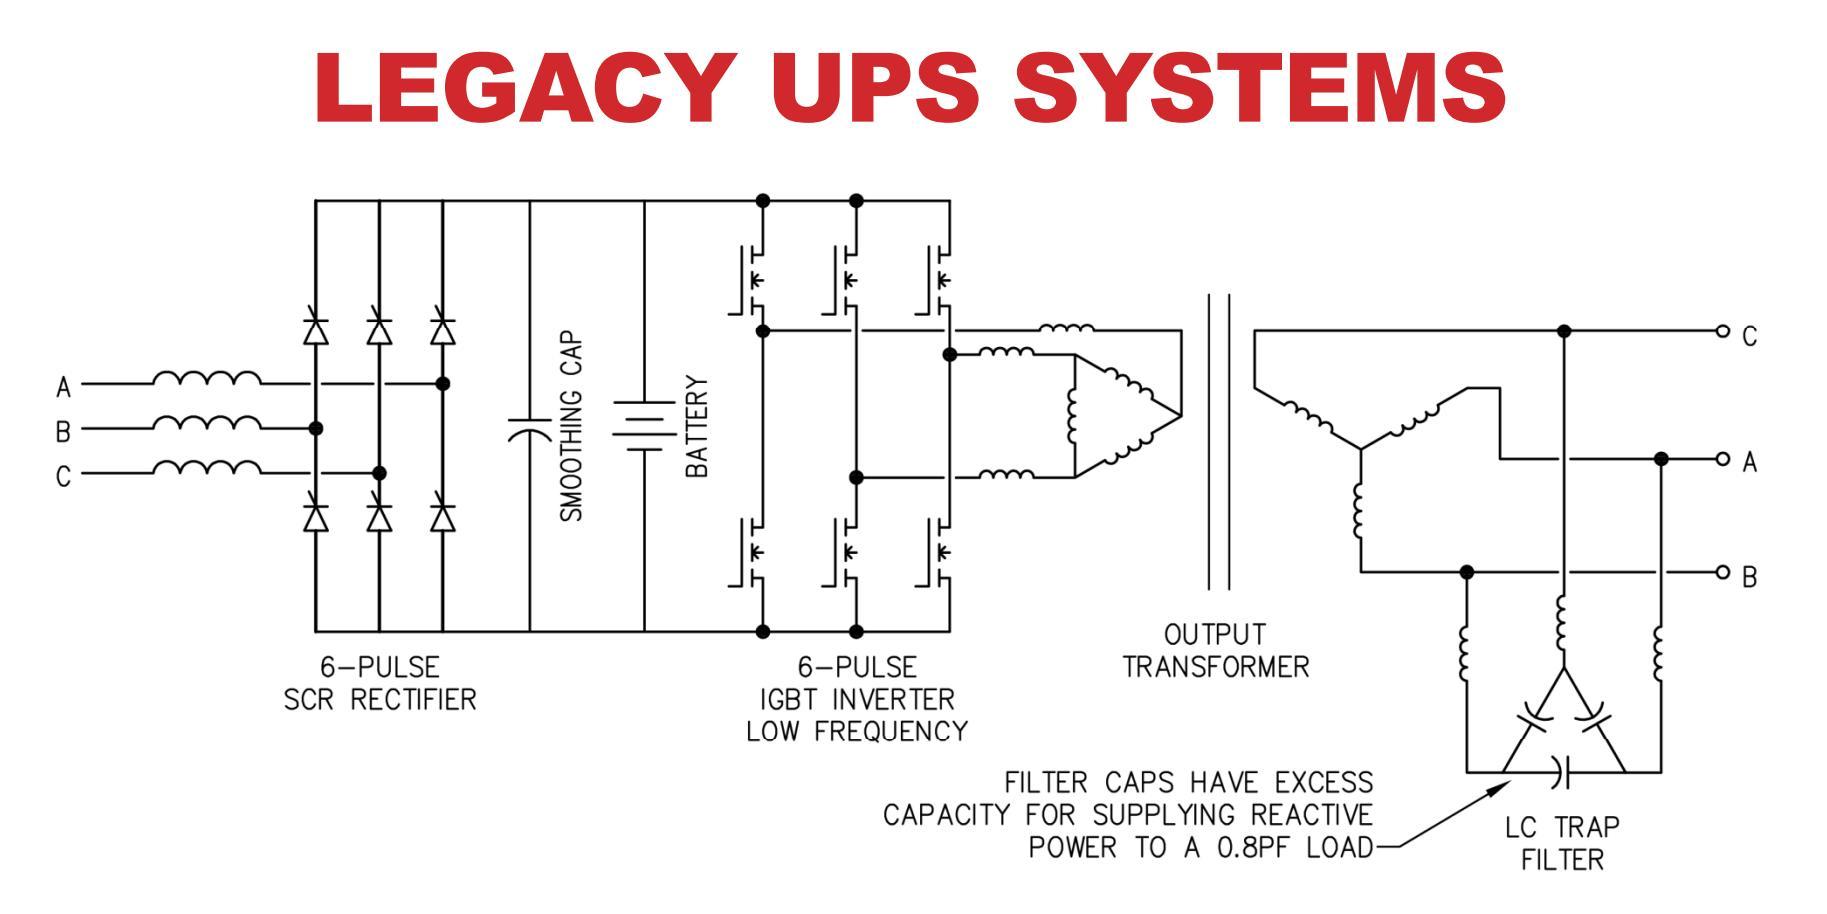
- Legacy UPS systems were originally developed in the 80's for the original SMPSs with PF ~0.7 but are still being made
- Most built today are not legacy but there are plenty of existing
- They must be derated for leading PF loads like PFC SMPSs

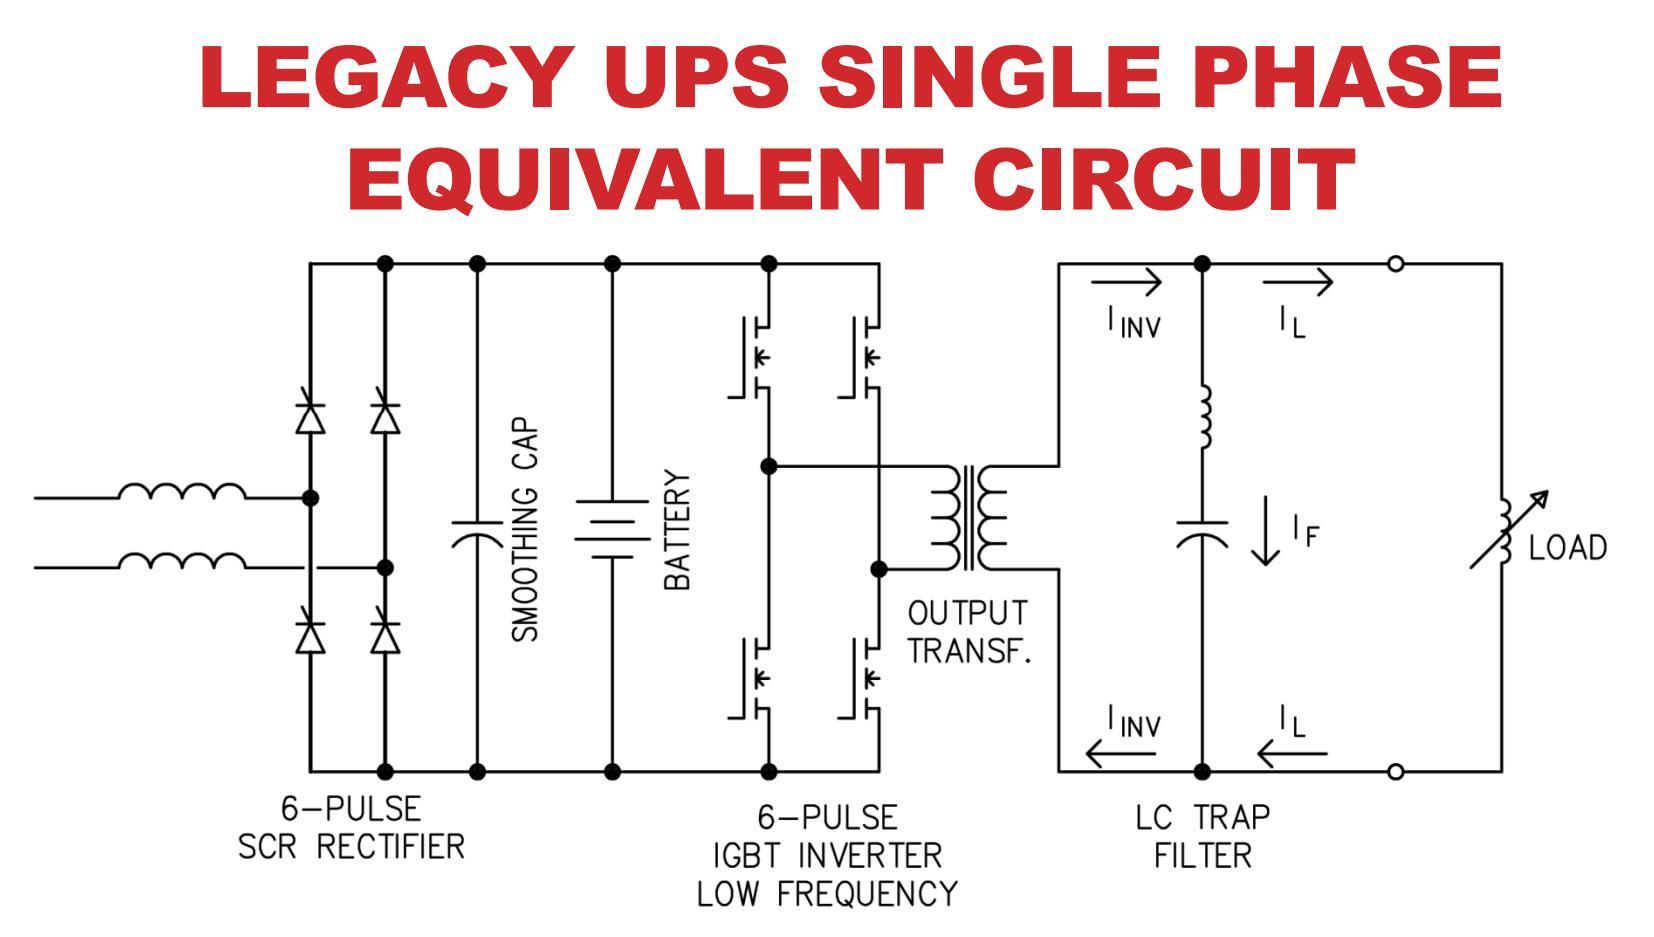
- I_{INV} = I_F+I_L. I_F net will be capacitive (-jX) and for a leading PF load, I_L will also be capacitive (-jX). Therefore, the net inverter and transformer current could exceed its designed rating and will also increase losses.
- Leading PF loads can also cause voltage (control) stability issues.
- Not as much potential for leading PF at UPS with 480V distribution

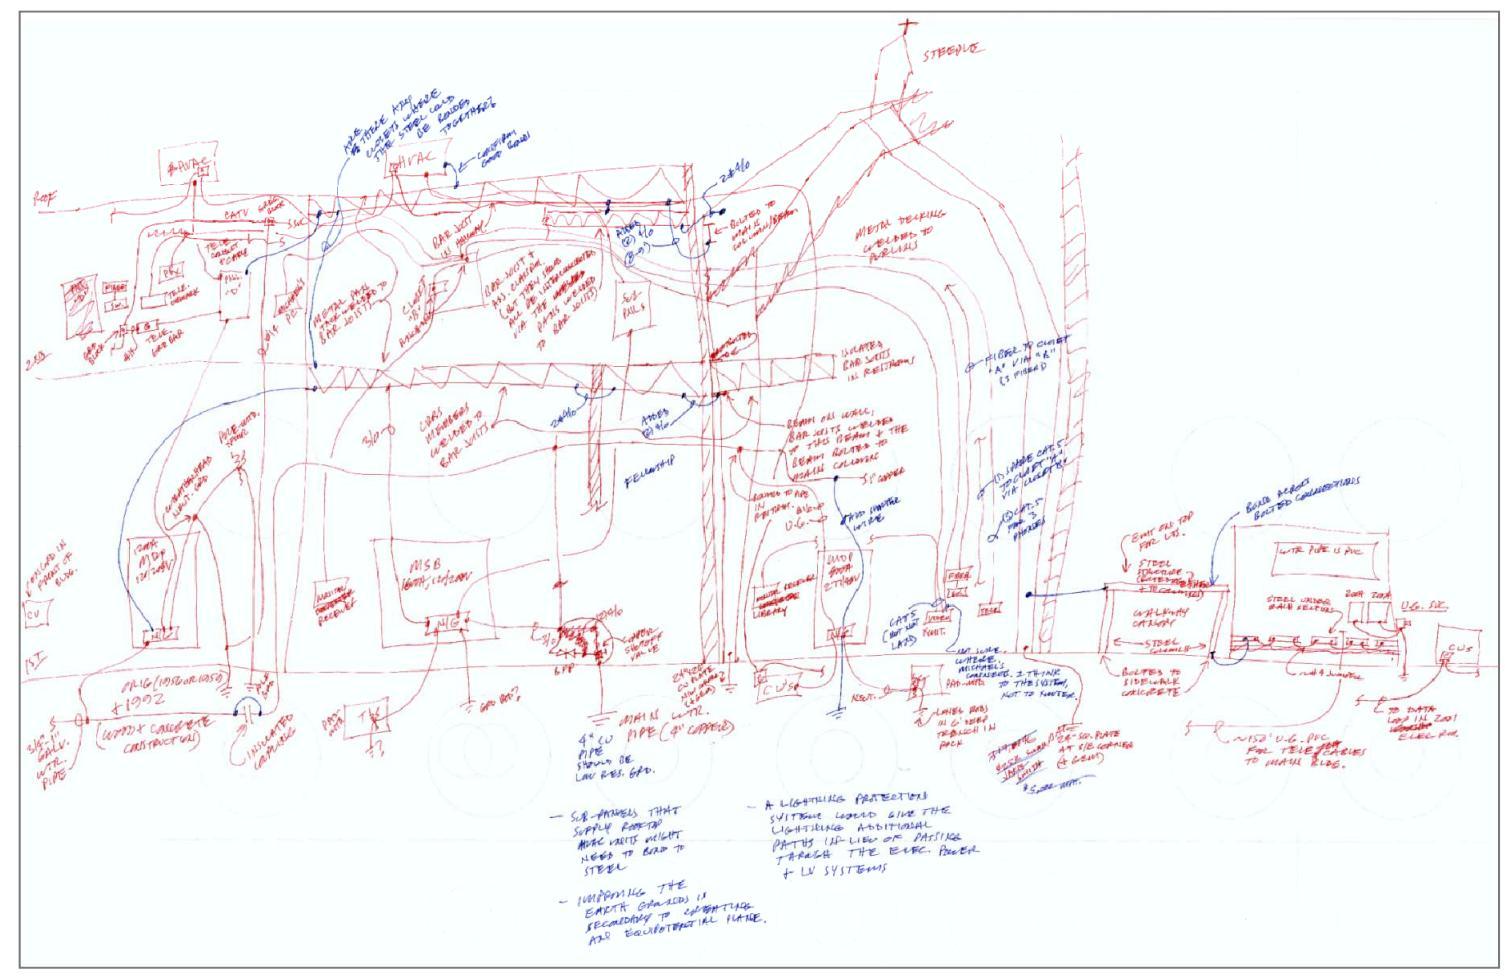
• HVAC DDC Control System.

- This was the main damage that occurred repeatedly.
- It occurred occasionally before the 2008 section but escalated after the 2008 section.
- This system includes a data cable (RS-485 protocol) that daisy-chains through all HVAC unit controllers.
- Video Transmitter in 2008 A/V Control Room and video Receiver in 2001 Café. The café receiver had been damaged 2 to 3 times prior to 2010.
- Intercom and Card reader at main front entrance.

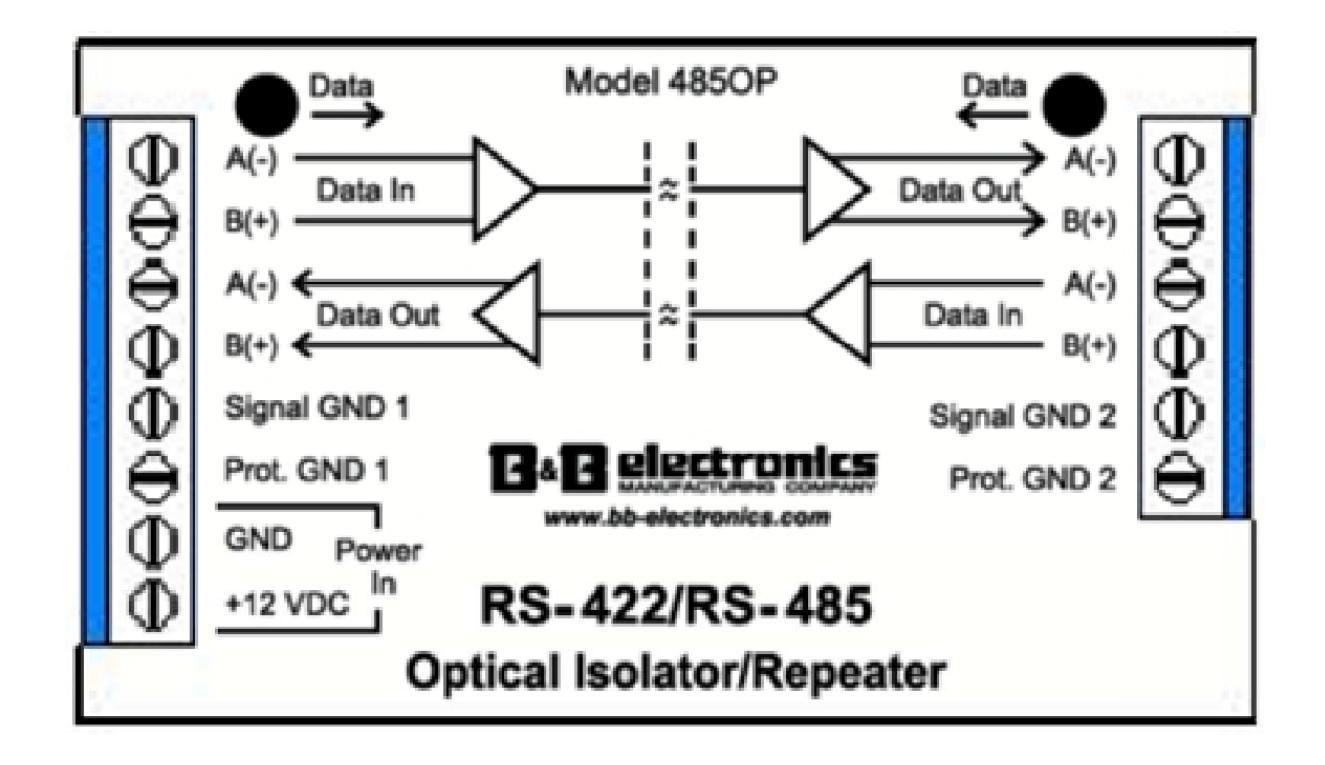
- •2/24/11 thunderstorm, no damage.
- •2/28/11 thunderstorm, three DDC controllers failed. Several had to be reset.
- •3/23/11 and 4/4/11, Thunderstorms, no damage.
- •Earth Grounding work completed 4/4/11.
- •Optical Isolators installed 4/5/11.
- •Most other work completed by 4/22/11.
- •In summer of 2011, a severe storm damaged a circuit board and contactor in rooftop HVAC unit.
- •No issues with any thunderstorms since summer 2011 event.

- SPD for all Electrical Services.
- SPD for all sub-panels that supply rooftop equipment.
- Bonded the same sub-panels to the building steel.
- Monitoring system for SPDs to send alarms via the LAN.
- Improved installation of ac supply SPDs for fire alarm control panels and for low-voltage SPD for fire alarm outdoor circuit to PIV.
- Installed outdoor exposed DDC data cables in steel conduit.
- Intercom and Card reader at main front entrance.

•As of December 2010, bonding of steel and water pipes were completed.
