Lightning Protection and Surge Arrester Application on NB Power Transmission Lines

John Williamson, NB Power Transmission Corporation, Canada 2008 IEEE PES Transmission and Distribution Conference and Exposition, Chicago

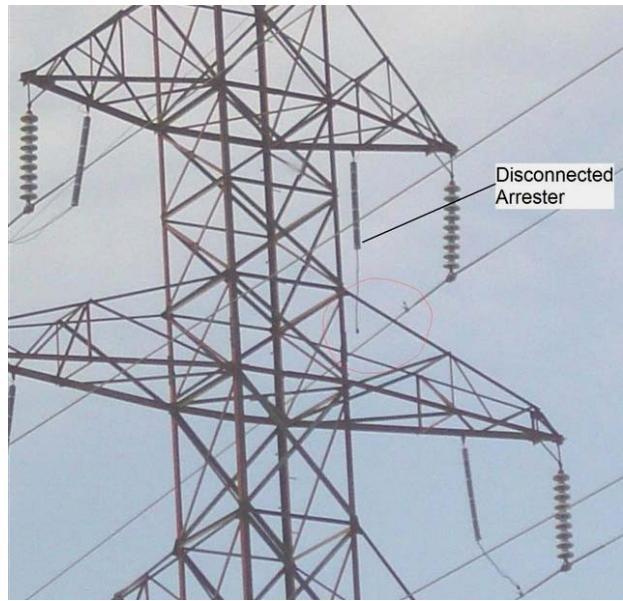
The purpose of the disconnector is to automatically disconnect the arrester from the transmission system under conditions where the arrester has failed internally and thereby isolate the faulty arrester from the system (Figure 6). Under normal lightning strikes, within the arrester rating, the disconnector does not operate.

Figure 6 - line arrester which has disconnected

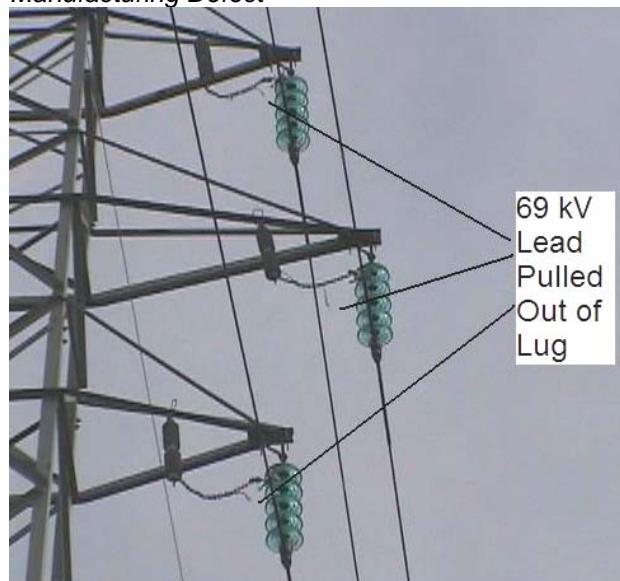
Figure 7 – 69 kV arresters with poor crimp on lug allowing strands to pull out

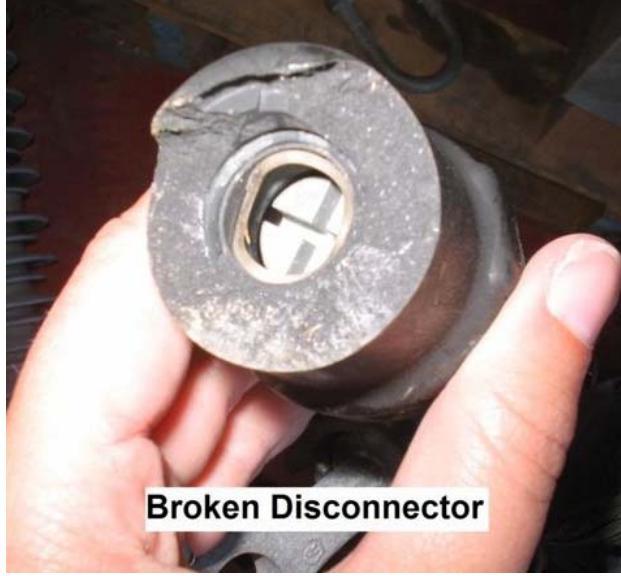
Improper Installation

Figure 8 – 69 kV disconnector broke because lead was too tight

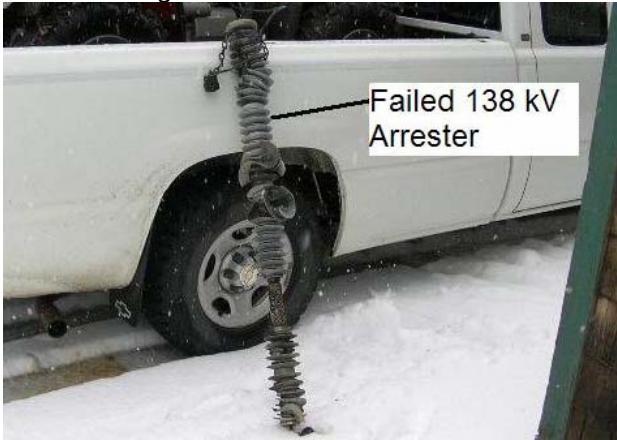
Manufacturing Defect

Figure 9 – 138 kV improper moisture seal on weathershed end cap. Two units failed causing line outages

The other three outages due to failed arresters were at 138 kV and were attributed to a manufacturing defect. Investigation into these three failures concluded that the arresters had been supplied with an improper moisture seal on the weathershed end cap. This allowed moisture ingress, which resulted in an internal fault.

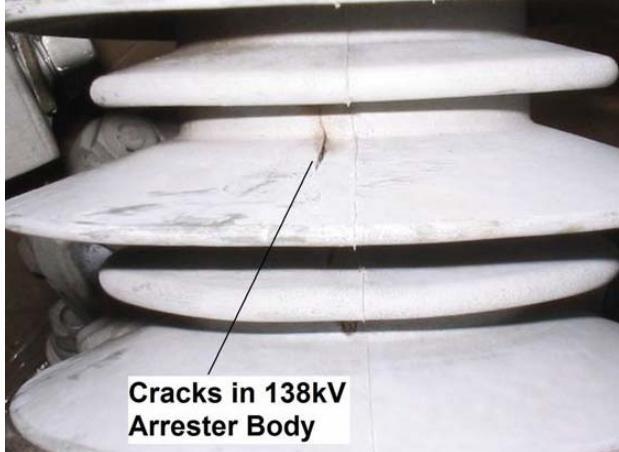
Manufacturing Defect

Figure 10 – 138 kV split in weathershed from internal tracking due to moisture ingress through end cap. Thermovision inspection recommended.

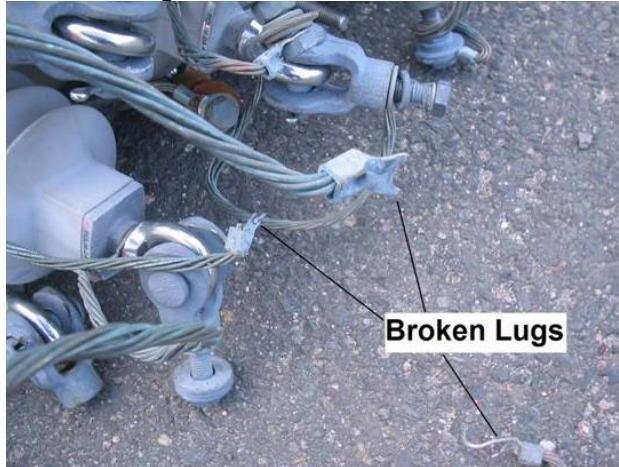
Manufacturing Defect

Figure 11 – 69 kV inferior lugs broke while in service

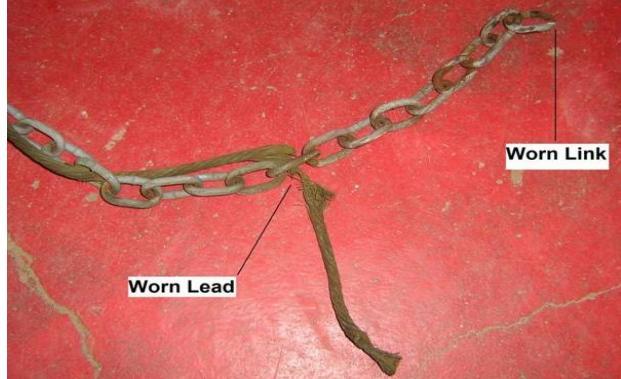
Design Defect

Figure 12A – 138 kV lead and chain worn out after six years of service.

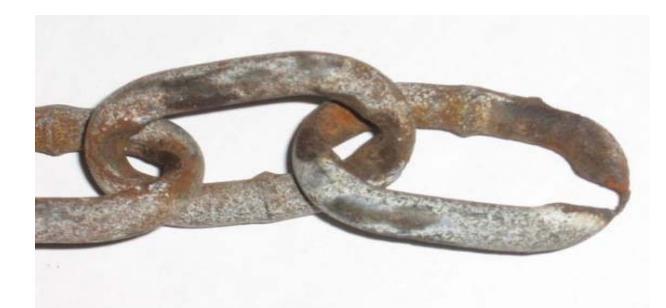
Worn Chain Link Figure 12B – 138 kV close-up of chain link

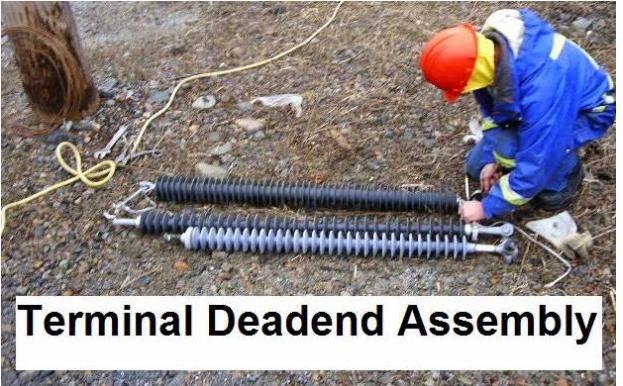
Figure 19 – 138 kV assembly being installed is longer then insulator being removed

Figure 19 shows a typical 138 kV insulator/arrester assembly used to deadend the transmission line. The picture illustrates that the insulator being removed was shorter then the insulator/arrester being installed. This can influence conductor sag and resulting clearances.

It is the opinion of the writer that 90% of the mechanical problems experienced with arresters and described in this paper can be eliminated by using arrester/insulator assemblies similar to that shown in Figures 15 and 19 above.
