## Application of Custom Power to Mitigate Power Quality Disturbances

By:- Vernon Pryde

### Voltage Sag Semiconductor FAB 1995-2005

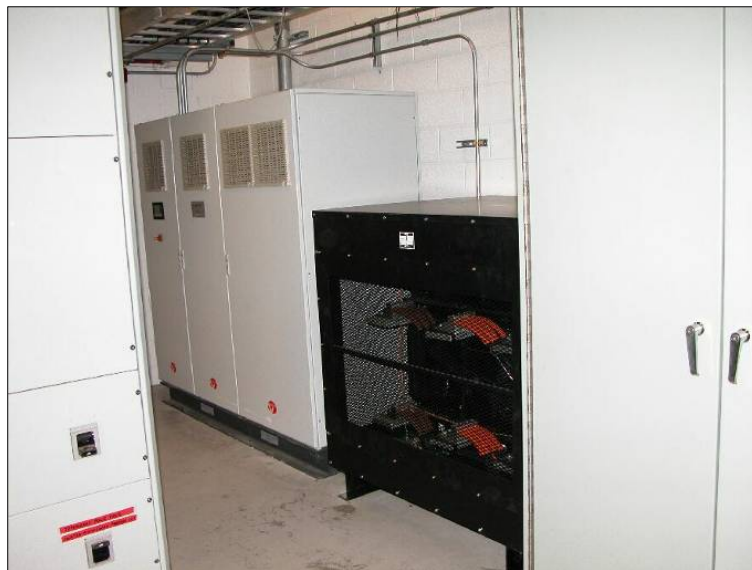
## The Solution

1600kVA AVC installed Aug 2002

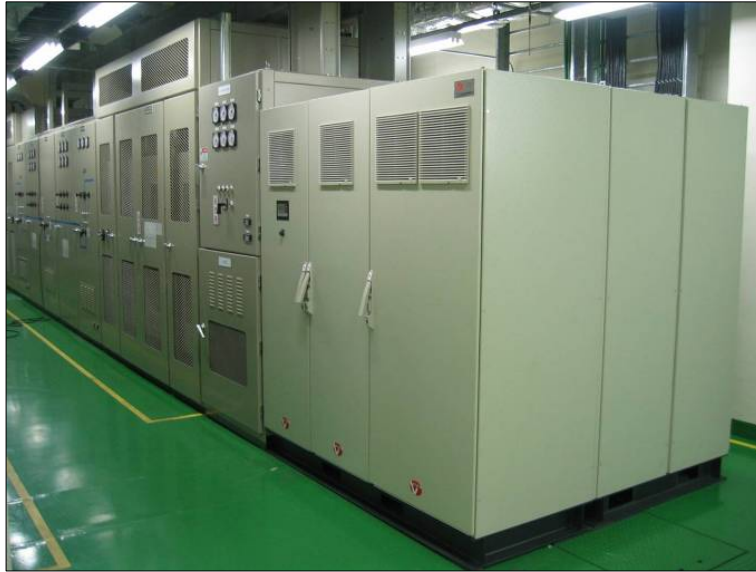
## 1.5MVA 208V AVC

Protecting multiple FAB production tools

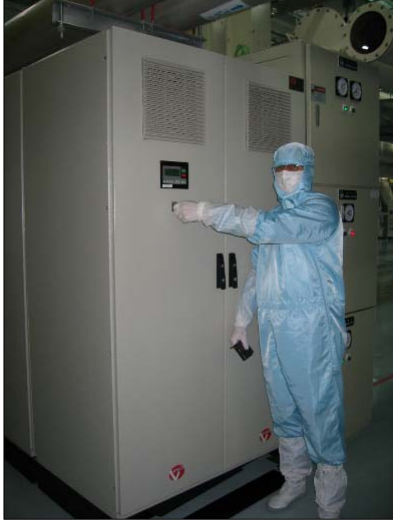
## 50 x 650kVA AVC In FAB Plant

Sag Depth	175kVA	75kVA	50kVA	25kVA	Avg
10-20%	1	4	2	4	2.8
20-30%	7	6	9	4	6.5
30-40%	19	16	20	21	19.0
40-50%	5	6	1	3	3.8
>50%	0	0	0	0	0.0

Logging for one month  
including a snow storm

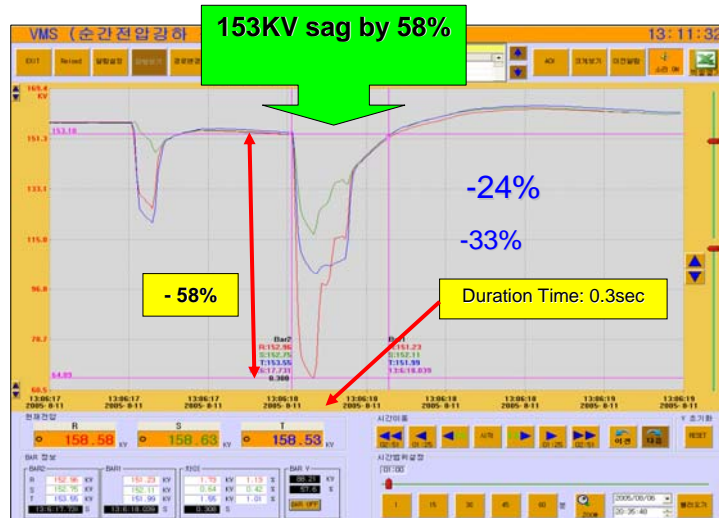
## Voltage Sag 13:00hr Aug. 11. 2005

Over 300 pieces production machinery protected.

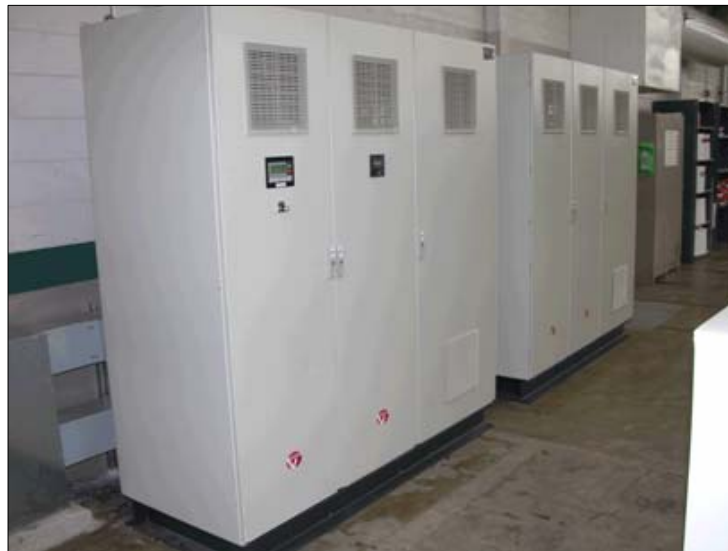
## 3MVA AVC Controller Section

3000KVA, 480Vac, 60Hz Vectek AVC
