Recent Progress in Understanding the Electrical Reliability of GaN High-Electron Mobility Transistors

J. A. del Alamo

IEEE Boston Reliability Chapter Meeting
MIT Lincoln Laboratory, Feb. 17, 2015

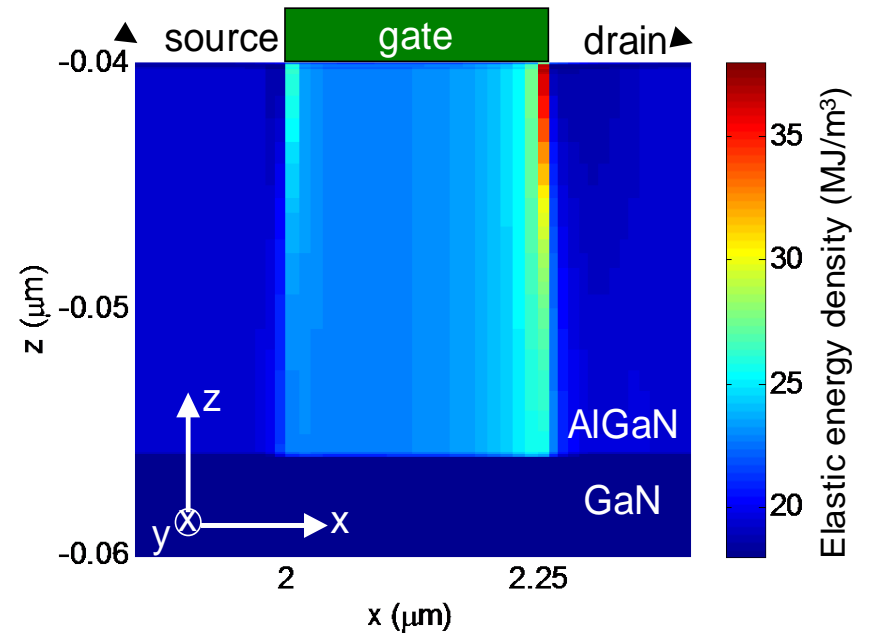
Model for critical voltage

$V_{GS} = -5$ V, $V_{DS} = 33$ V
16nm 28% AlGaIn

$$T_1 = \underbrace{\left(C_{11} + C_{12} - 2 \frac{C_{13}^2}{C_{33}} \right) S_{10}}_{\text{Mismatch stress}} + \underbrace{\left(\frac{C_{13} e_{33}}{C_{33}} - e_{31} \right) E_3}_{\text{Inverse piezoelectric stress}}$$

$$W = \frac{C_{33}}{C_{11} C_{33} - 2 C_{13}^2 + C_{12} C_{33}} T_1^2$$

$$\propto (T_{10} + a E_3)^2$$

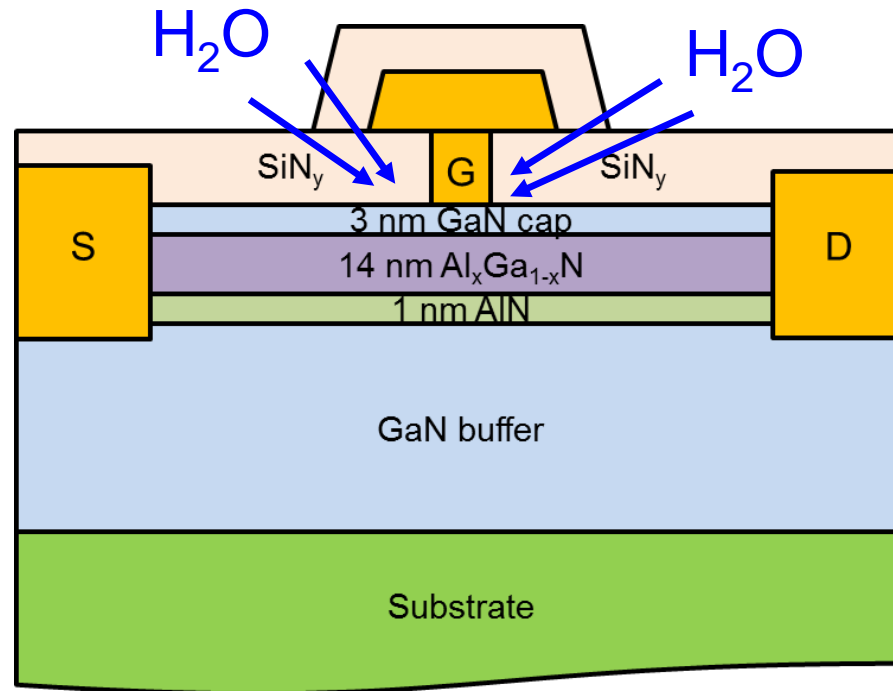
Source of water: diffusion through SiN

- Water-vapor transmission rate (WVTR) through 100 nm of PECVD SiN:

0.01~0.1 g/m²/day

- Gao's estimate of necessary WVTR to cause pits:

0.05~0.1 g/m²/day
