# SWITCHING TRANSIENTS INDUCED TRANSFORMER FAILURES

Presented to  
IEEE-IAS – Atlanta Chapter  
April, 19, 2010  
By David Shipp, PE

## Case Study Overview: Data Center Transformer Failure Attributed to Circuit Breaker Induced Switching Transients

System Configuration, Failure Analysis  
and RC Snubber Fix

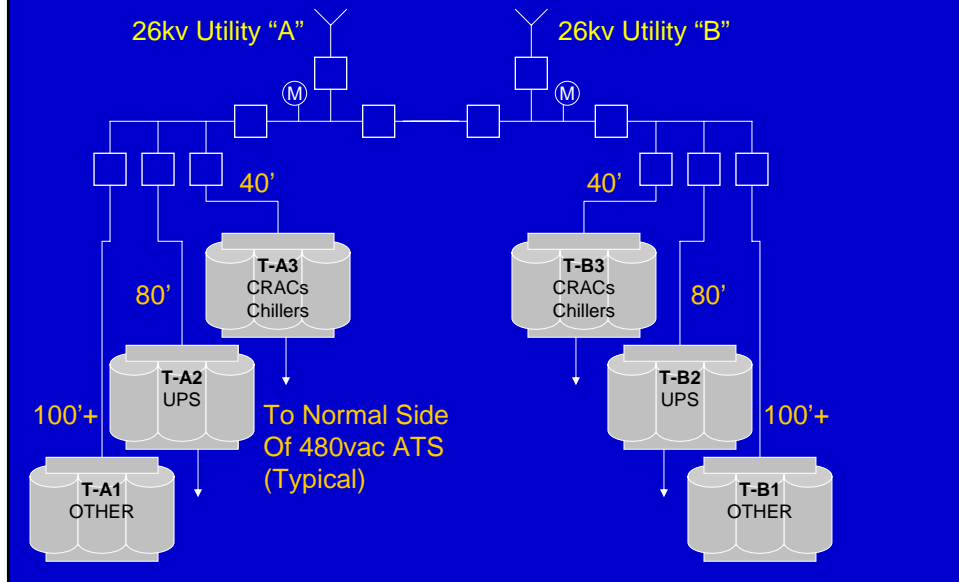
## Simplified System Configuration

- **Utility Service:**
  - 26kV
  - Double Ended Loop Through
- **Transformers**
  - (6) Total
  - 26kV Primary, 480V Secondary
  - VPI
  - 3000kVA AA / 3990 kVA FA
  - 150 kV/bil
- **Switching Device**
  - Vacuum Circuit Breaker
- **Cable**
  - 35kV, 133% EPR Insulation, 1/3 Concentric Ground

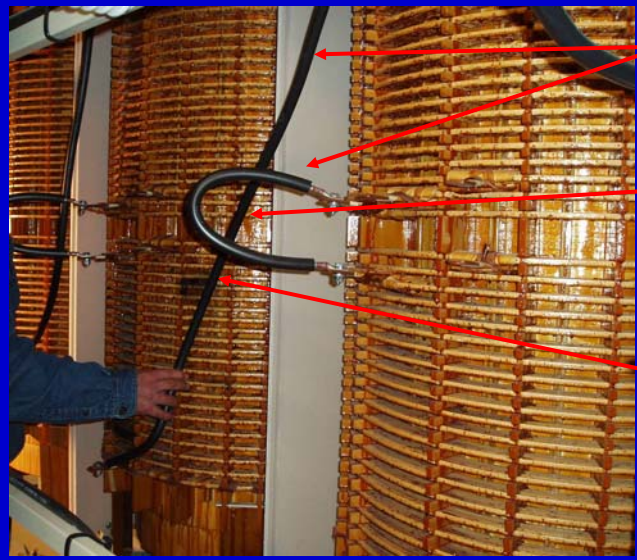
# Failure #1 Transformer Failure On De-Energization

15KV Cable  
In 26KV  
Transformer

No Coil to Coil  
Cable Supports

Some Burn  
Marks Match  
Point of  
Cable Contact

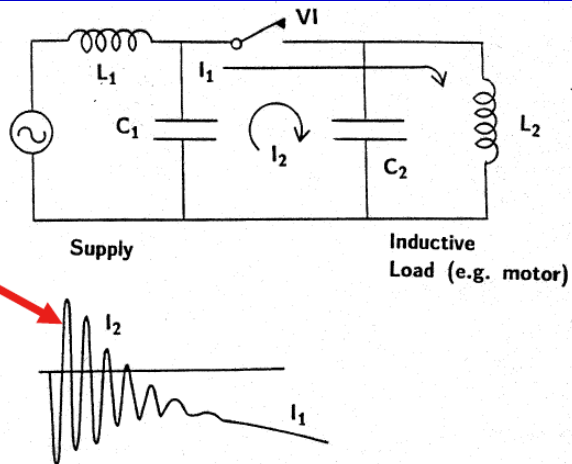
## Switching Inductive Loads OPENING

- If a restrike occurs on opening, a high frequency current flows with current zeros

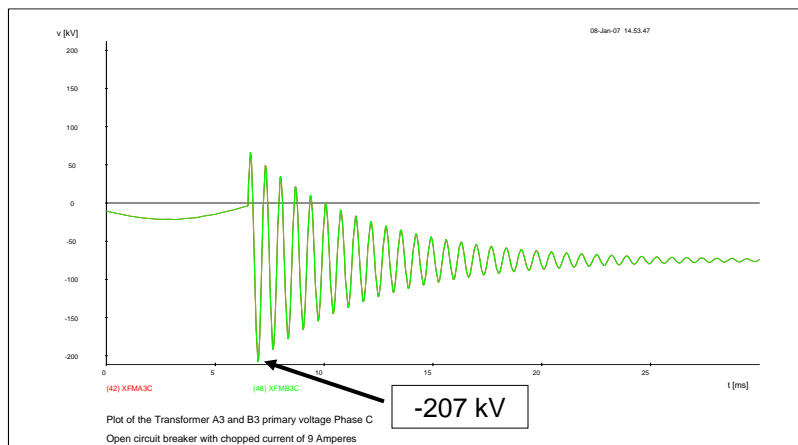
### Data Center, NJ 12/06 - W/O Snubbers

- 26.4 kV
- Vendor "B" Breakers
- 4 Bkrs Switched at Once
- 2 Dry Type Txmrs Failed (40 Ft of Cable)
- 2 Txmrs Did not Fail (80 Ft of Cable)
- Unfaulted Txmr Winding Failed BIL @162 kV ( Rated 150 kV)

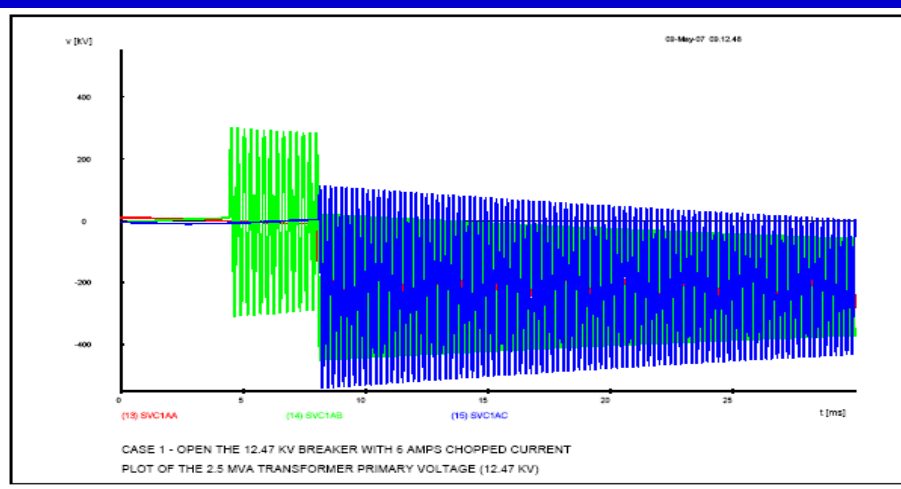
### 425 kV - 12.47 kV - 23 kHz Ring Wave

- 12.47 kV System
- 20+ Year Old Oil Filled Txmrs
- Vendor "A" Vacuum Bkrs retrofitted on Primary
- 10 Feet of Cable
- No Problem at Startup

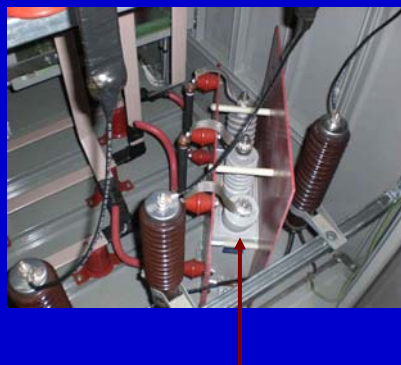
### Snubber - 3 Phase Capacitor Generally Solidly Grounded System

- Paper Mill - AL
- 13.8 kV

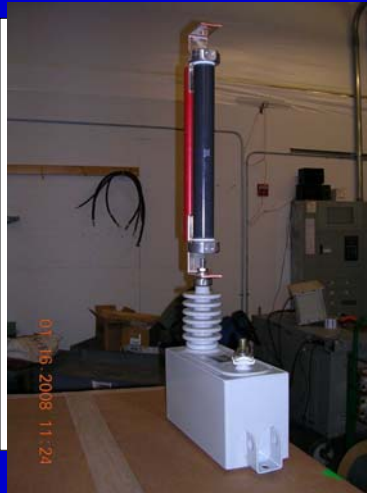
## Snubber – Single Phase Capacitors

- Silicon “Chip” Plant
- Montana
- Very Specialized Dry Type Txmrs
- 13.8 kV
- Cables < 100 feet
- Primary Fused Switch AF Solution
- Vendor “A” Vac Bkrs
