Ultrasonic detection of stress corrosion cracks in pipe samples in gaseous atmosphere

Abstract—Stress corrosion cracking (SCC) is a serious threat to gas pipelines. Current in-line inspection tools have issues with the detection and sizing of small cracks. Advances in gas-coupled broadband ultrasound enable new detection methods based on Guided Ultrasonic Waves (GUW). Recently, the potential to detect SCC using Halfwave’s ART Scan[®] tool was successfully demonstrated on real pipe samples with SCC, submerged in water [1]. In this study, the ultrasonic detection of SCC is experimentally demonstrated, using pressurized gas at 60 bar as acoustic coupling medium. A custom-made test scanner with 32 transmit/receive channels was developed to perform circumferential scans of 425 mm × 60° from the inside of pipe samples of diameters close to 36 inches. The gaseous atmosphere of 60 bar (nitrogen) required the experiments to be conducted inside a pressure tank that contained both the test scanner and pipe samples. Broad-band pulses were transmitted, and signals were received from all scan positions. Processed parameters like spectral power and wall thickness estimates were calculated. 2D pl

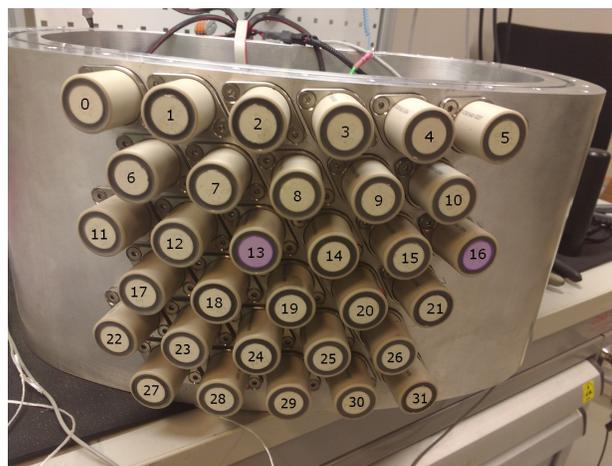
Fig. 1. Scanner head containing 32 broadband gas transducers, of which two dedicated transmit channels (13 and 16).

The experimental test set-up has been designed to investigate the detection potential of SCC from inside 36” and 38” pipe samples in gas (nitrogen) at 60 bar. For this purpose, a custom-made scanner was manufactured to allow mechanical scanning inside a high-pressure chamber. The scanner head consists of 32 broadband ART Scan[®] gas transducers; 2 transmit (Tx) transducers and 30 receive (Rx) transducers. In this work only one Tx channel (13) is used. Fig. 1 displays a picture of the scanner head.

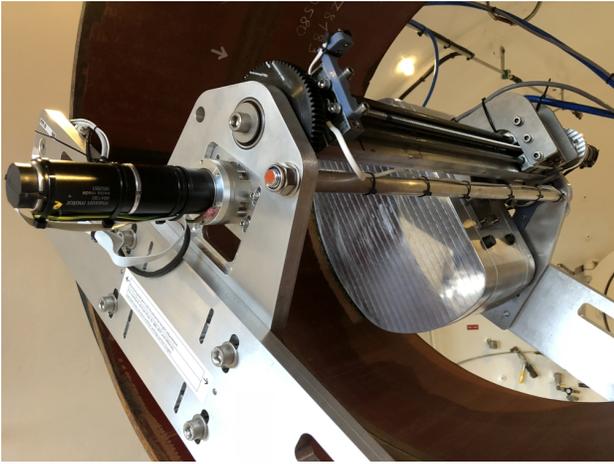
Fig. 2. Set-up of the test scanner inside a pipe sample.

The scanner head could mechanically translate and rotate to perform circumferential scans of $425 \text{ mm} \times 60^\circ$. Scans were performed internally in the pipe with a stand-off distance between the transducers and the pipe wall of approximately 60 mm. Maximum scan resolution was $0.5 \text{ mm} \times 0.2^\circ$. The experiments at pressures of 60 bar were conducted inside a pressure tank that contained both the test scanner and pipe sample (see Fig. 2). Pictures of the experimental set-up in the pressure chamber at the Norwegian Underwater Institute are depicted in Fig. 3.

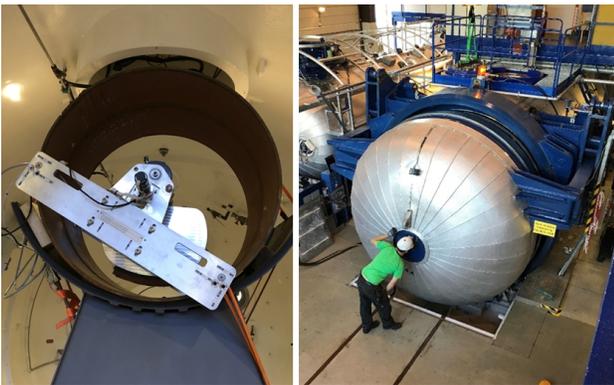
Fig. 3. Picture of the set-up inside the pressure chamber (left) and of the pressure chamber at the Norwegian Underwater Institute (right).

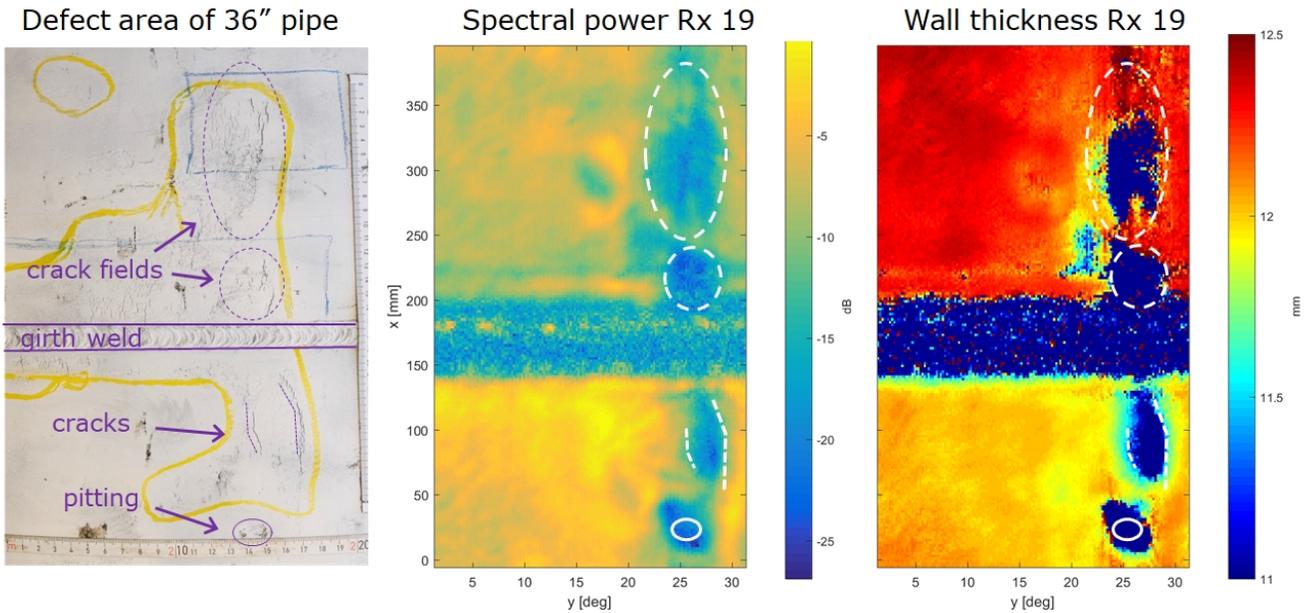
Fig. 4. Side-by-side comparison of a picture of the scanned area of the 36" pipe sample with marked defects (left) and processed spectral power (center) and wall thickness estimates (right) from channel 19 from the same area.

Different processing methods were applied to find sensitive and specific parameters that could lead to robust detection of crack-like defects. A comparison of two processed parameters of a scanned area of the 36" pipe sample that includes stress corrosion cracks, is presented in Fig. 4. The left plot depicts the outer surface of the pipe section where SCC areas have been made visible by powder treatment. The dashed lines mark cracks and crack fields, and a solid ellipse marks a pitting corrosion. The maximum depths of the two isolated cracks below the girth weld is 4.3 mm, corresponding to approximately 35% of the pipe wall thickness. Fig. 4 plots the spectral power (center) and the thickness estimates (right) from Rx channel 19. The horizontal structure centered around $x \approx 170 \text{ mm}$ corresponds to the location of the girth weld. The areas with reduced power (center) and reduced wall thickness estimates (right) on the right side of the scan (around $y \approx 25^\circ$) correspond to locations of cracks, crack fields and pitting corrosion. The spectral power shows up to 20 dB lower signal levels for SCC affected regions.

spatial resolution over the point-wise processed source images (see e.g. center plot of Fig. 4). This can be expected since the inversion result compensates for the effects of the finite acoustic beam width and the projected distance between the Tx-Rx transducer pairs, which makes reconstructed defects look smaller than in point-wise processed plots.

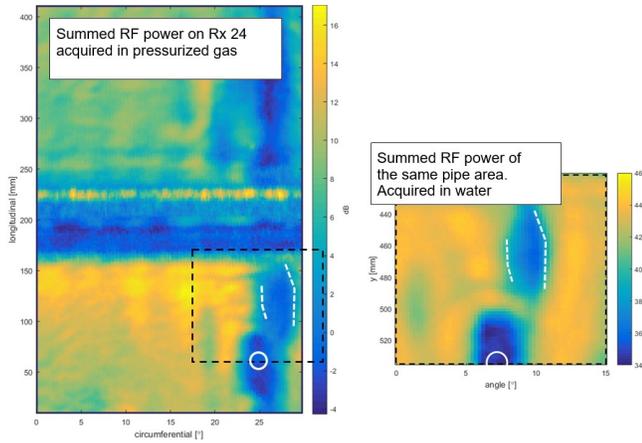
Fig. 5. Summed RF power plots from the 36" spool acquired in pressurized gas (left) and in water (right). The scan area in water has been smaller than in gas and is approximately marked by the dashed rectangle. The approximate locations of the 4.3-mm-deep crack and pitting corrosion dent are marked in white.

In a previous study [1], where water was used as the acoustic coupling medium, the same 36" pipe was scanned. Fig. 5 displays the summed RF power as acquired in gas (left) and of an overlapping area in water (right). The scan parameters were not identical, however, the observed similarities are evident. This result suggests good reproducibility and increased confidence in the experimental results in pressurized gas.

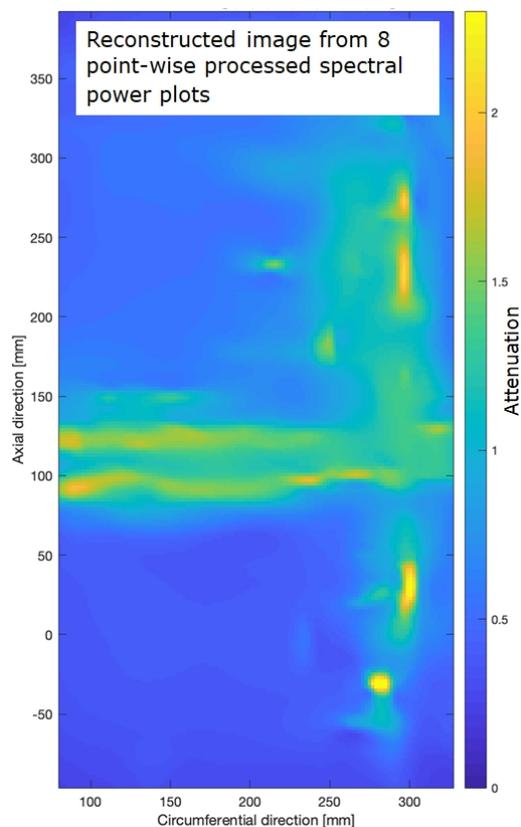
Fig. 6. Tomographic inversion result of combining spectral power plots from 8 receive channels surrounding 1 transmit channel.

Initial sizing of detected defects inside the scanned area of the 36" pipe is based on tomographic inversion [3], applied to point-wise processed spectral power plots. The inversion algorithm converged on the result shown in Fig. 6 and combined information from eight transducer pairs with different relative orientations. Bright yellow parts of the image indicate high attenuation, while dark blue indicate no attenuation. The pitting and the crack below the girth weld match particularly well with the observed defects. Furthermore, the resulting image indicates that there is a noticeable improvement in

The estimated dimensions of three selected defect areas are based on a threshold set at 60% of the maximum reconstructed attenuation value from Fig. 6, and are displayed in Table II. These estimates based on tomographic inversion are within reasonable accuracy as compared to the measured dimensions.

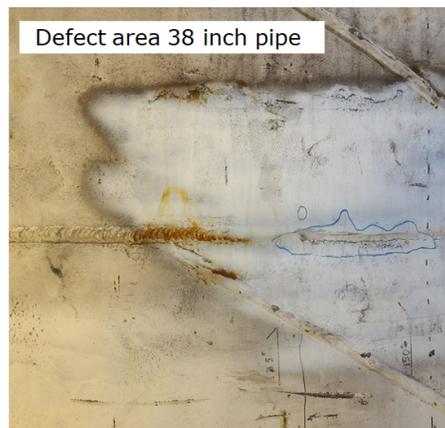
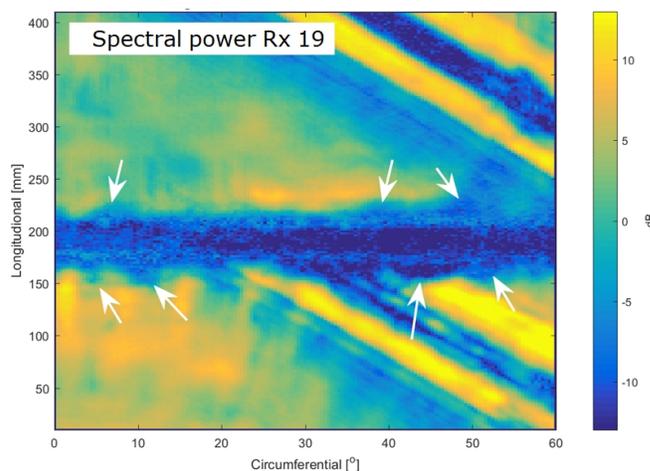
Fig. 7. Side-by-side comparison of the scan area of the 38” pipe (top) and the corresponding time windowed spectral power (bottom).

SCC close to the girth weld of the 38" pipe sample is shown in Fig. 7 with a photo of the spiral welds (top) and the corresponding spectral power plot (bottom). Some areas with low power around the girth weld that could be marked as suspicious areas are indicated with white arrows. These areas correspond to regions with both circumferential and small axial cracks. Fig. 7 therefore suggests the potential to detect significant cracks near a girth weld.
