TVA Customer Resources Comprehensive Services Staff Case Studies

Music City Power Quality Group/IEEE

By Gerald D. Johns, Power Utilization Engineer
TVA Kentucky Customer Resources

**Surge Protection on 4-Wire
Delta systems-Metal Oxide
Varistor Failures on 120/240
4-Wire Service**

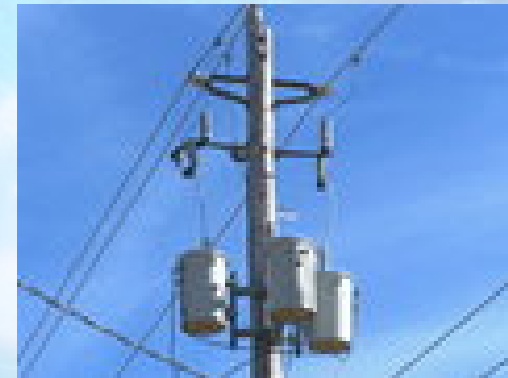
4-Wire Wye-Delta Transformer Bank

- Radio transmitter site with 3-phase, 4-wire, 200-amp 120/240 VAC service with 208 VAC “wild-leg”
- Normal load = mixture of 3-phase 240 VAC load and single-phase 120 and 240 VAC load
- 45-kVA bank with three identical 15-kVA 7.2 kV to 120/240 VAC single-phase transformers
- Ungrounded-wye primary and delta secondary

- Ungrounded primary neutral to avoid becoming a grounding bank

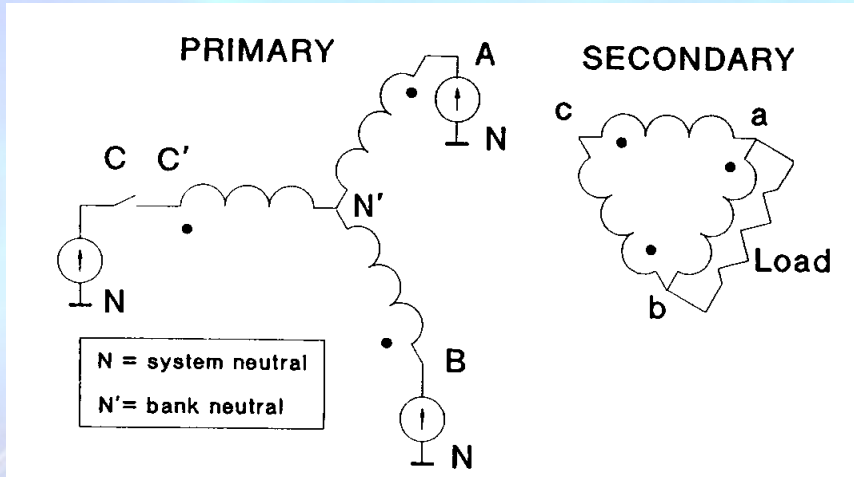
Primary neutral-shift due to load imbalance on secondary

Source: Walling, R.A., Hartana, R.K., Ros, W.J., "Self-Generated Overvoltages Due to Open-Phasing of Ungrounded-Wye Delta Transformer Banks", IEEE Transactions on Power Delivery, Vol. 10, January 1995, pp. 526-533.

- When one phase is opened on an ungrounded wye delta bank, there can be shift of the neutral voltage due to the load imbalance. With the absence of a ground reference at the physically intended neutral point, the neutral is left to float during a phase-loss condition.
- The position of the actual primary neutral point under this circumstance for ungrounded-wye/delta configuration is dependent on the load imbalance on the secondary side.
- During open-circuited conditions, i.e. no load, there is virtually no imbalance; hence no overvoltage occurs.

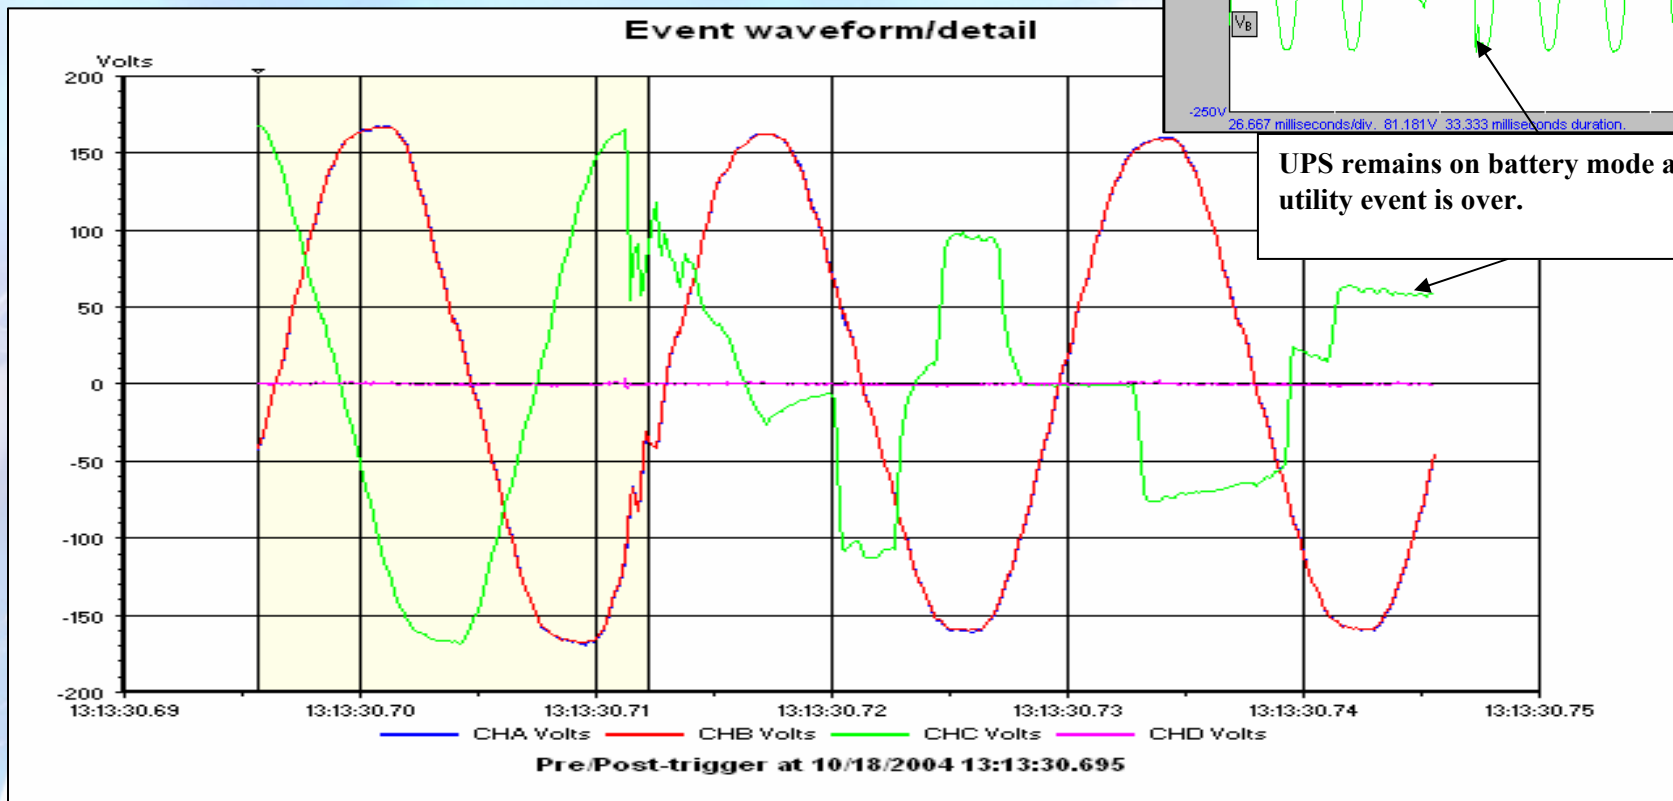
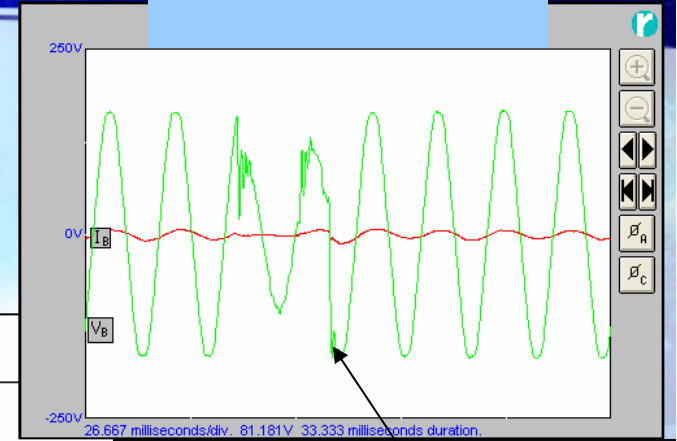
Case #2 - Same UPS when actual voltage sag occurs

UPS remains on battery mode after utility event is over.

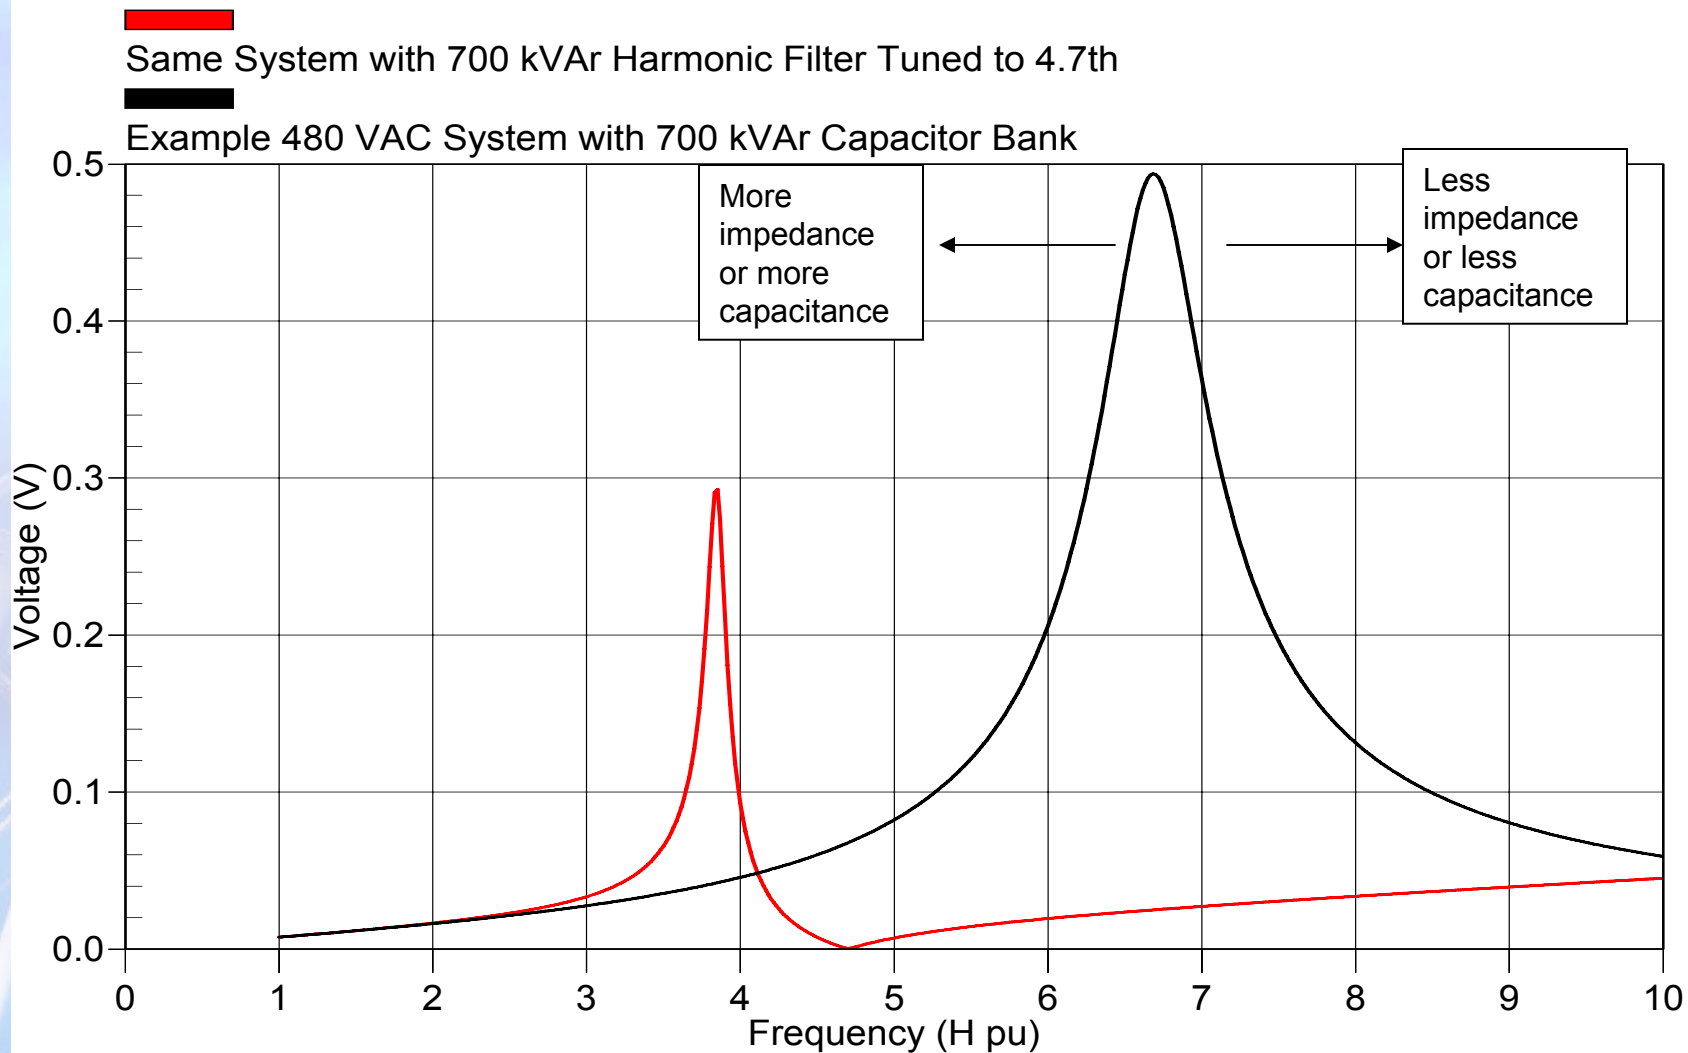
Example Frequency Scans

Frequency scans to identify resonant frequencies

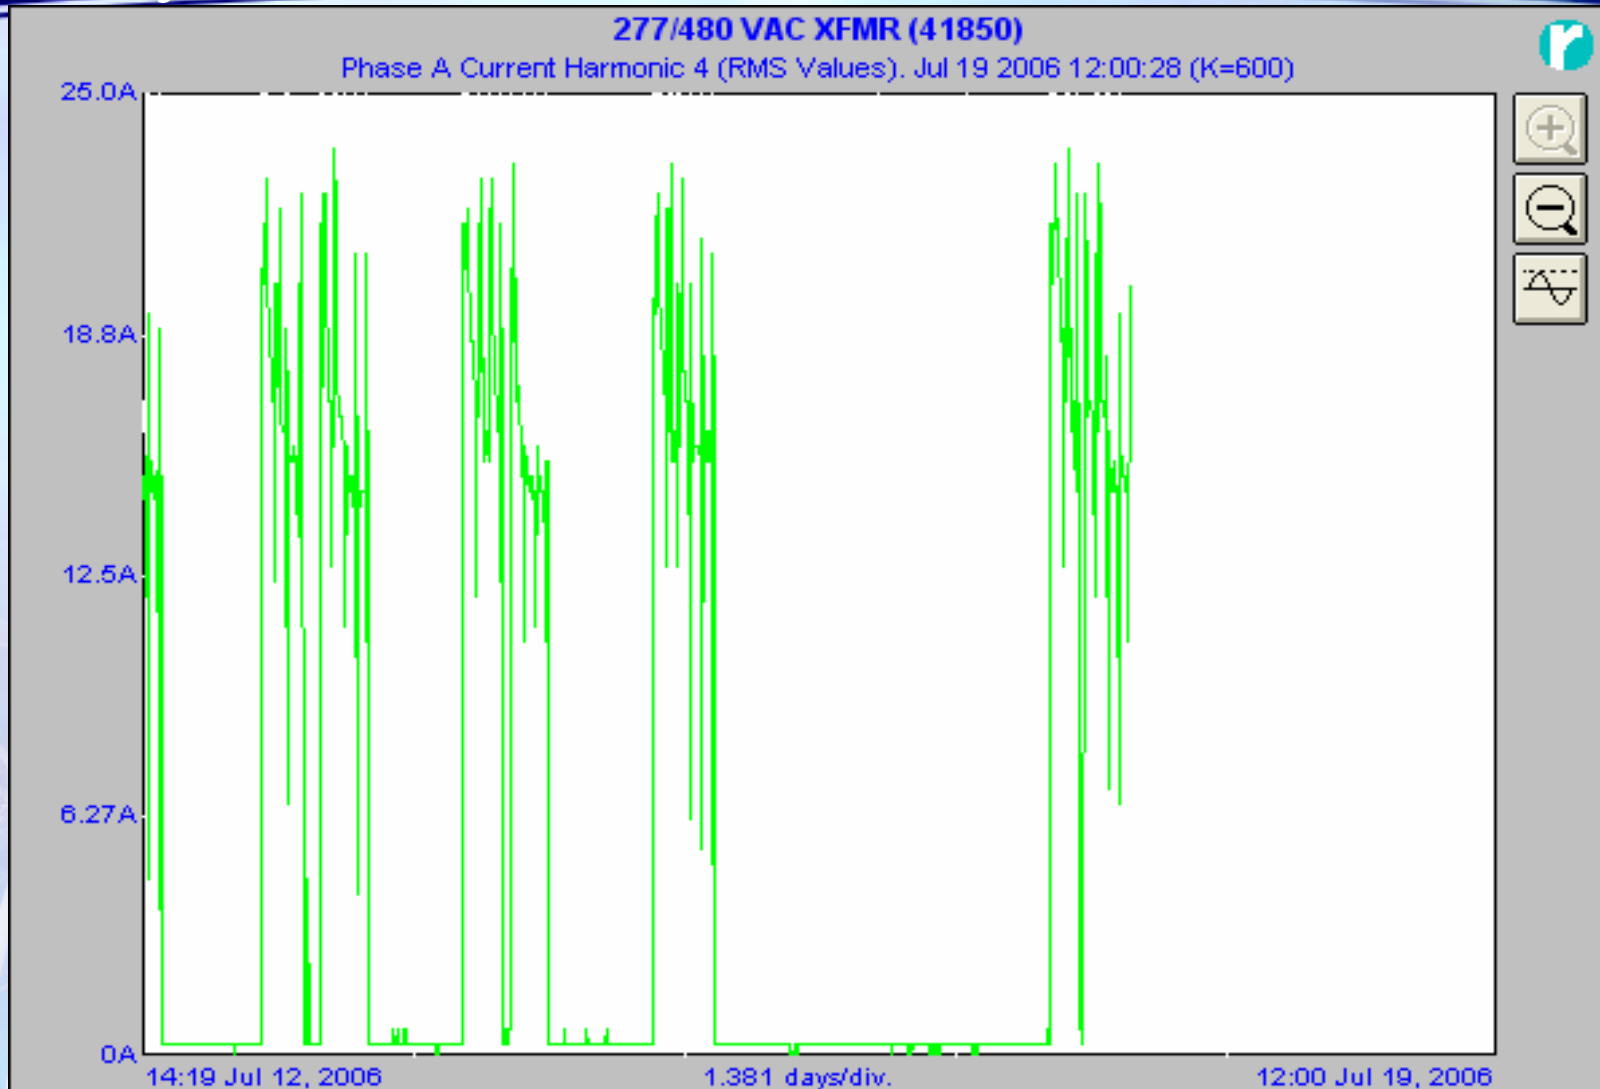
Time profile of 4th harmonic on Case #1 480 VAC system

With fundamental 60 Hz load current ranging 1,200-1,500 amps

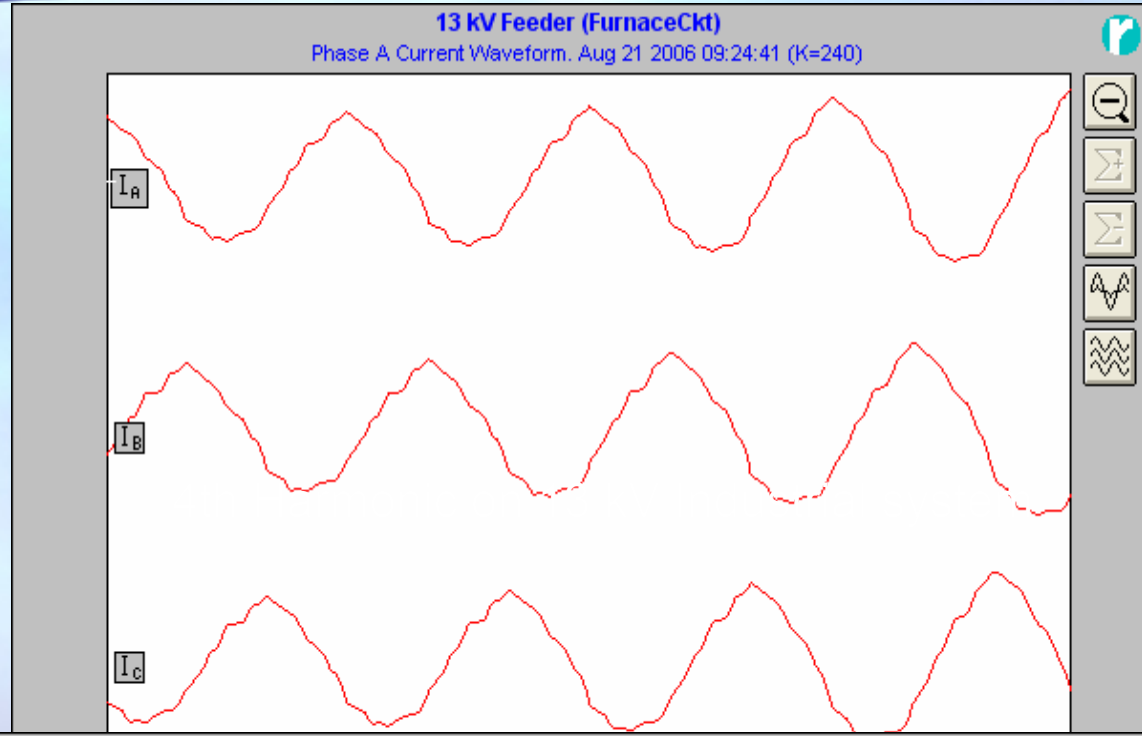
Case #2 - 4th Harmonic on 13 kV Industrial system snapshot

13 kV Feeder (FurnaceCkt)
Phase B Current Harmonics. Aug 21 2006 09:24:41 (K=240)

Harmonic	RMS Value	Phase	Percent
0	24.62A	180°	5.941%
1	414.4A	242.2°	100%
2	3.727A	33.52°	0.899%
3	2.527A	316.2°	0.609%
4	22.49A	228.9°	5.427%
5	6.252A	98.93°	1.508%
6	971.1mA	270°	0.234%
7	17.53A	307.5°	4.231%
8	746.2mA	231.3°	0.18%
9	640.7mA	255.9°	0.154%
10	556.1mA	335.2°	0.134%
11	12.30A	27.05°	2.969%

The table provides a detailed breakdown of the harmonic content in the Phase B current. The fundamental component (1st harmonic) is the largest, at 414.4A (100%). The 4th harmonic is the most significant distortion, at 22.49A (5.427%). Other notable harmonics include the 7th and 11th. The table includes columns for Harmonic order, RMS Value, Phase angle, and Percent of total current.

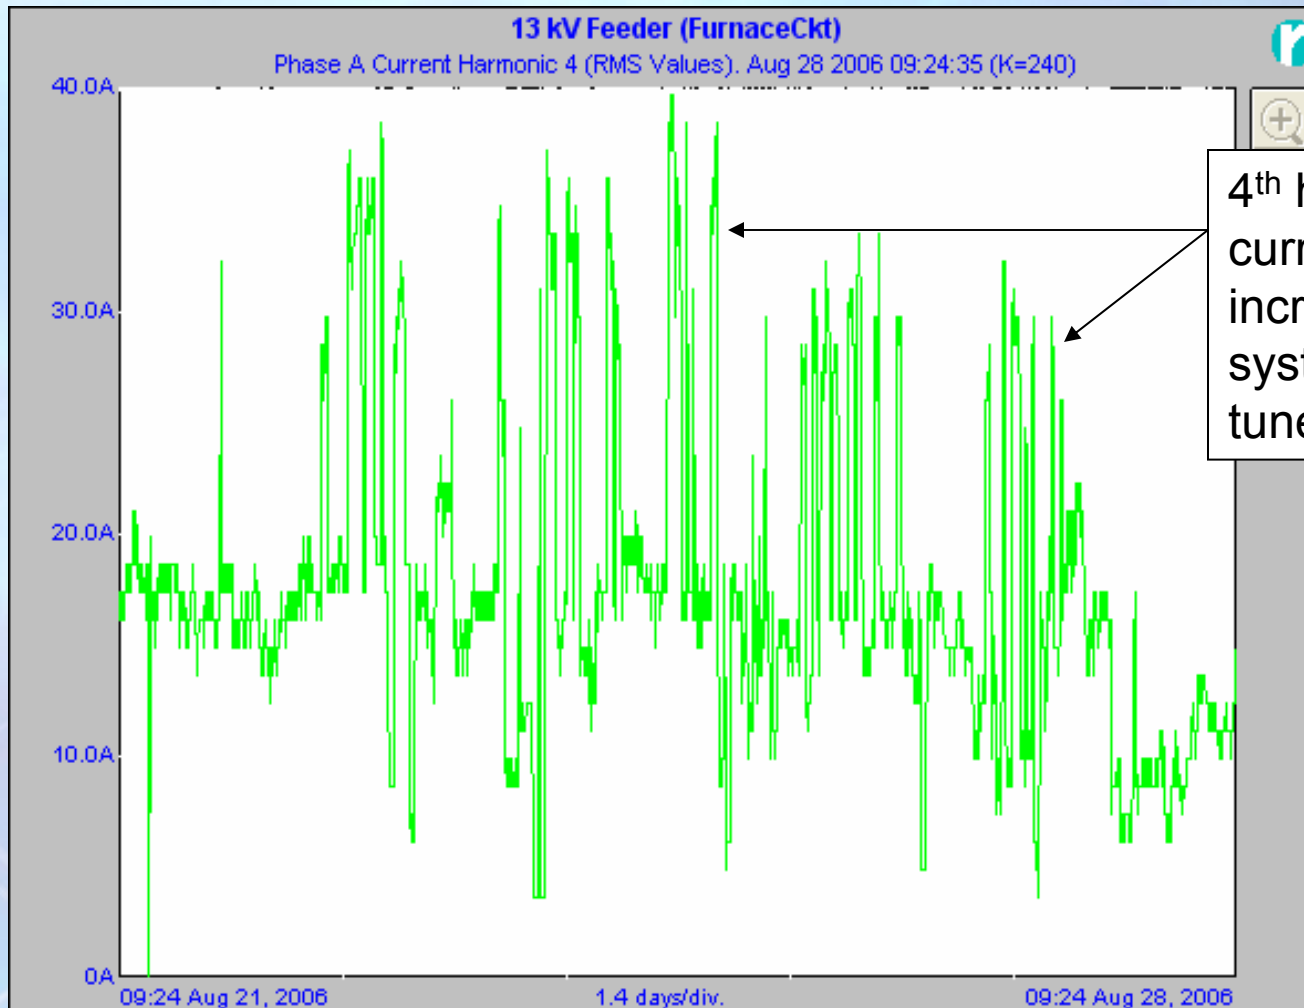
Case #2 - 4th Harmonic on 13 kV Industrial system time profile

4th harmonic current increases system parallel tuned to 4th
