## Transformer Failure Due to Circuit Breaker Induced Switching Transients

IEEE Central Tennessee Section  
May 1, 2012

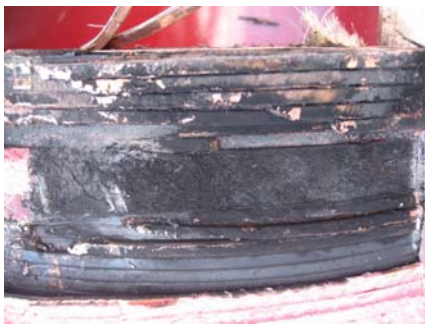
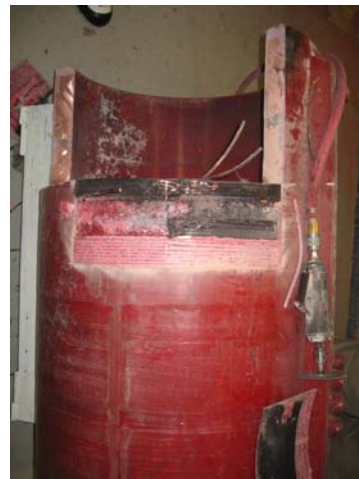
## Case 11 Paper Mill – 13.8 kV

- 4 x Cast Coil Transformer failures Vendor E, 13.8kV/600V, 1.5MVA and one 2MVA.
- Vendor C vacuum breaker
- Failure 2/3 into winding – internal resonance

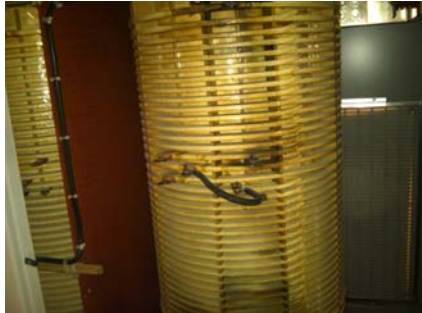
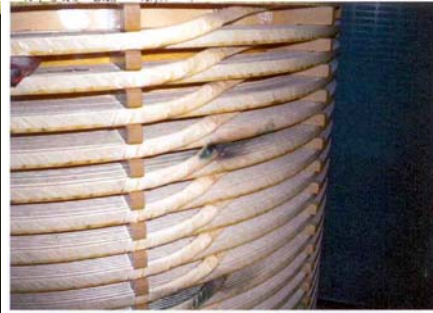
## Case 12 Hospital – Kentucky – 12.47 kV

- Failure during commissioning
  - Emergency Room Transformers
  - Vendor C Vacuum Breakers
  - Vendor F, Transformer
- VPI transformer

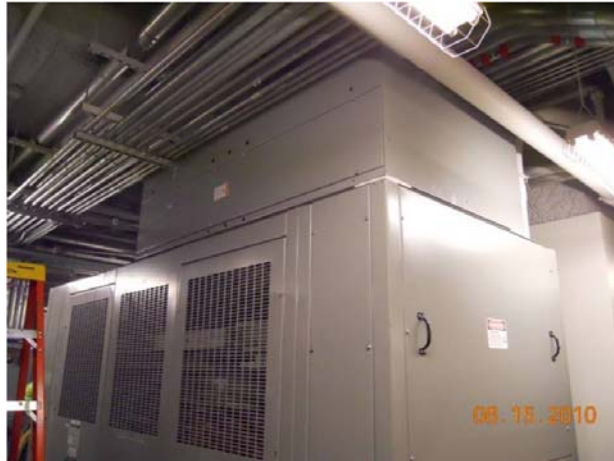
12.47kV snubber mounted  
horizontally above transformer

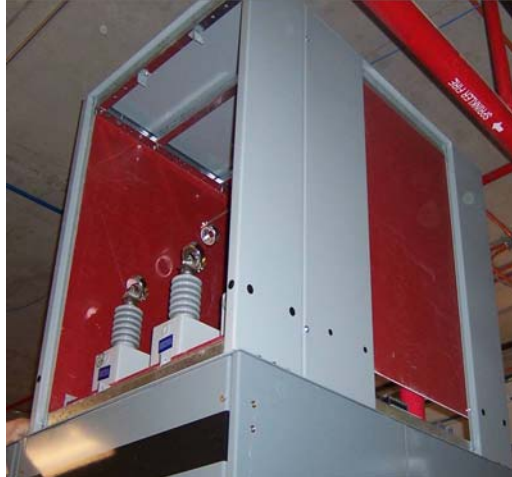
## Office Building – top hat

- This 15 kV design was mounted above the MVS. The resistors had not been installed.  
36"L x 54"D x 45"H.

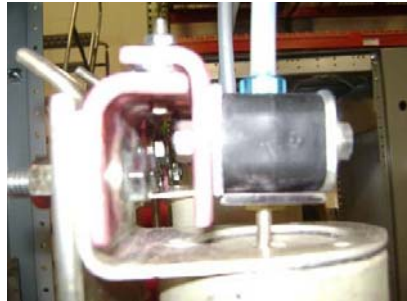
## Design Options - Fuse Blown Detection

- The fuse striker pin operates a mechanical linkage and operates a micro switch when the fuse blows.

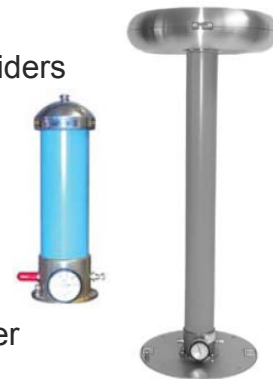
## Test Equipment

- Test equipment included voltage dividers and a transient recording device
- Voltage Dividers
  - Capacitive and resistive elements
  - 10MHz frequency response
  - SF6 insulated
- Three-Phase Power Quality Recorder
  - transient voltage waveshape sampling
  - 8000 Vpeak full scale, 200 nsec sample resolution
  - 5 Mhz sampling

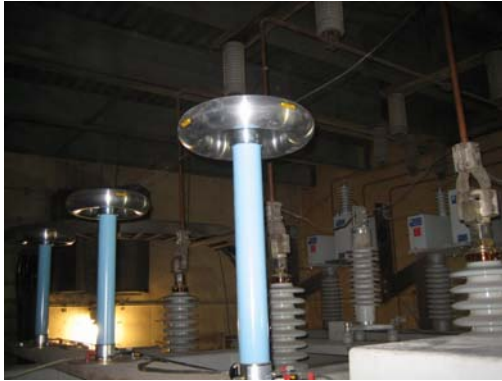
Voltage Dividers Installed  
at Primary Bushings of Transformer

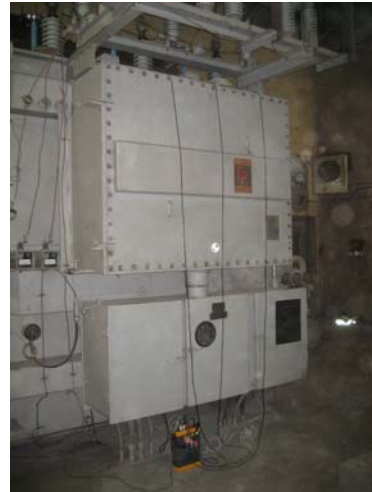
PQ Meter and Test Leads
