UPS CASE STUDY SERVER INCOMPATIBILITY

PRESENTED AT IEEE / MCPQG MEETING NOVEMBER 28, 2012

BY MIKE PUCKETT, PE

LIGHTNING CASE STUDY

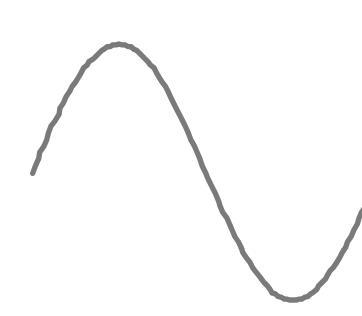
I.T. EQUIPMENT POWER SUPPLIES

Power Supply Waveform Prior to Mid 80's Power Supply Waveform beginning around Mid 80's

Power Supply Waveform for Data Center I.T beginning around 2002

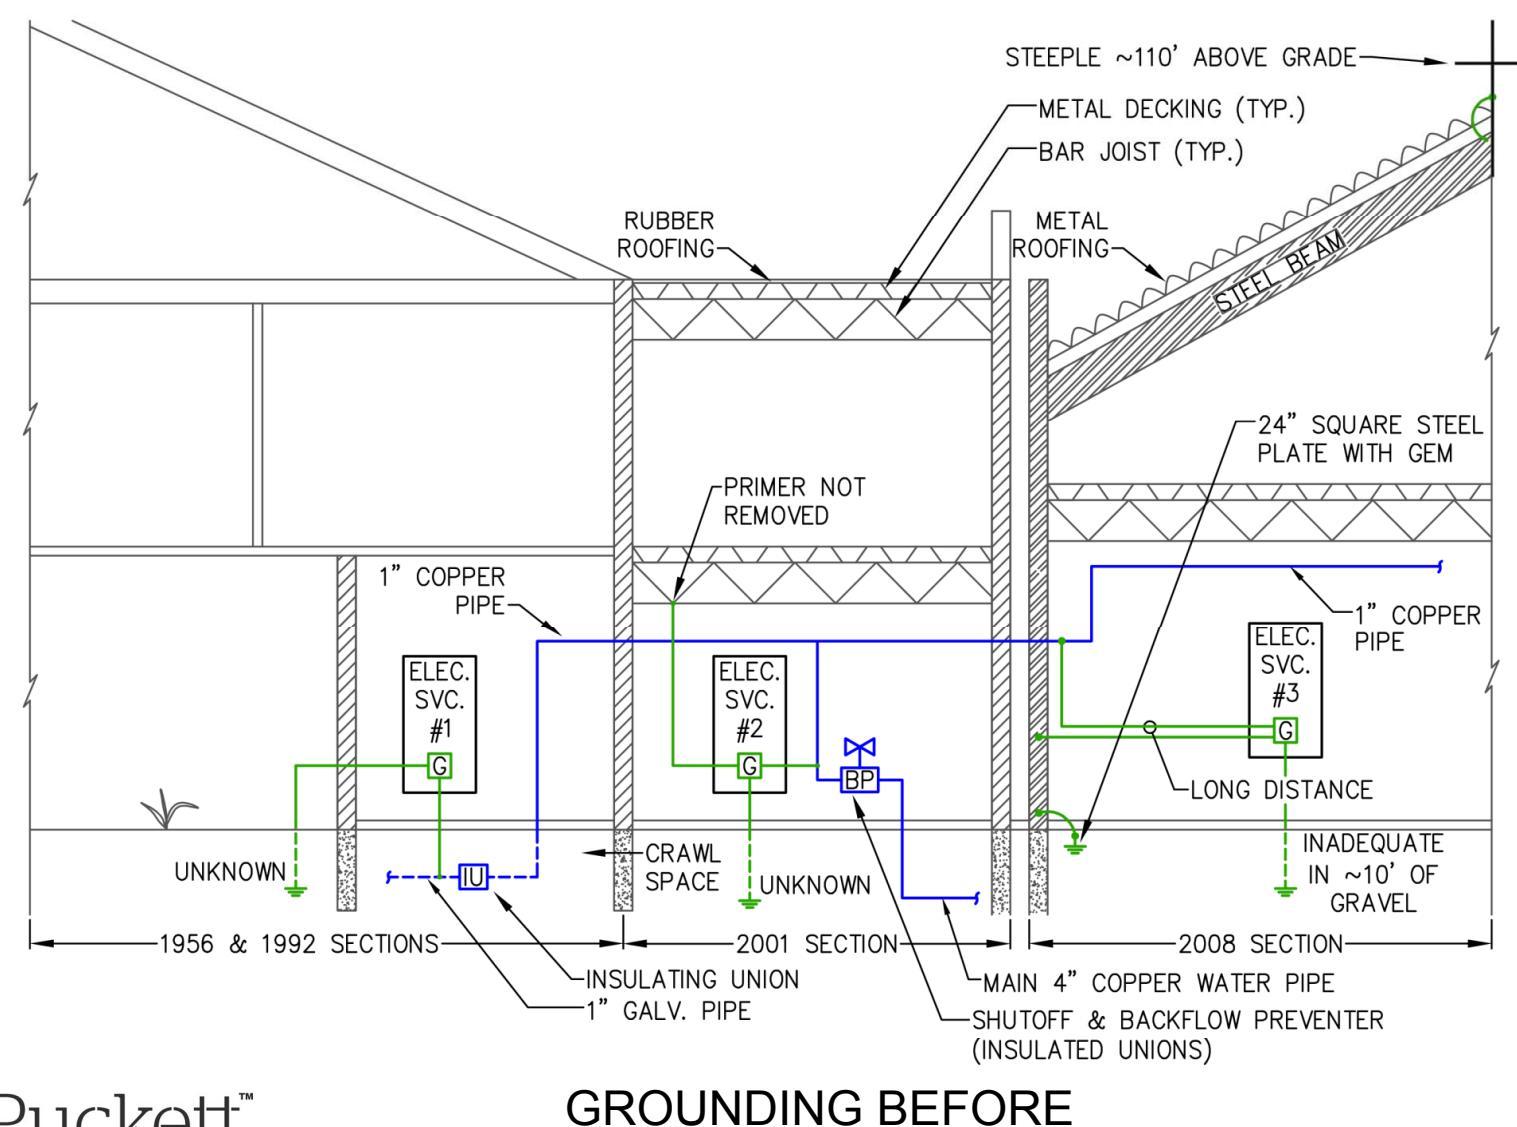
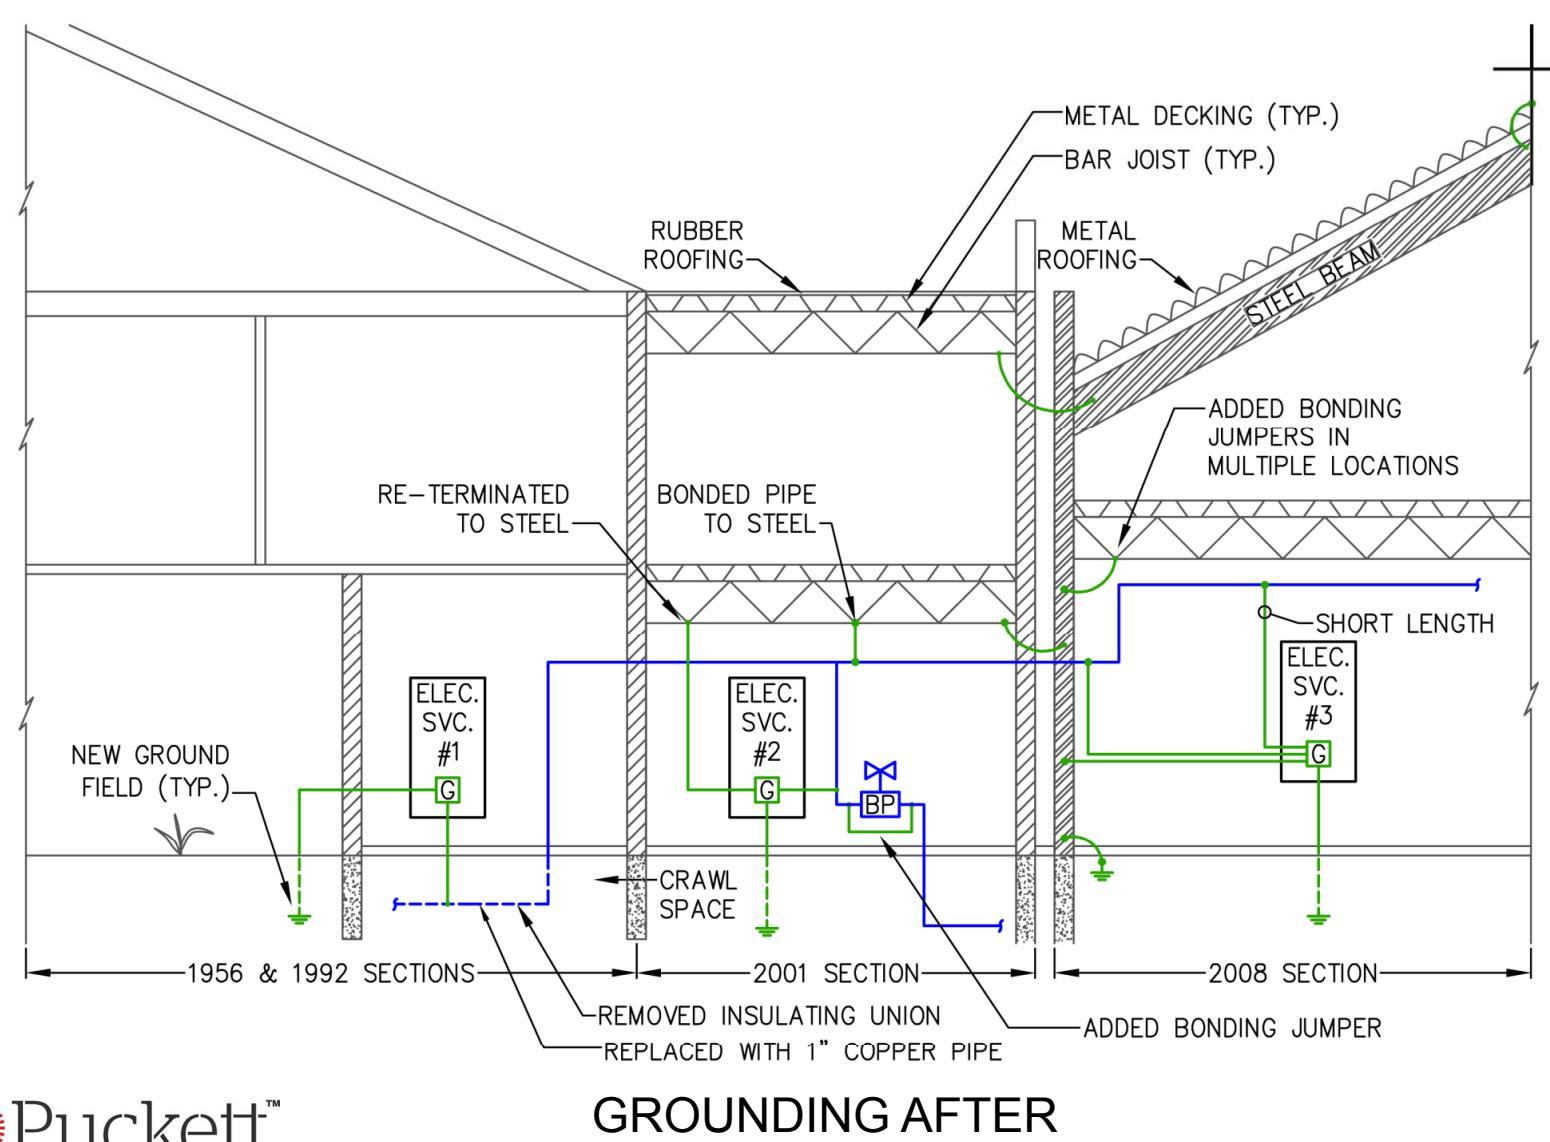
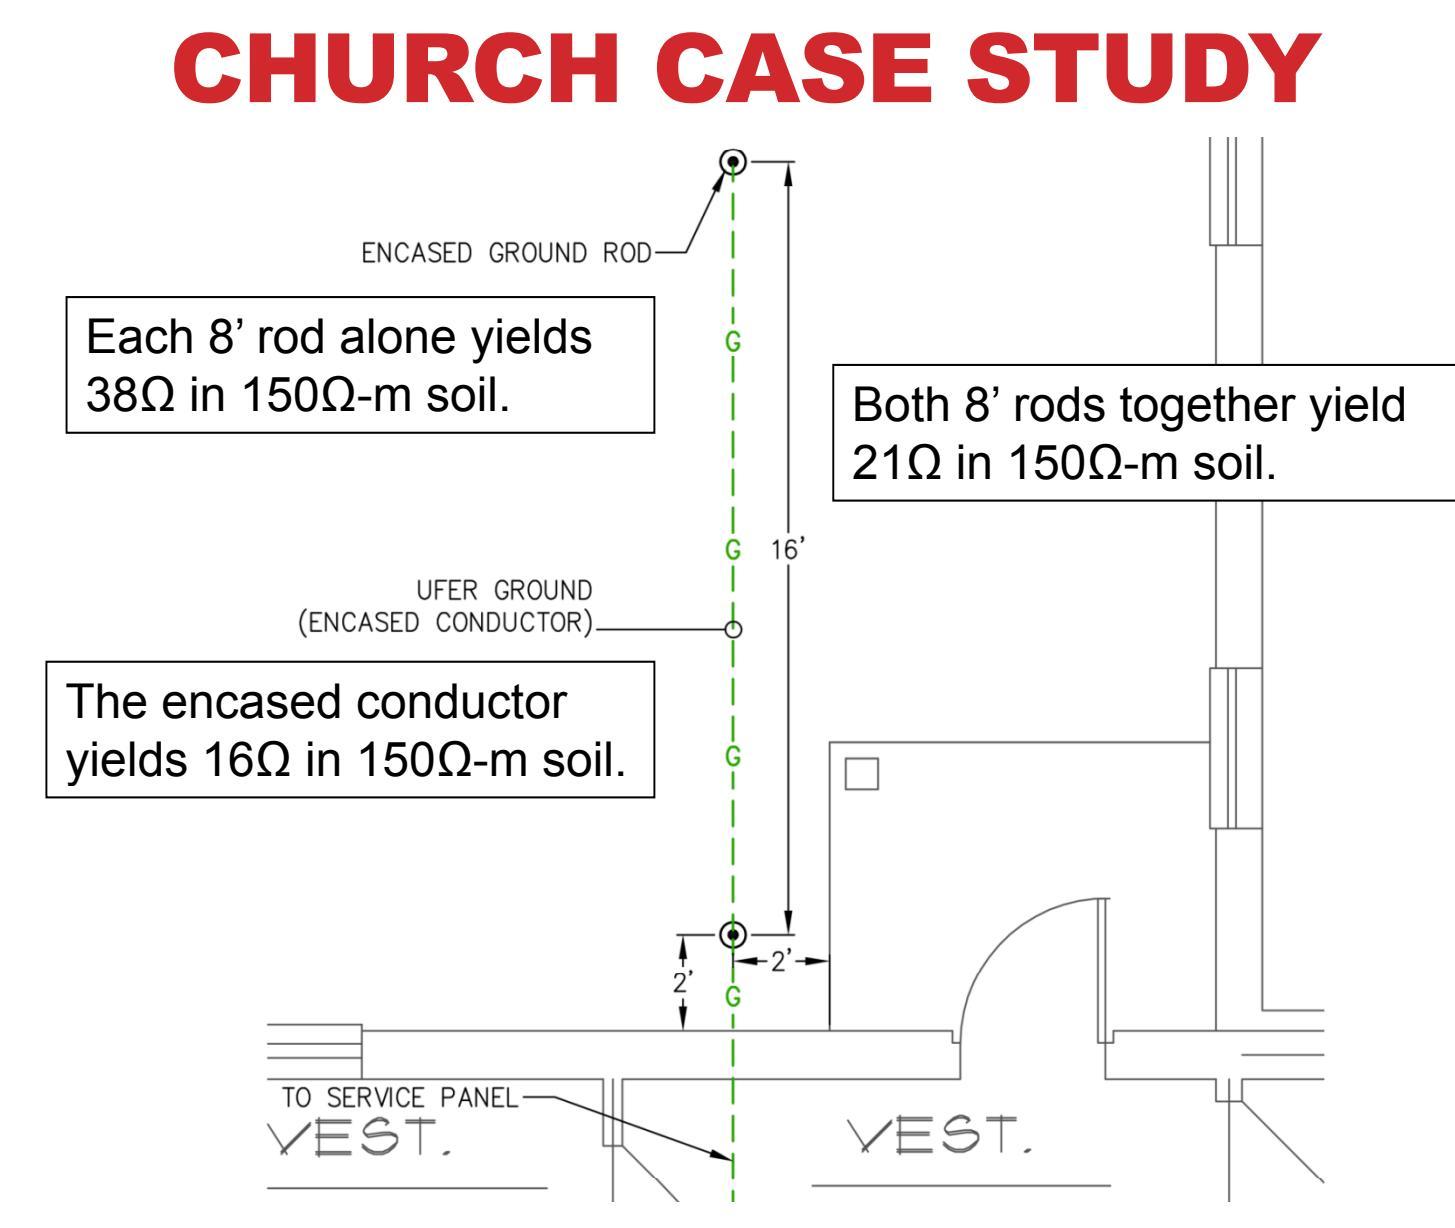
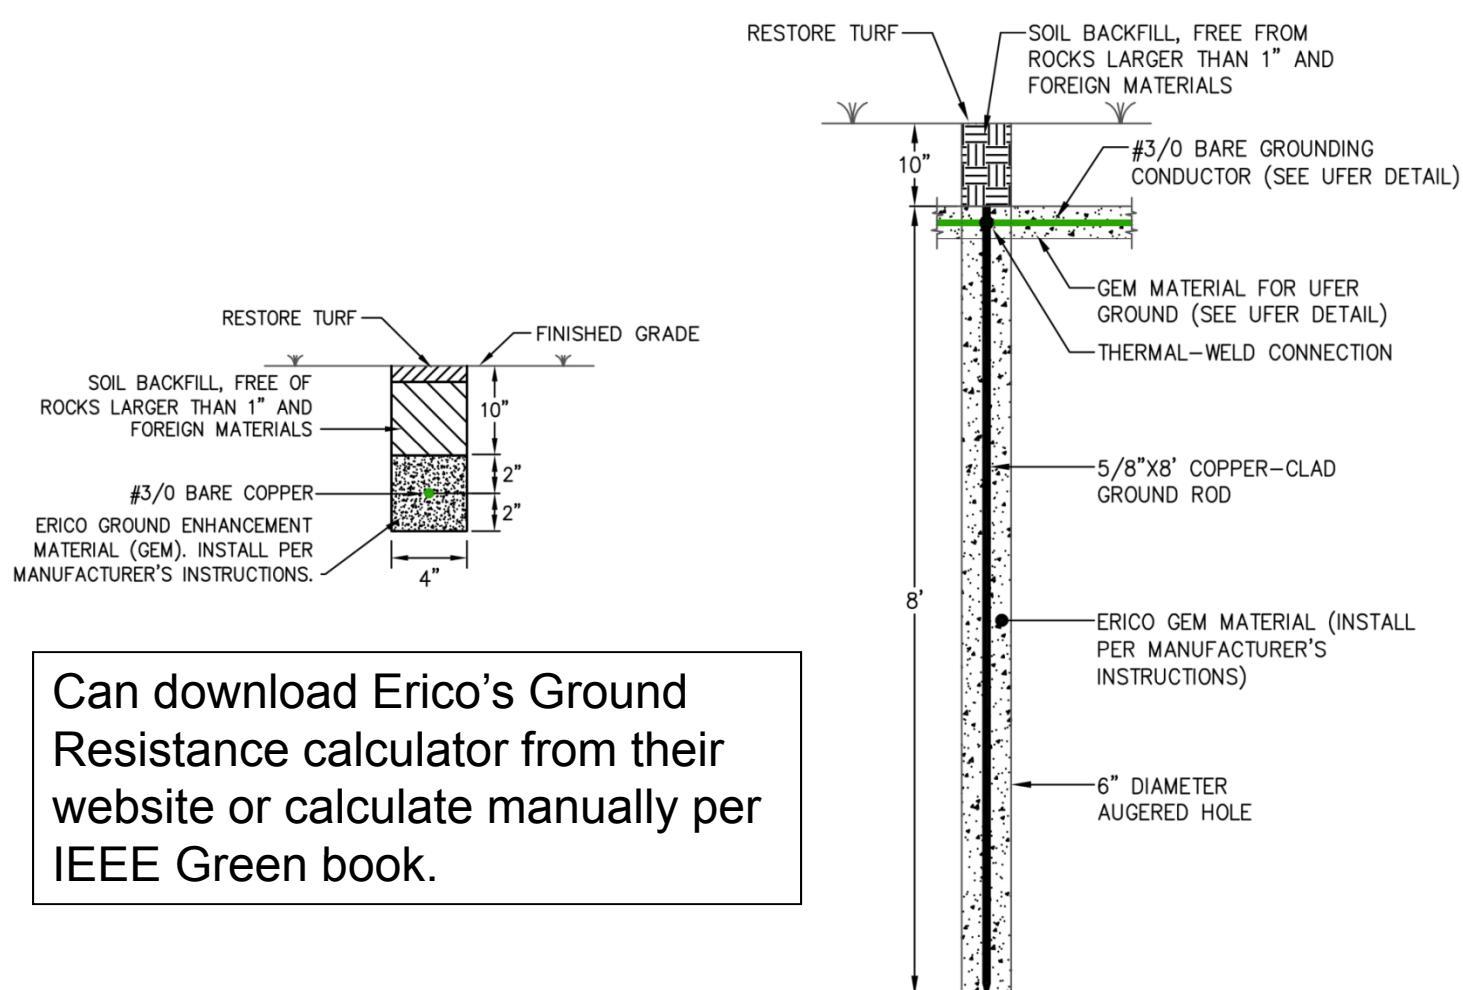
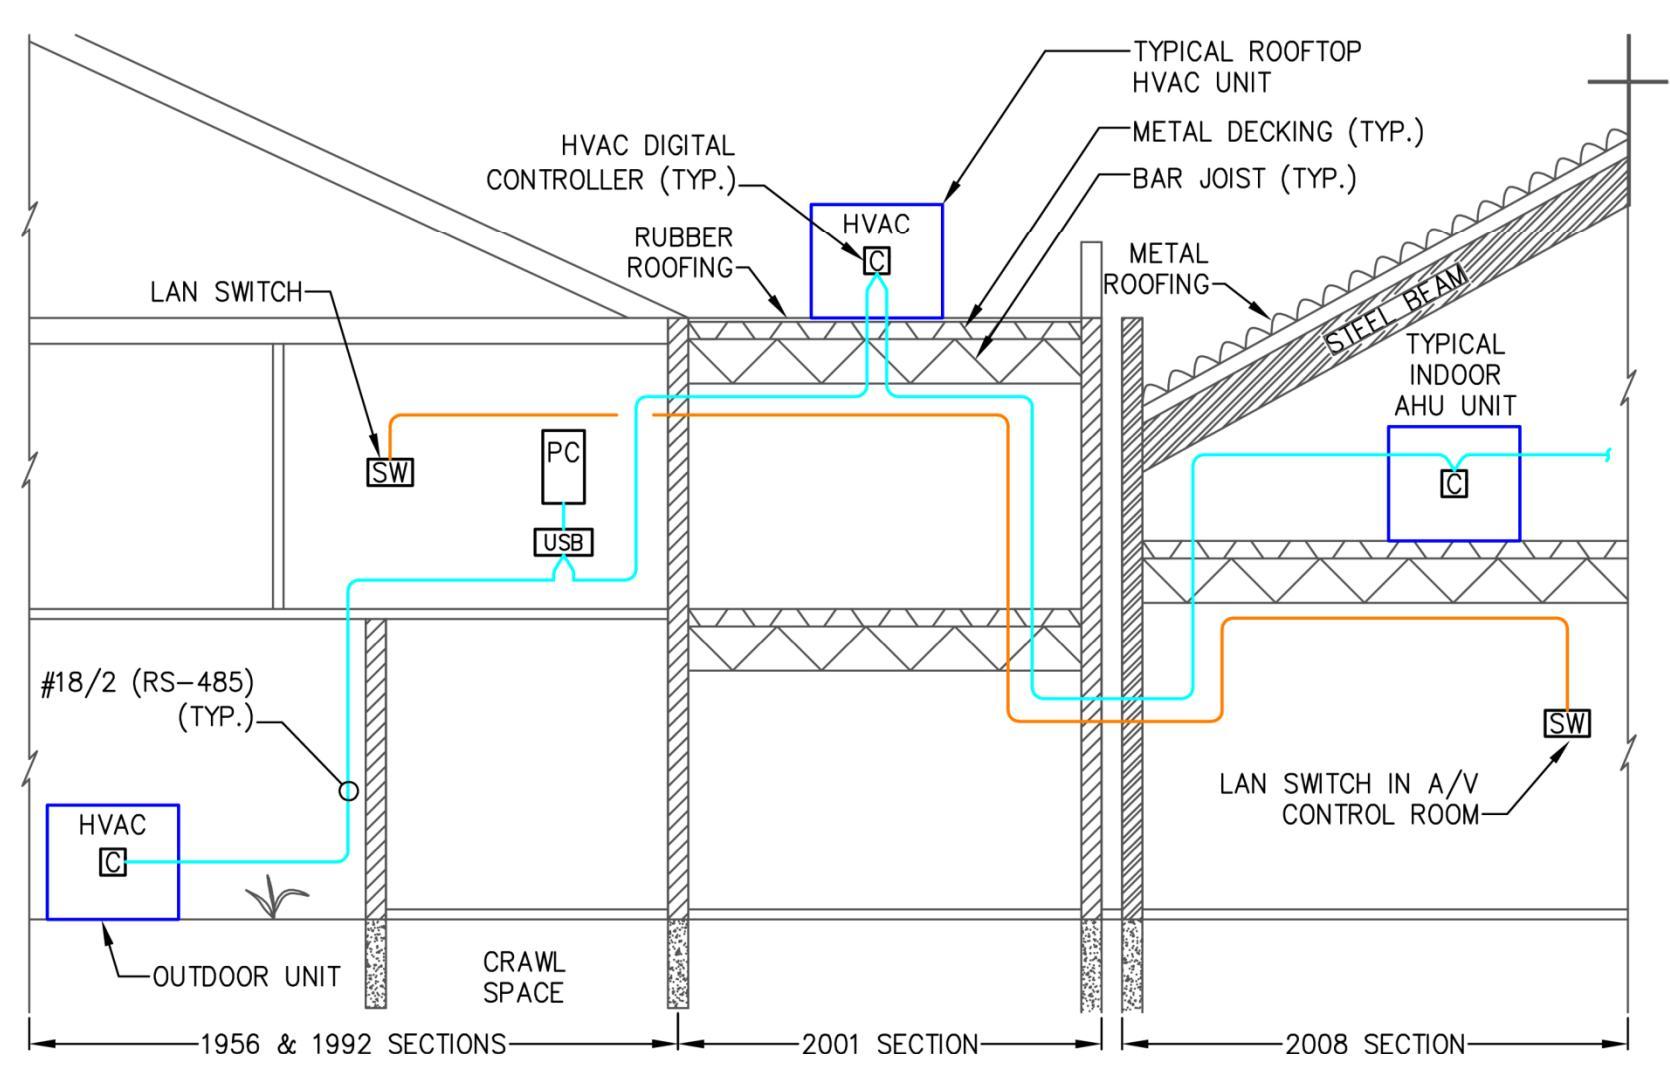
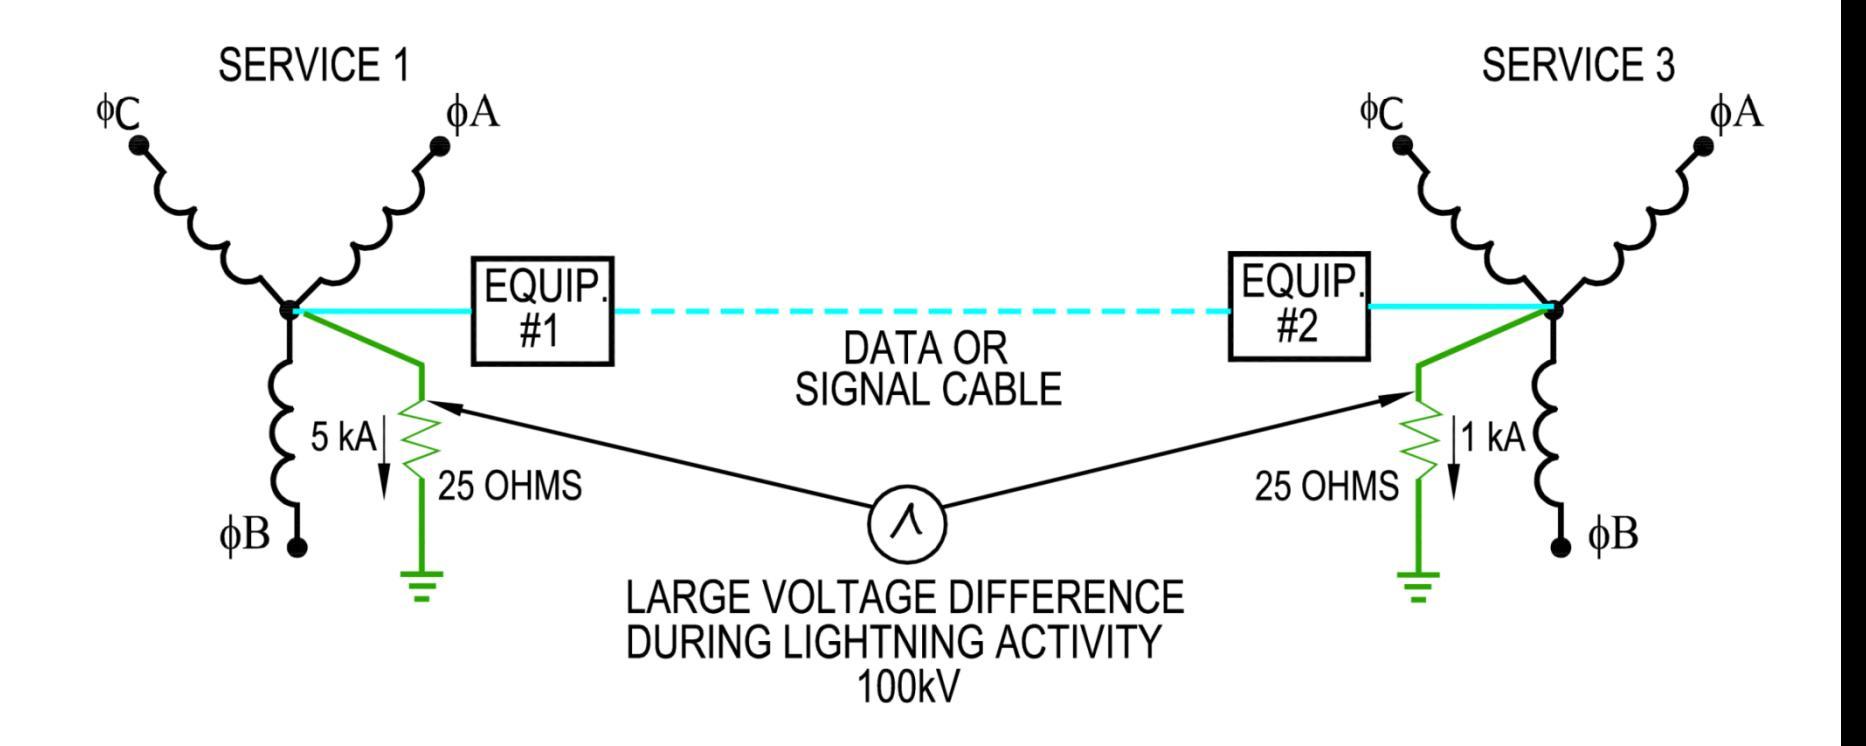
SITE SURVEY AND ANALYSIS

• HVAC DDC Control System.

- This was the main damage that occurred repeatedly.
- It occurred occasionally before the 2008 section but escalated after the 2008 section.
- This system includes a data cable (RS-485 protocol) that daisy-chains through all HVAC unit controllers.
- Video Transmitter in 2008 A/V Control Room and video Receiver in 2001 Café. The café receiver had been damaged 2 to 3 times prior to 2010.
- Intercom and Card reader at main front entrance.

- •2/24/11 thunderstorm, no damage.
- •2/28/11 thunderstorm, three DDC controllers failed. Several had to be reset.
- •3/23/11 and 4/4/11, Thunderstorms, no damage.
- •Earth Grounding work completed 4/4/11.
- •Optical Isolators installed 4/5/11.
- •Most other work completed by 4/22/11.
- •In summer of 2011, a severe storm damaged a circuit board and contactor in rooftop HVAC unit.
- •No issues with any thunderstorms since summer 2011 event.
