Lightning Protection and Surge Arrester Application on NB Power Transmission Lines

John Williamson, NB Power Transmission Corporation, Canada 2008 IEEE PES Transmission and Distribution Conference and Exposition, Chicago

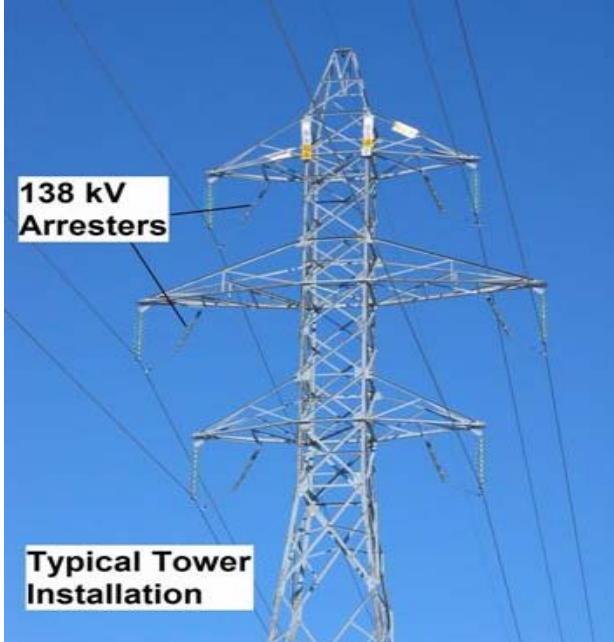
Figure 4 – typical double circuit tower with arresters

Historical information from fault locating relays of lightning events was used to identify locations prone to lightning strikes. Arresters were then applied on all phases of the double-circuit towers in areas where lightning outages had been experienced in the past. Figure 4 illustrates a typical double circuit 138 kV tower with arresters installed on all phases. No improvements were made to the existing tower grounding systems.

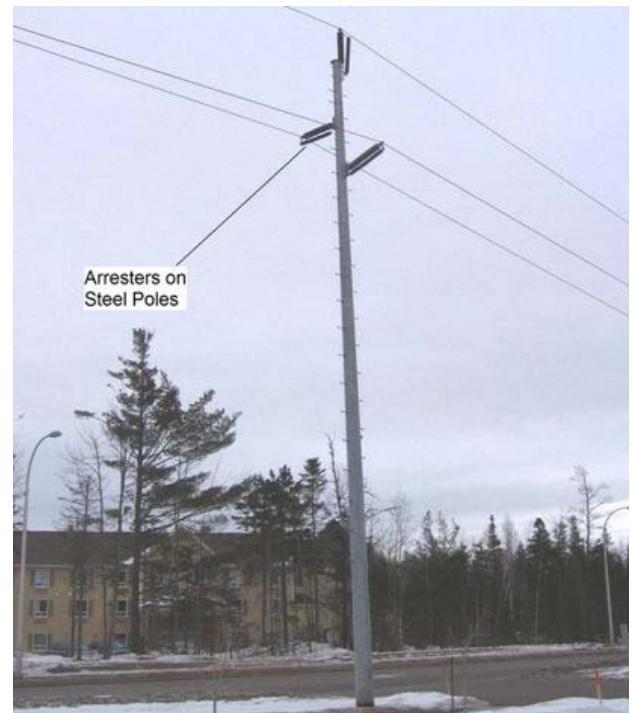
Figure 14 – 138 kV single steel pole side post design

The 138 kV single pole installation shown in Figure 14 was constructed with arresters installed at every second pole. Poles were at 80 meter spacing and every second pole was chosen in an effort to minimize cost. Each pole includes a grounding conductor around the pole one meter out from the pole. It has since been learned that a single arrester on the top phase of every pole would be a more efficient design, assuming grounding resistance is low.^[8] The insulator/arrester assembly, which is appropriate for this application is shown in Figure 15.

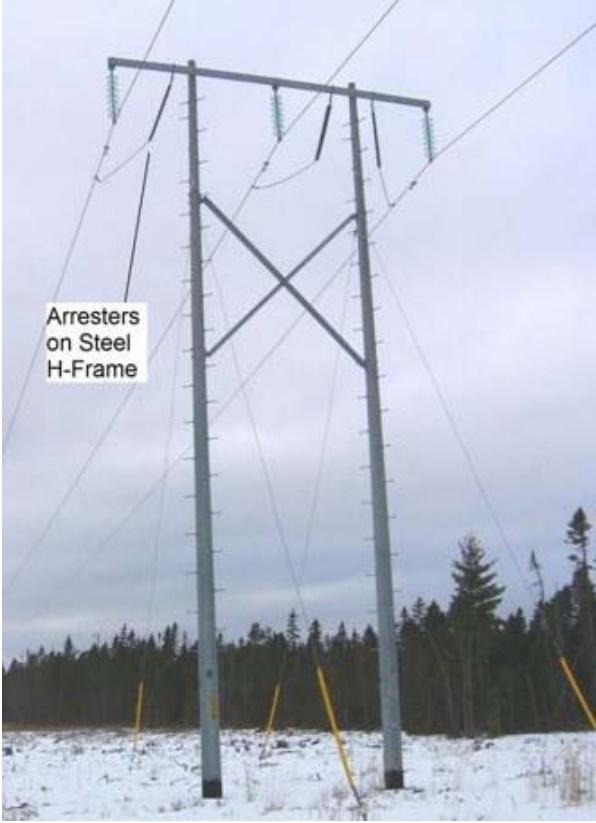
Figure 16 – 138 kV arrester installation on new steel H-Frame structures

shown in Figure 16. Arresters were installed on all phases at every structure. No lightning outages have been experienced to date on this section of line.

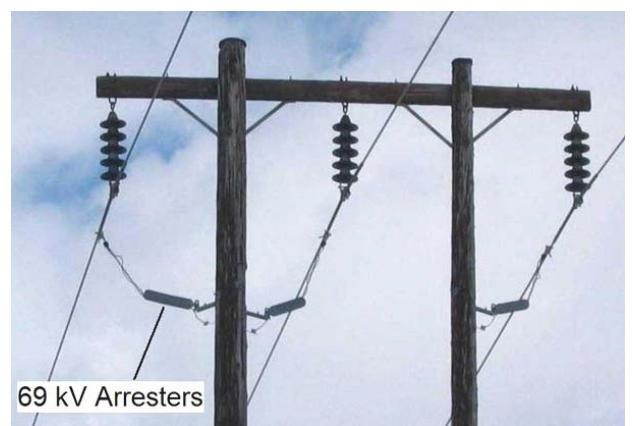
Figure 17 – 69 kV arrester installation on wood pole H-Frame structures

In 2002, NB Power installed arresters on an existing 69 kV wood pole H-Frame transmission line (Figure 17). The arresters along with grounding conductors where installed while the line was energized. The installation was followed by a single transmission line outage to clamp the arrester lead to each phase conductor.

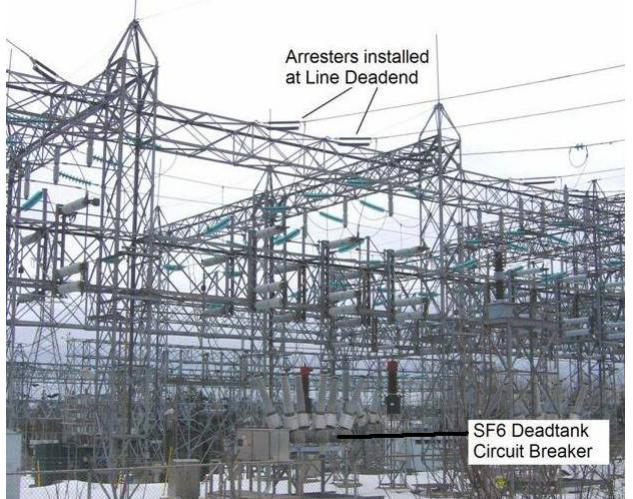
Figure 18 – terminal station showing arrester and insulator assembly at line deadends

In 2002, NB Power experienced the failure of a 138 kV SF6 deadtank circuit breaker during lightning conditions. Following this event, a study was undertaken by Kinectrics Inc. on behalf of NB Power to investigate the application of line arresters on transmission line towers near the station. The study concluded that arresters installed at the transmission line deadend tower at terminal stations can provide a margin of lightning protection to a station SF6 breaker which is located within 100 meters of the deadend tower.

NB Power has since undertaken to install line arresters at transmission line deadend towers for stations with SF6 deadtank circuit breakers (Figure 18).

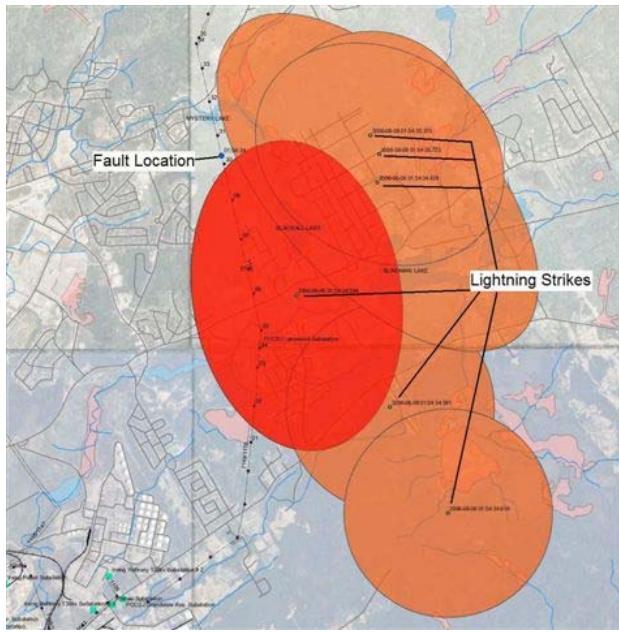
Figure 20 – example lightning detection system results for a transmission line fault

An example of a lightning event in August 2006 was studied using the Vaisala information and is illustrated (Figure 20). Fault locating relays identified the 138 kV lightning fault location as being near structure 30. Information gathered from the lightning detection system identified six different lightning strikes within 1.5 seconds of the recorded fault time.

The ability of the lightning detection system data to confirm that a transmission line outage was caused by lightning was investigated. It was hoped that this would permit faster restoration by an operator. NB Power was not able to conclude that the technique was suitable to be used in this manner. However, the lightning detection system will be used to generate a historical lightning map of the province. The map will be used to identify areas which are prone to lightning related outages and may be a suitable location for improvements to transmission line lightning performance.
