# *Overhead Transmission/Distribution Condition Assessment and Maintenance*

Geoffrey Bibo

March 24, 2011  
St. Louis Section PES Chapter  
St. Louis, MO

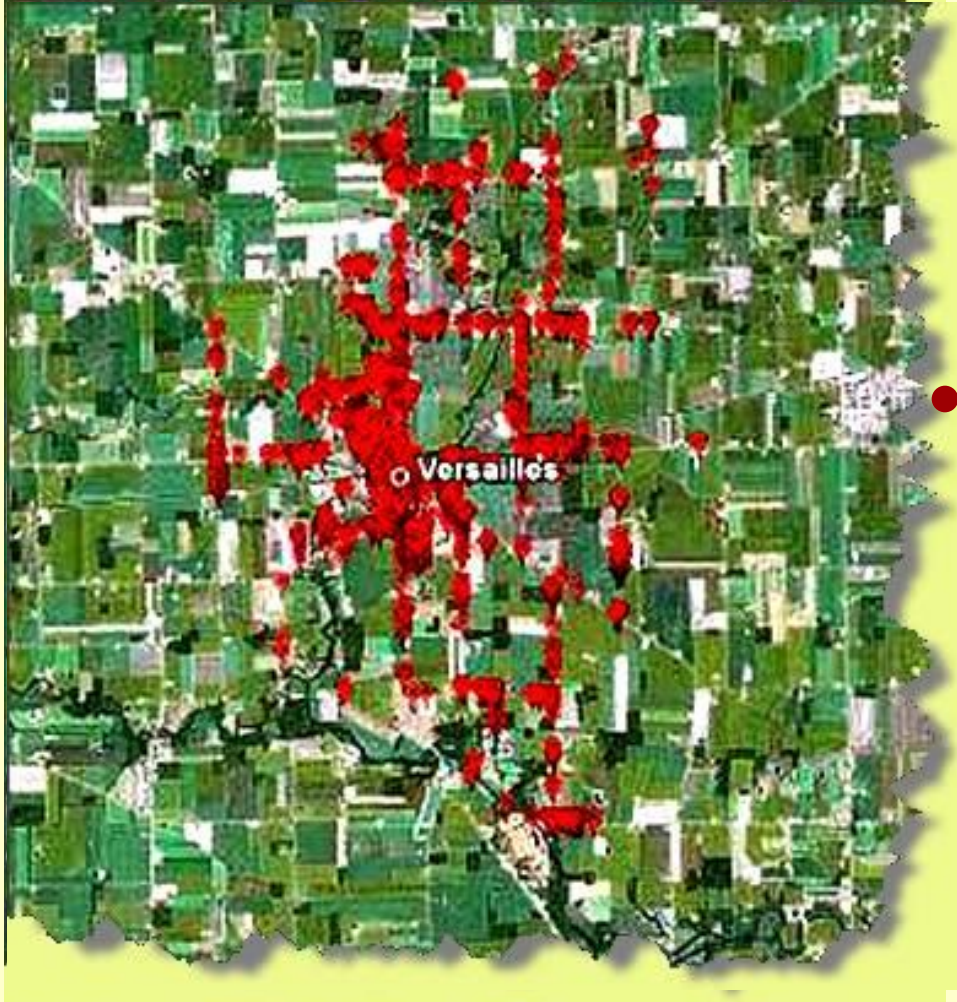
# Seasonal Damage

- *Support for FEMA Assistance*
  - *Preparedness*
  - *Post storm recovery*
  - *Post restoration hardening*
  - *Mitigation assessment*

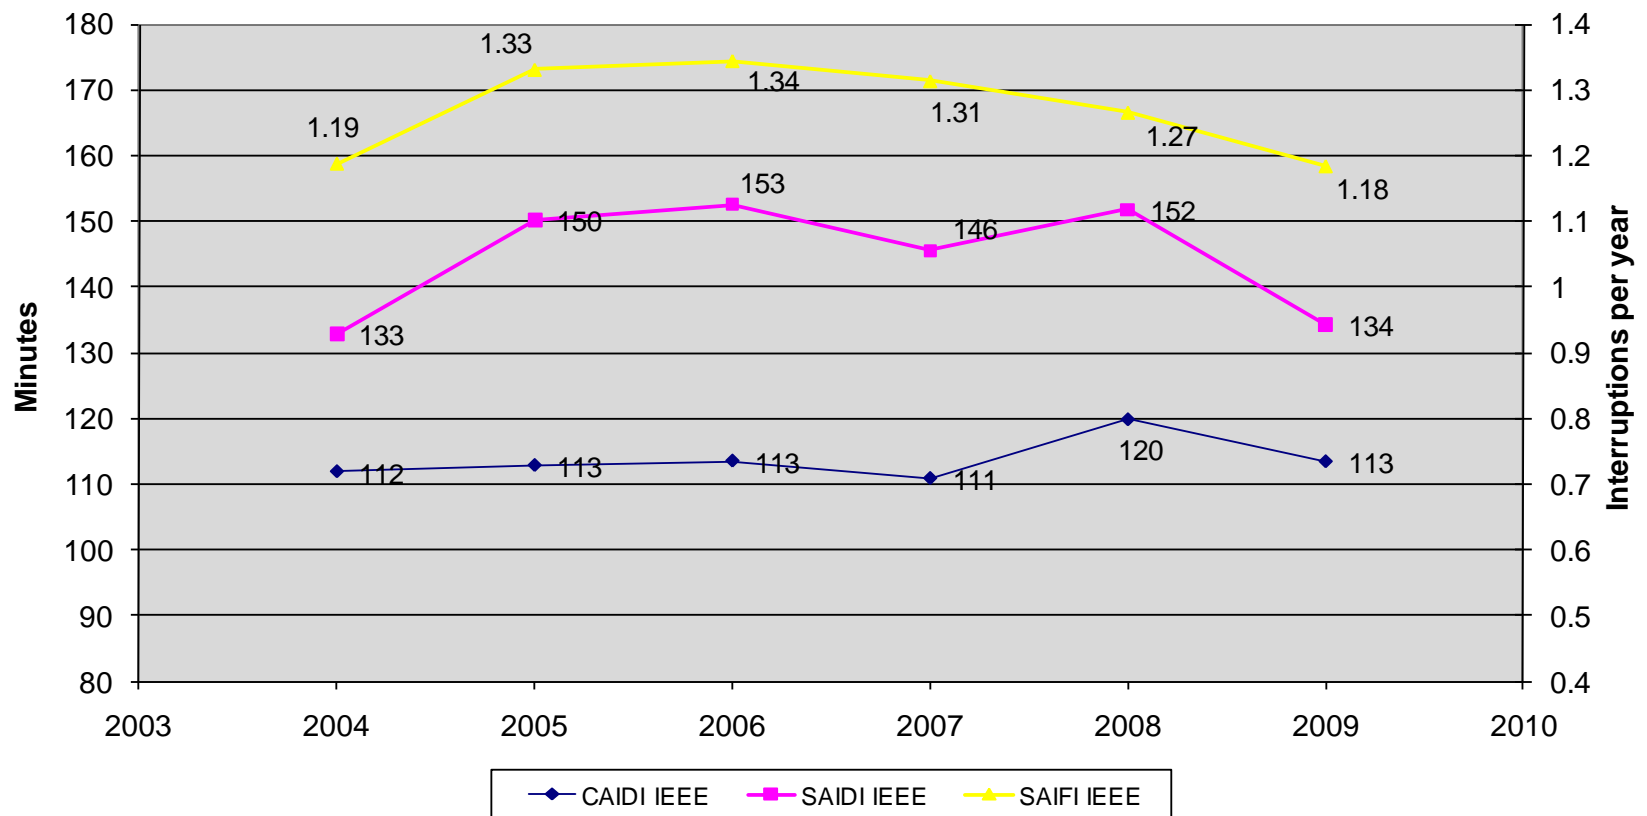
## Trends for Utilities providing data: through 2009

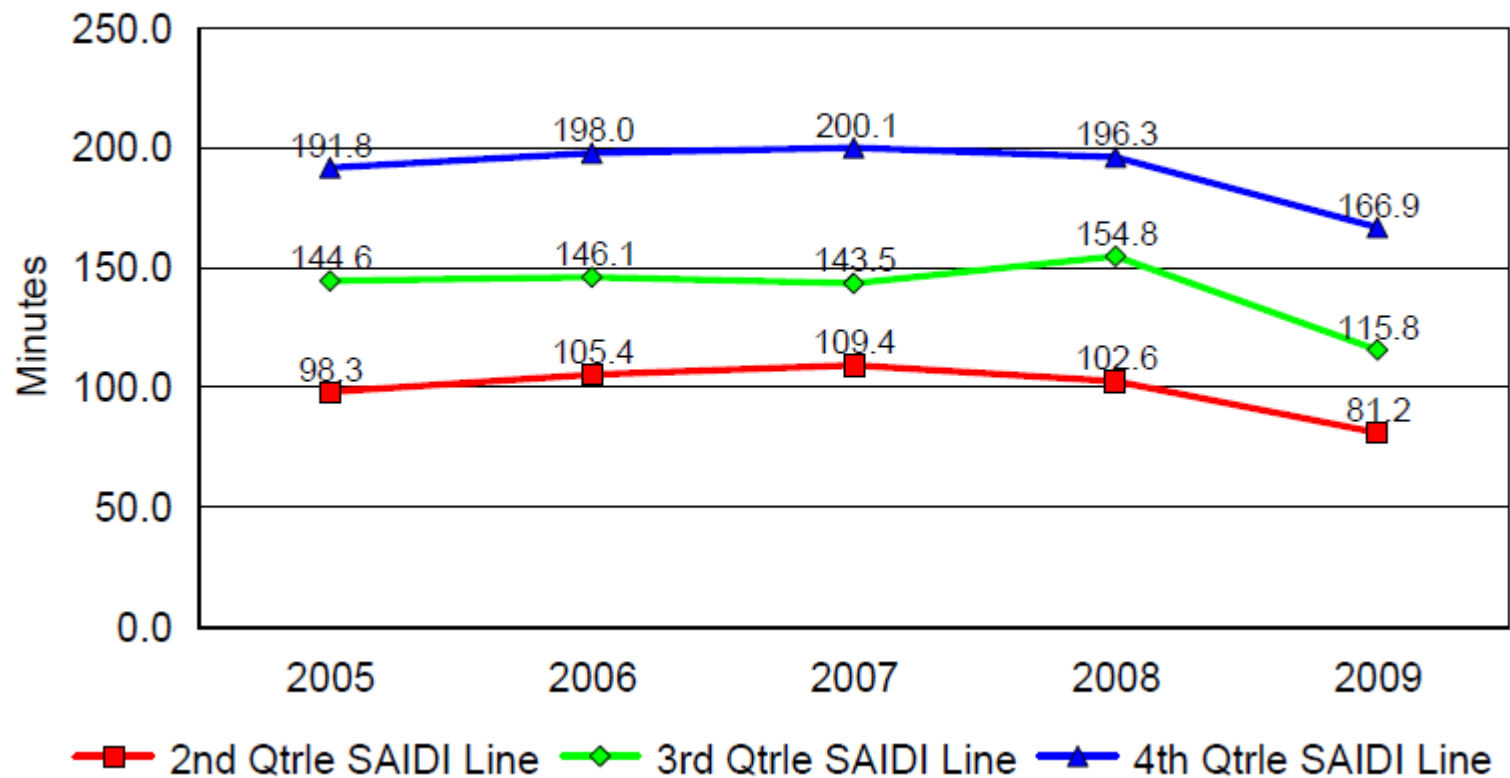
## 2005 to 2009 IEEE SAIDI Benchmarking Quartiles

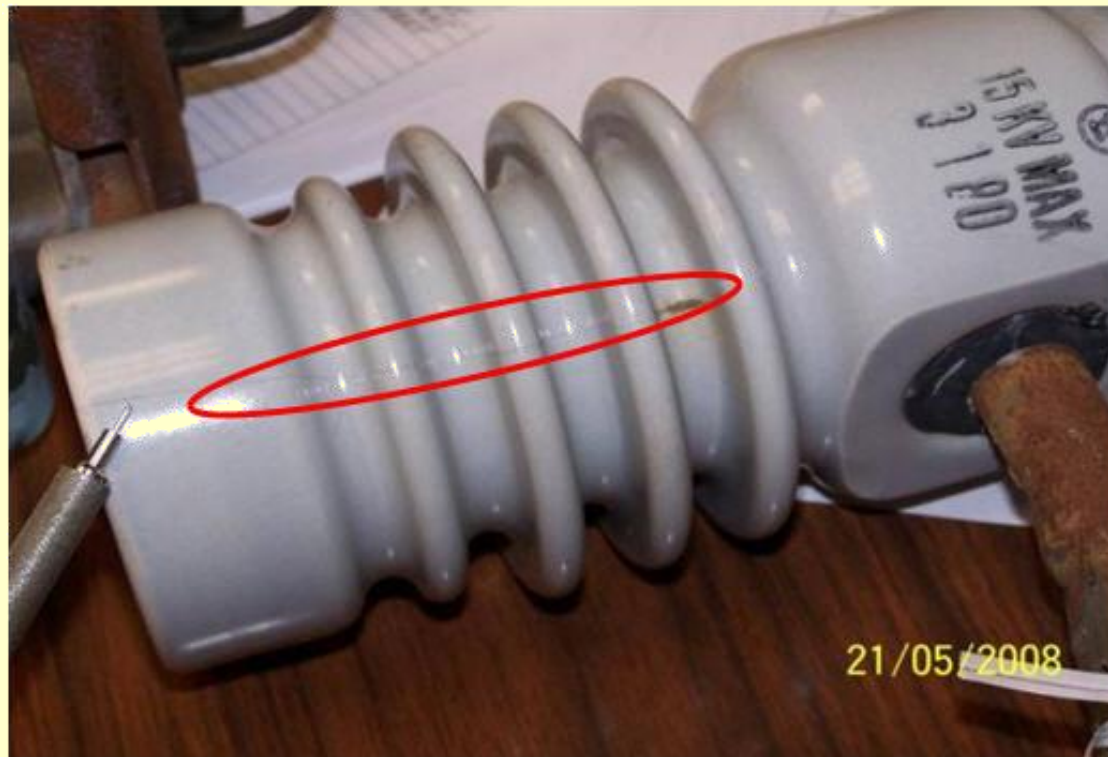
# Symptoms of Hidden Dangers

## Porcelain Cracks

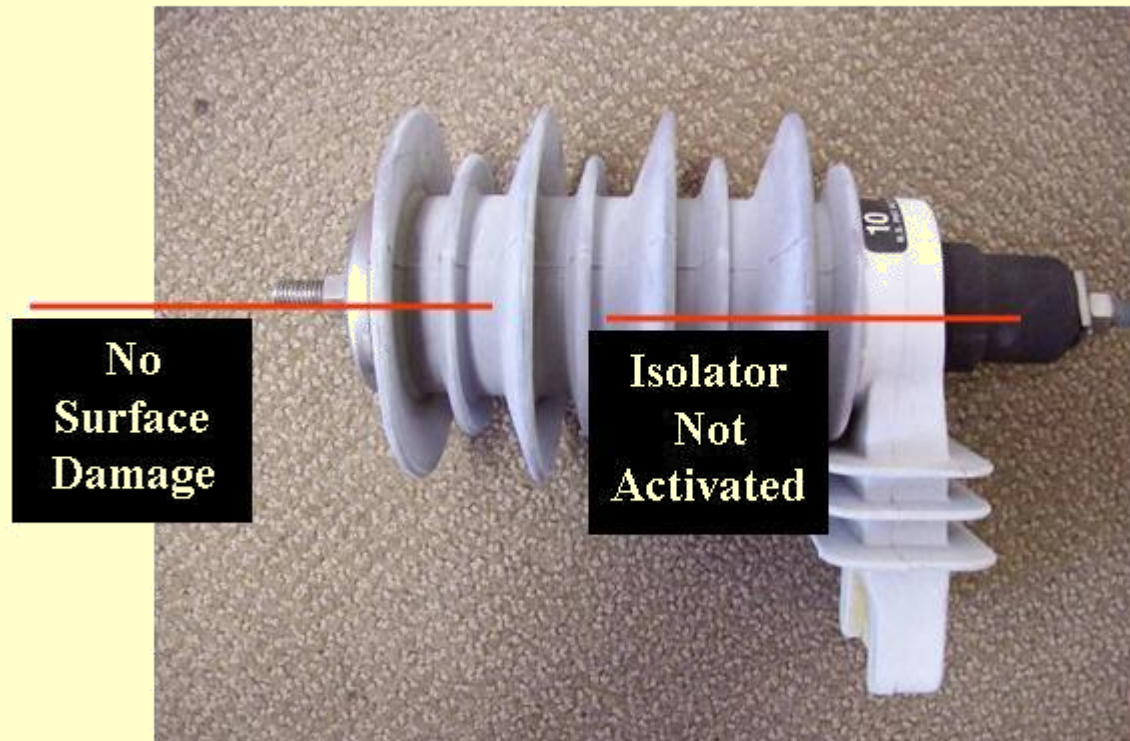
# Hidden Damage – No Protection

## Example of No Visual Damage

**Represents about 50% of PD-Active, Lab Confirmed Failed, Findings**

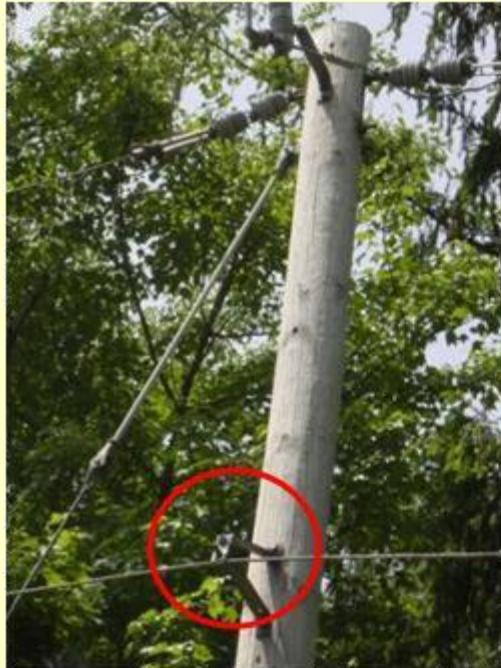
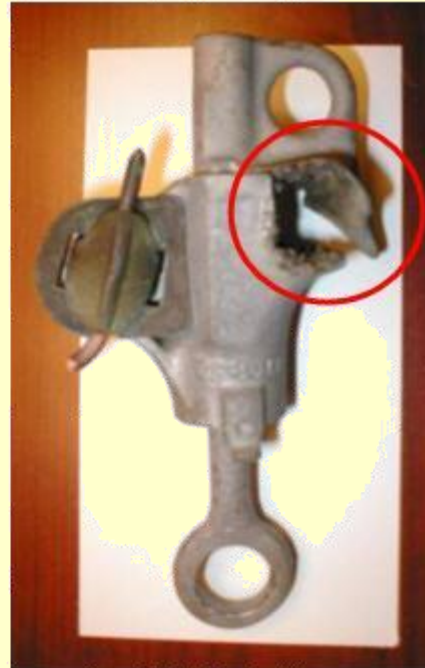
## Loose/Degraded Brackets and Clamps

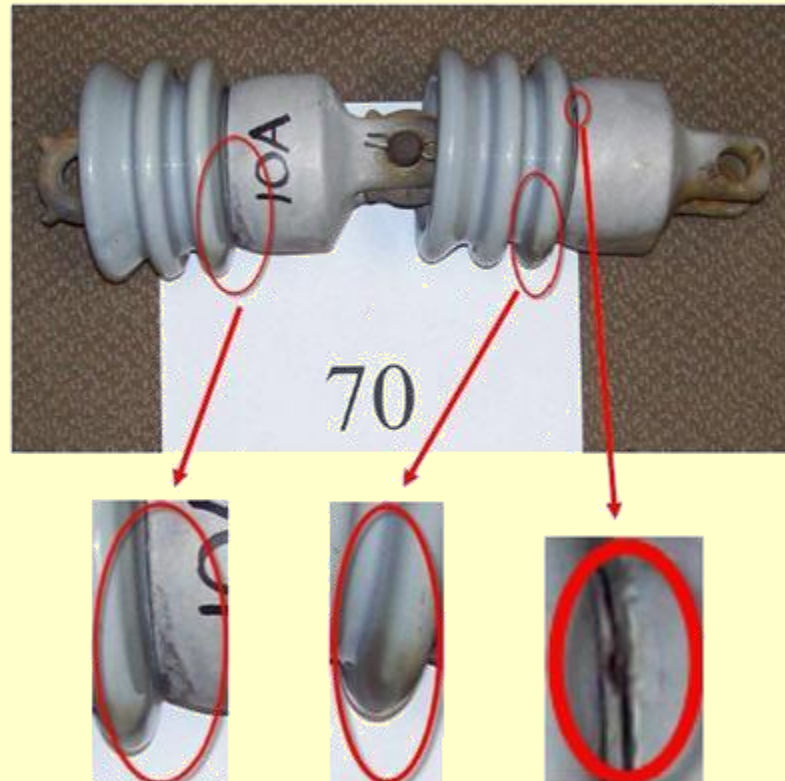
# Low Cost Parts Failures Lead to Expensive Pole Fires

## Damaged Dead-Ends

Findings: Tracking marks that are indicative of flashover ground current flow

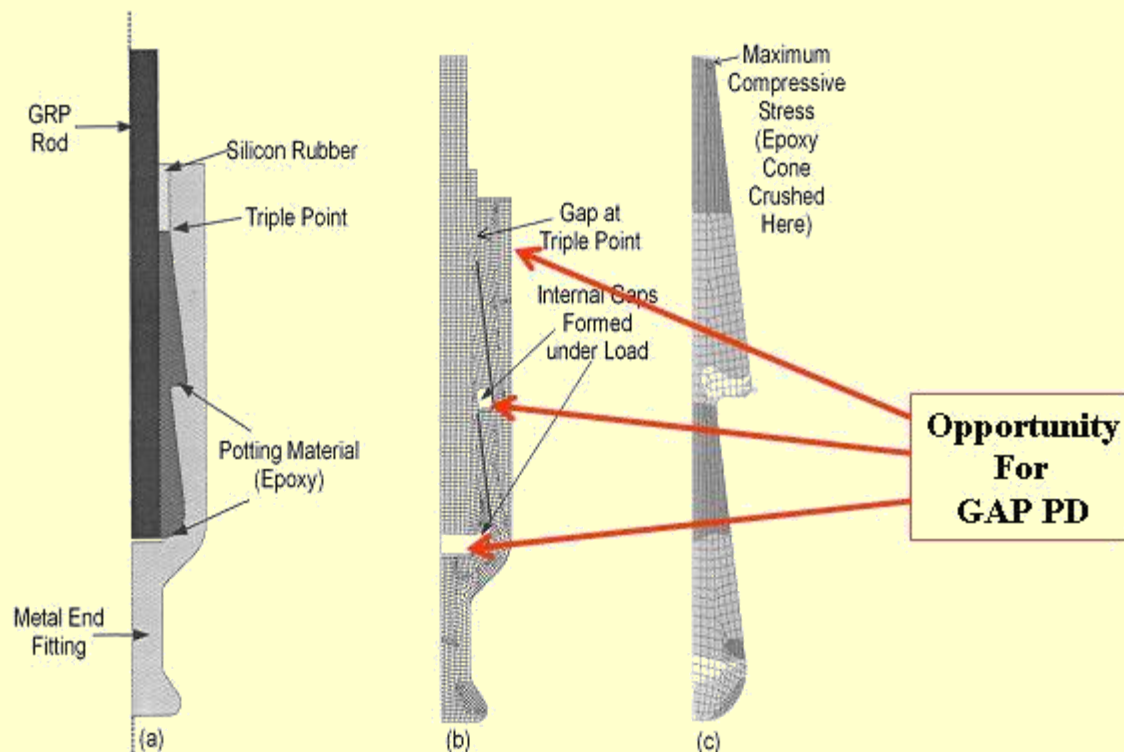
# Polymer Insulators

## Brittle Failure of Non Ceramic HV Insulators<sup>7</sup>

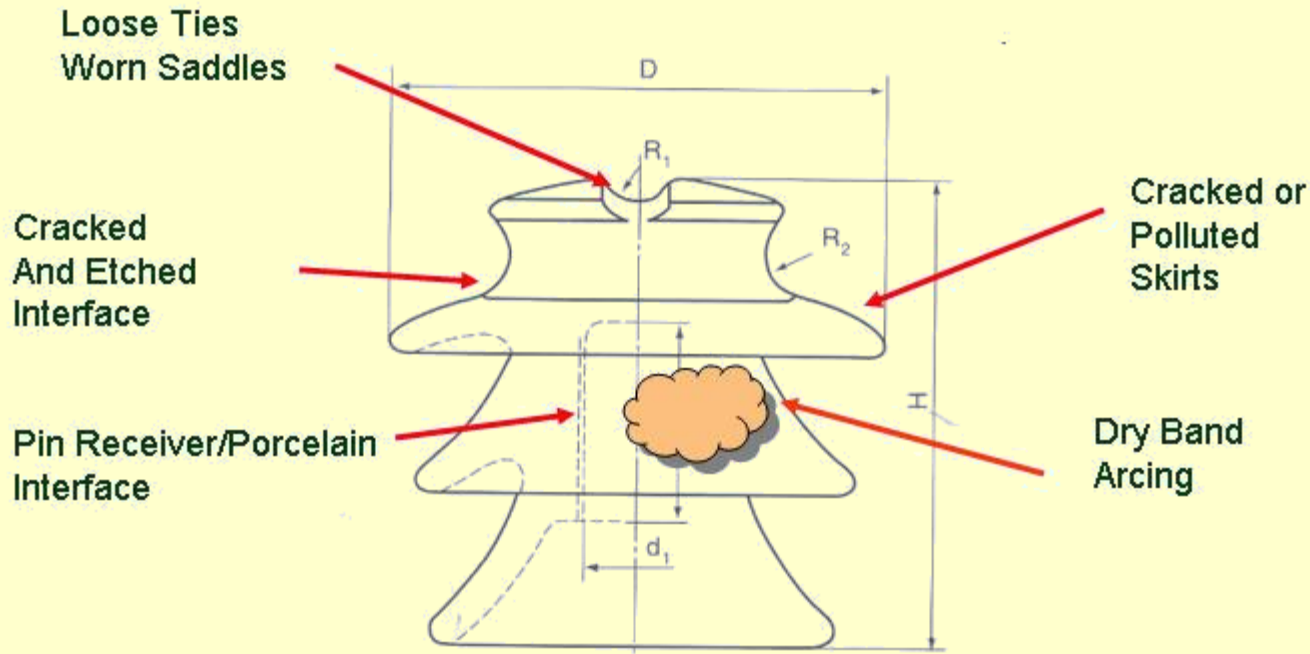
Fig 4

# Culprit in Unknown Operations

## Why Pin Insulators Pose Such a Problem

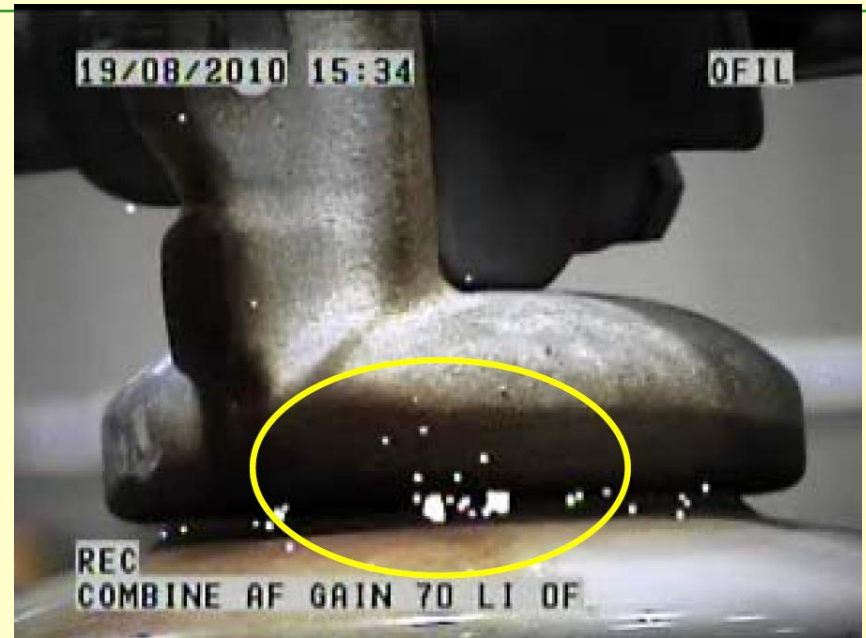
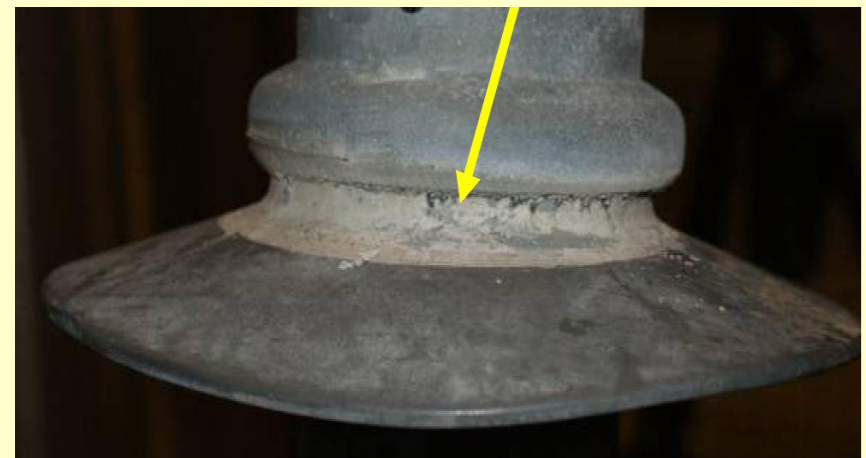
# Transmission Component Lab Testing

- TMX Circuits chosen based on:
  - SGS Benchmarking Study
  - Previous known “noise” areas
  - Proximity to coastal areas
  - 3+ insulator failures last 5 yrs
- Independent Test of
  - Two post porcelain insulators
  - One polymer insulator
- Components Energized
  - Visual inspection
  - Daytime UV camera inspection
  - IR camera inspection
- Test results
  - 1 porcelain insulator – corona discharge and visual damage
  - 1 polymer insulator – visual inspection showed fitting seal interface damage

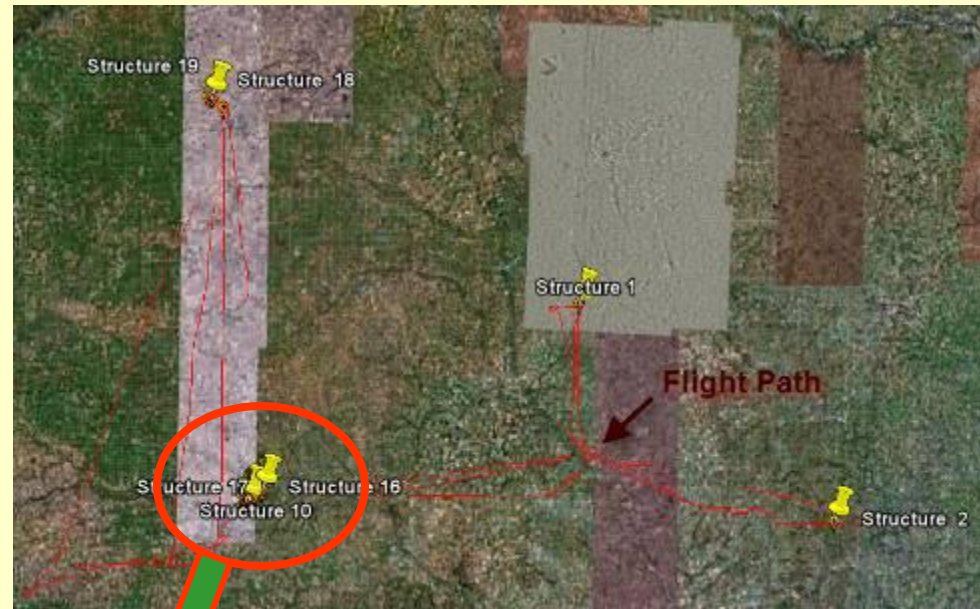
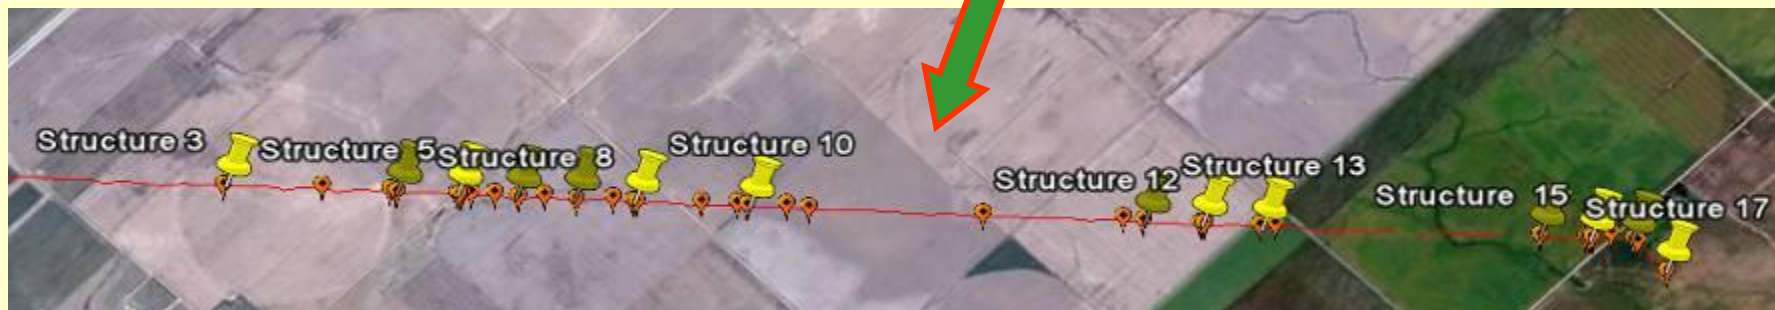
# Density of Findings

- Few findings over a large area ~ 200 flight miles
- Consistent, localized findings ~ 2 miles

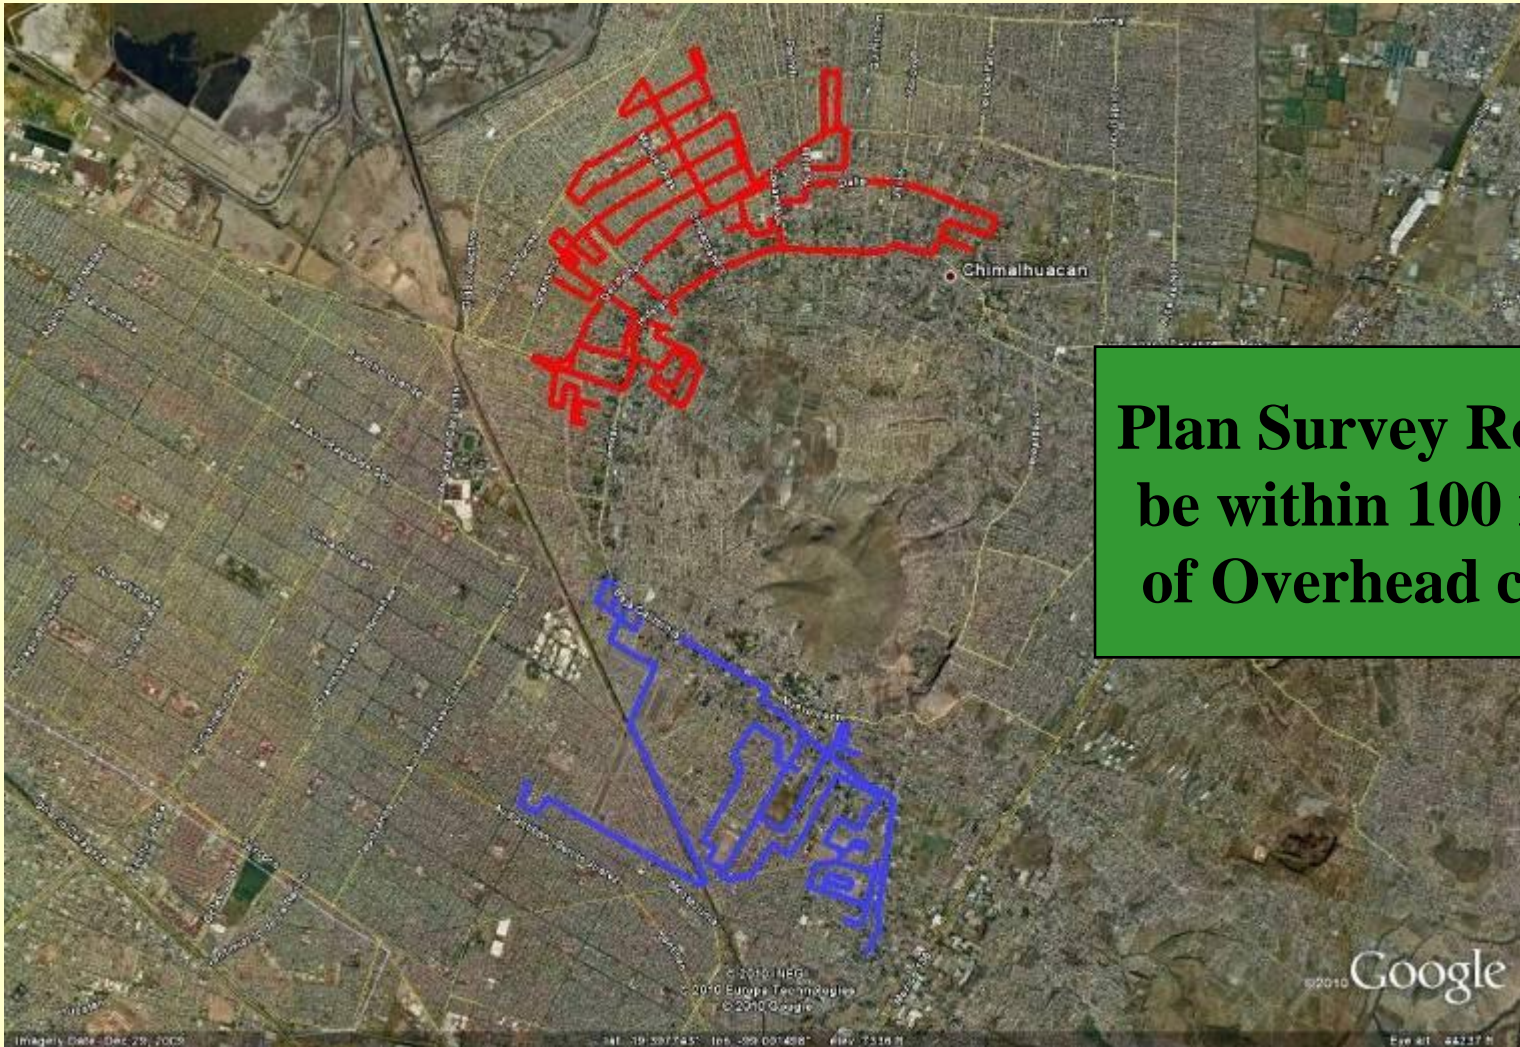
# Survey Design

**Plan Survey Routes to be within 100 meters of Overhead circuits**

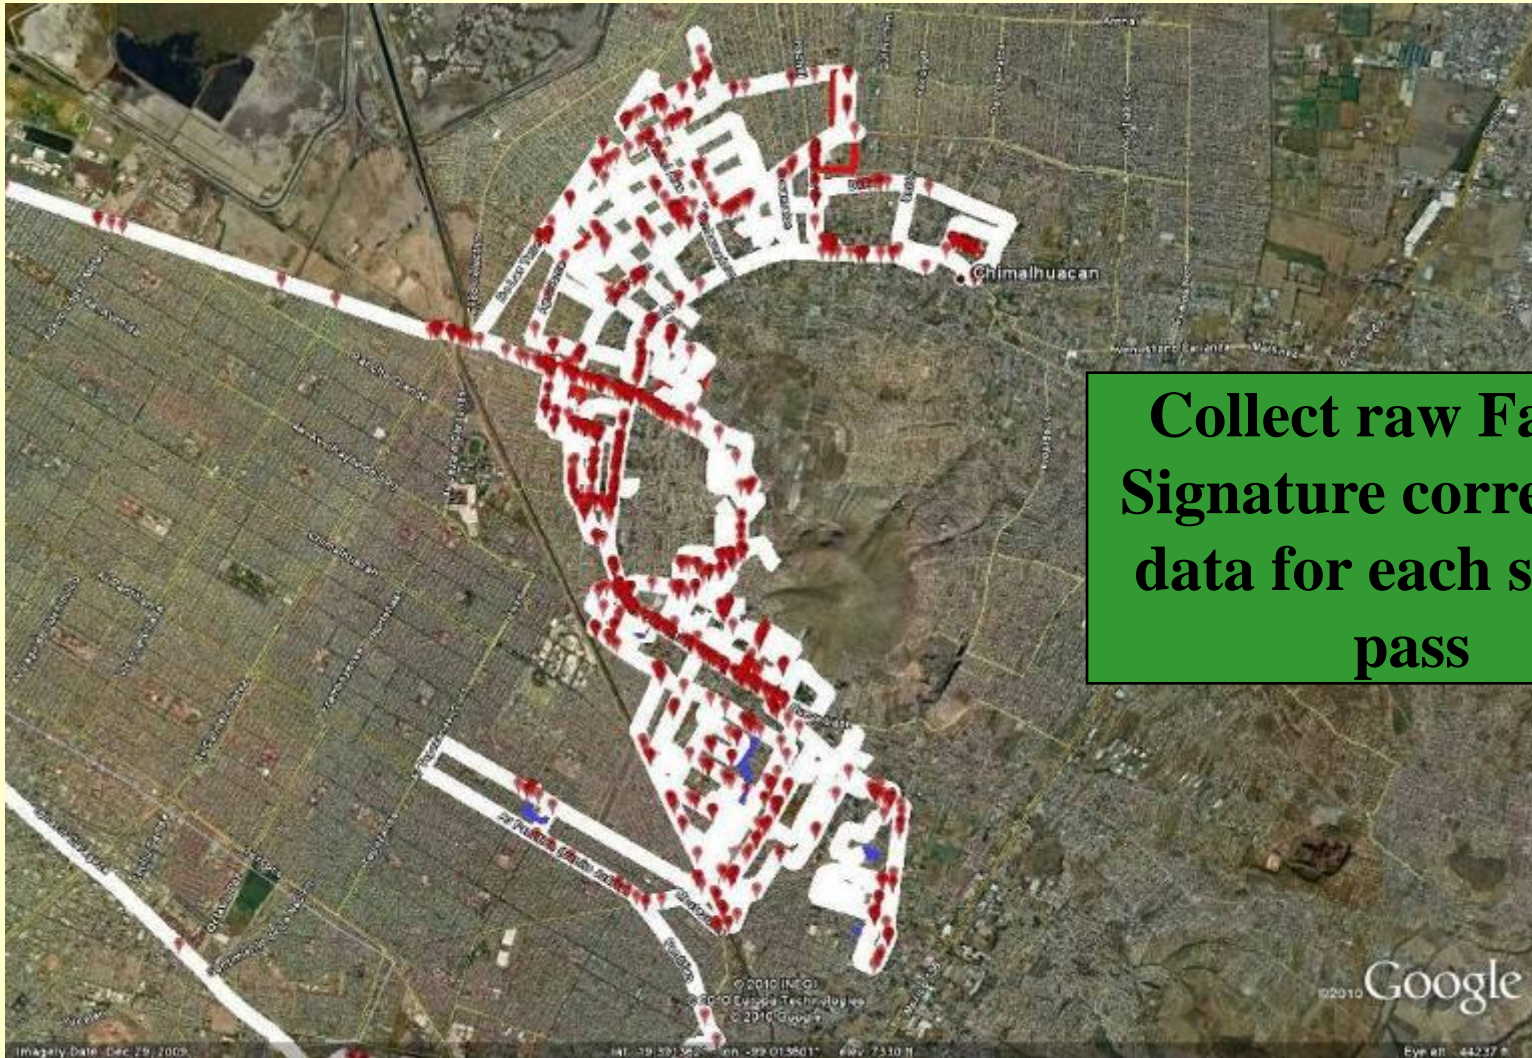
# Real-time Data

**Collect raw Failure Signature correlation data for each survey pass**

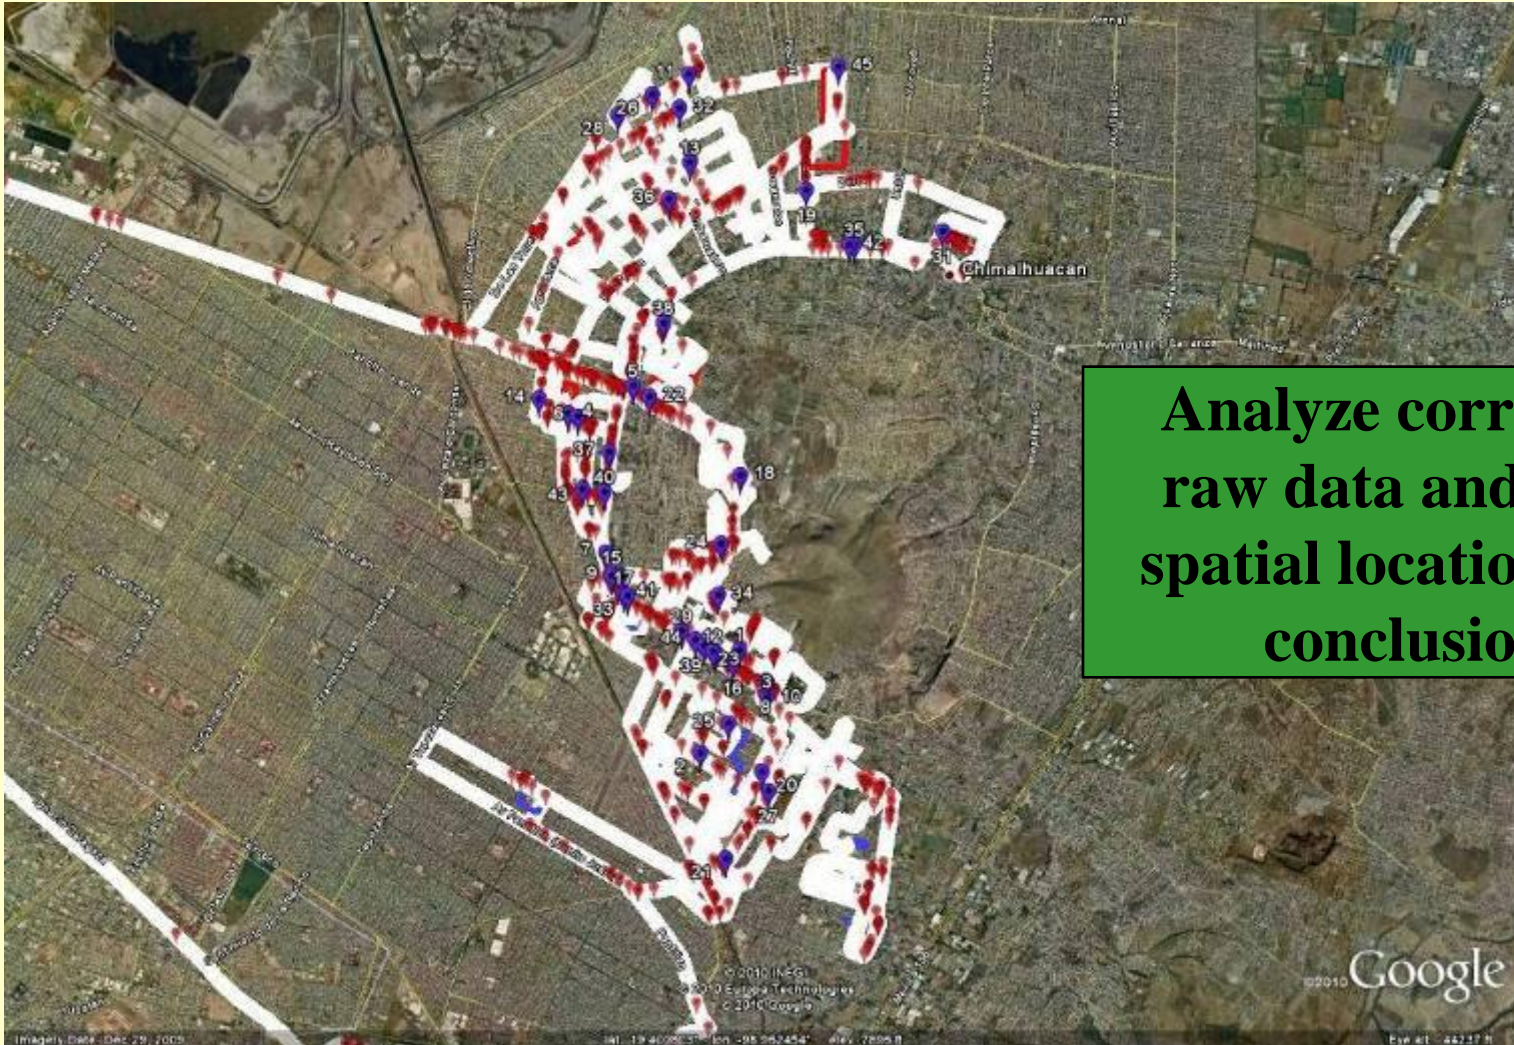
# Statistical Analysis Yields Accurate Results

**Analyze corrected  
raw data and geo-  
spatial locations for  
conclusion**

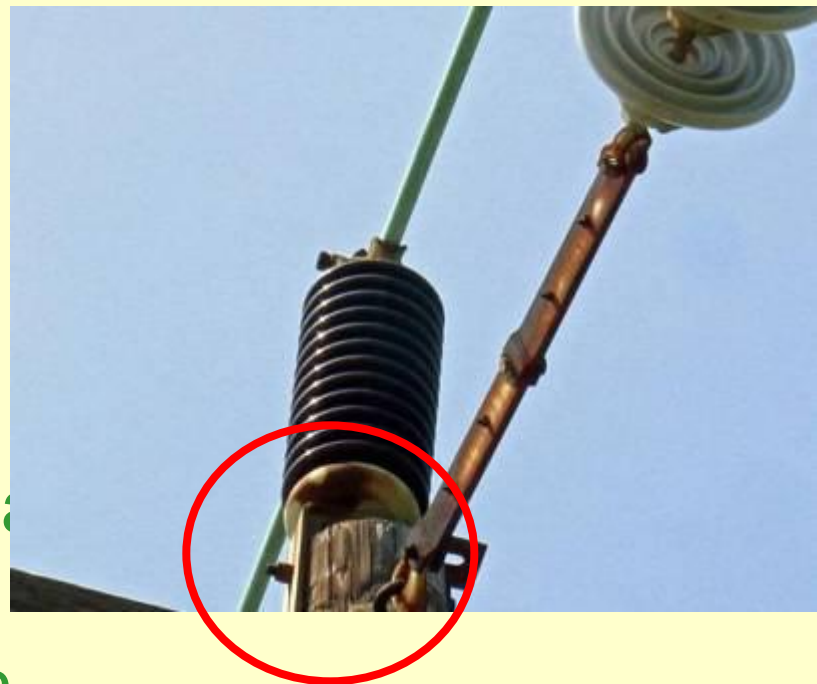
# Case Study

- Problem – A Northeast IOU has a recurring 69kV line outage problem that 2 years of IR scanning cannot locate.
- Solution – An Exacter demonstration survey located a 69kV post insulator that when replaced, corrects the problem.
