Power Quality Case Studies: Voltage Sag/Voltage Drop

Music City Power Quality Group Meeting
November 28th, 2012

Problem #1 – Voltage Sag

Problem #2 – Voltage Drop

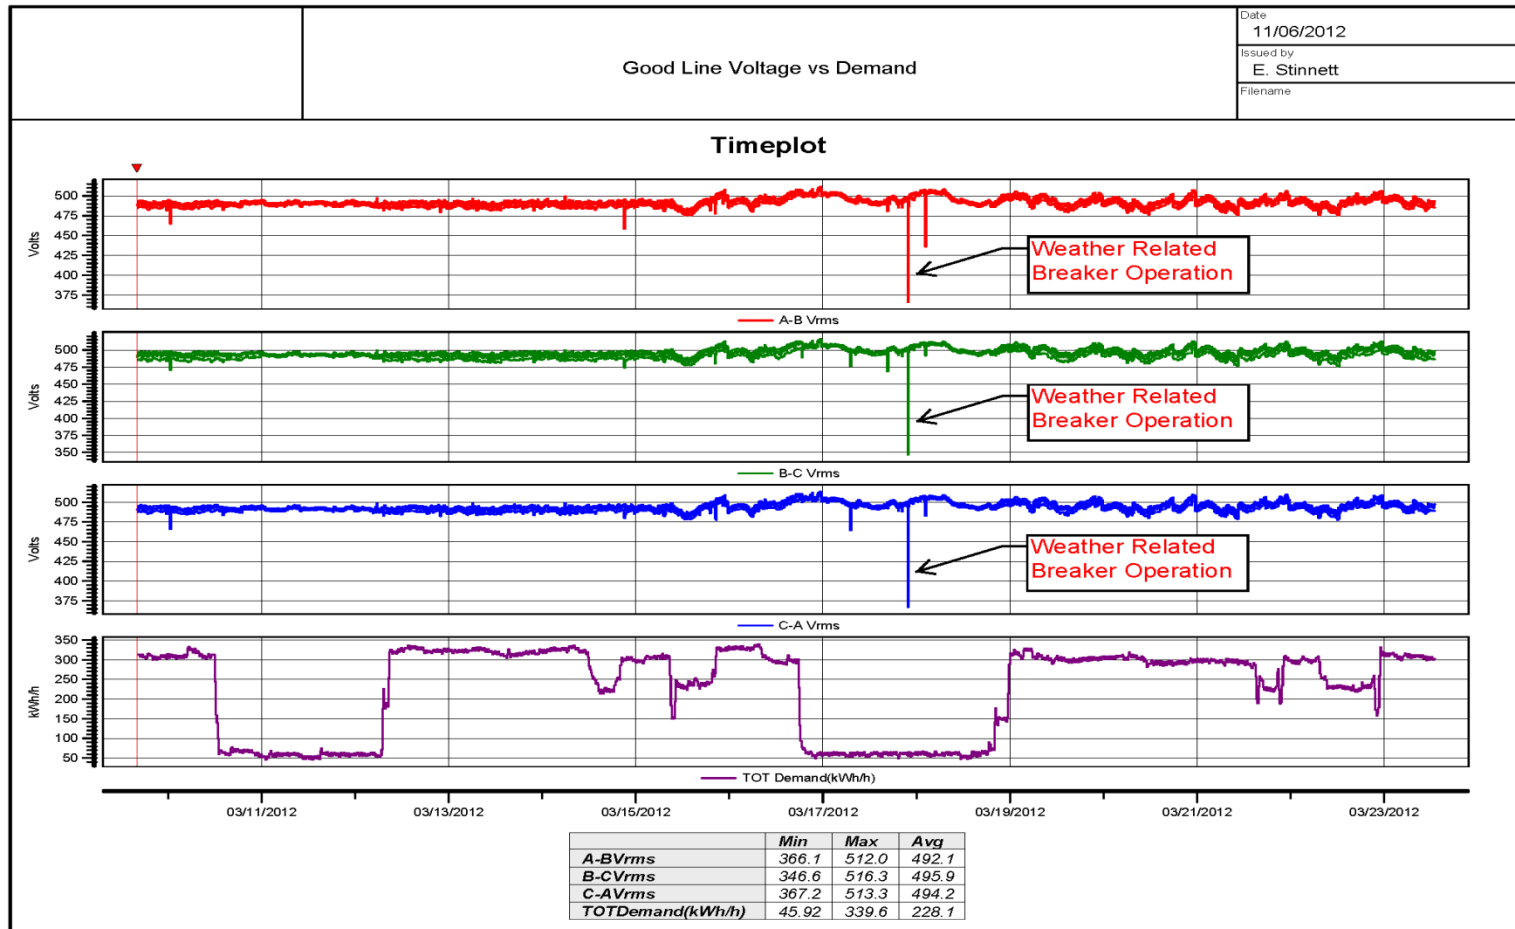
Step 1: Meter Incoming Utility (Good Line)

- We can most likely rule out utility line issues because both transformers are fed from the same utility feeder. A sag on the line is seen by both transformers.
- The Bad Line transformer seems to maintain a constant 480V voltage during the monitoring period. Voltage sags measured at the Bad Line were identical to those on the Good Line.
- Maybe both process lines are not identical. Solution to their problems might be traced to a point where both lines are different.
- Time to go into the plant a look at the layout of the two lines.

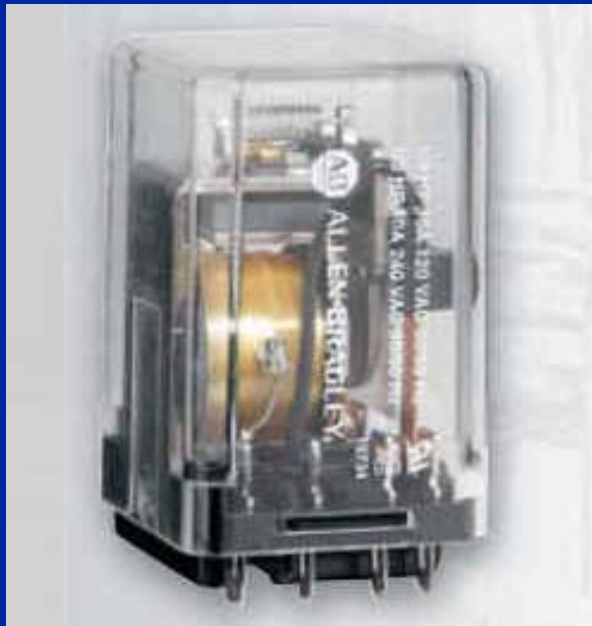
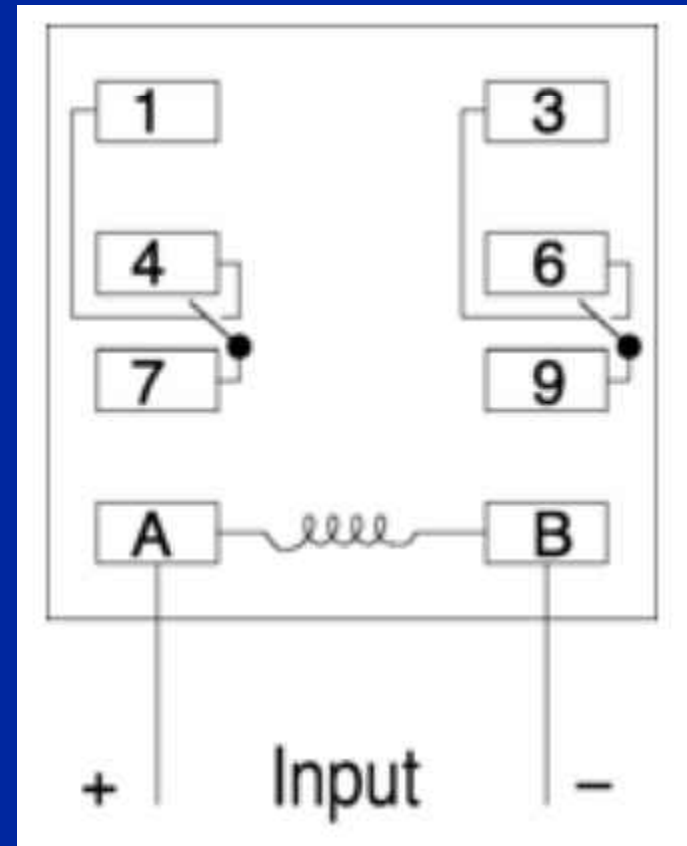
Relays

- **Emergency Stop (ESTOP) buttons or pull cords are circuits designed to shutdown lines or sections of lines anytime there is an emergency.**
 - **A relay within an ESTOP circuit is wired back to MCRs within motor panels. By pressing a button (usually a big red one) or by pulling a pull-cord, the hardwired circuit is broken and an ESTOP relay coil is de-energized.**
 - **Once the ESTOP coil is de-energized the MCR within a motor panel drops out and all of the motors on that circuit shut down instantly to prevent injury or damage to equipment.**

- A comparison of ESTOP circuitry between the Good Line and the Bad Line showed that the Good Line was utilizing DC relays while the Bad Line was using AC relays for their ESTOP circuits.
- The AC E-Stop relays from the Bad Line were replaced with DC relays a month after study was done.
- Process outages due to momentary voltage sags have ceased even during summer storm months.

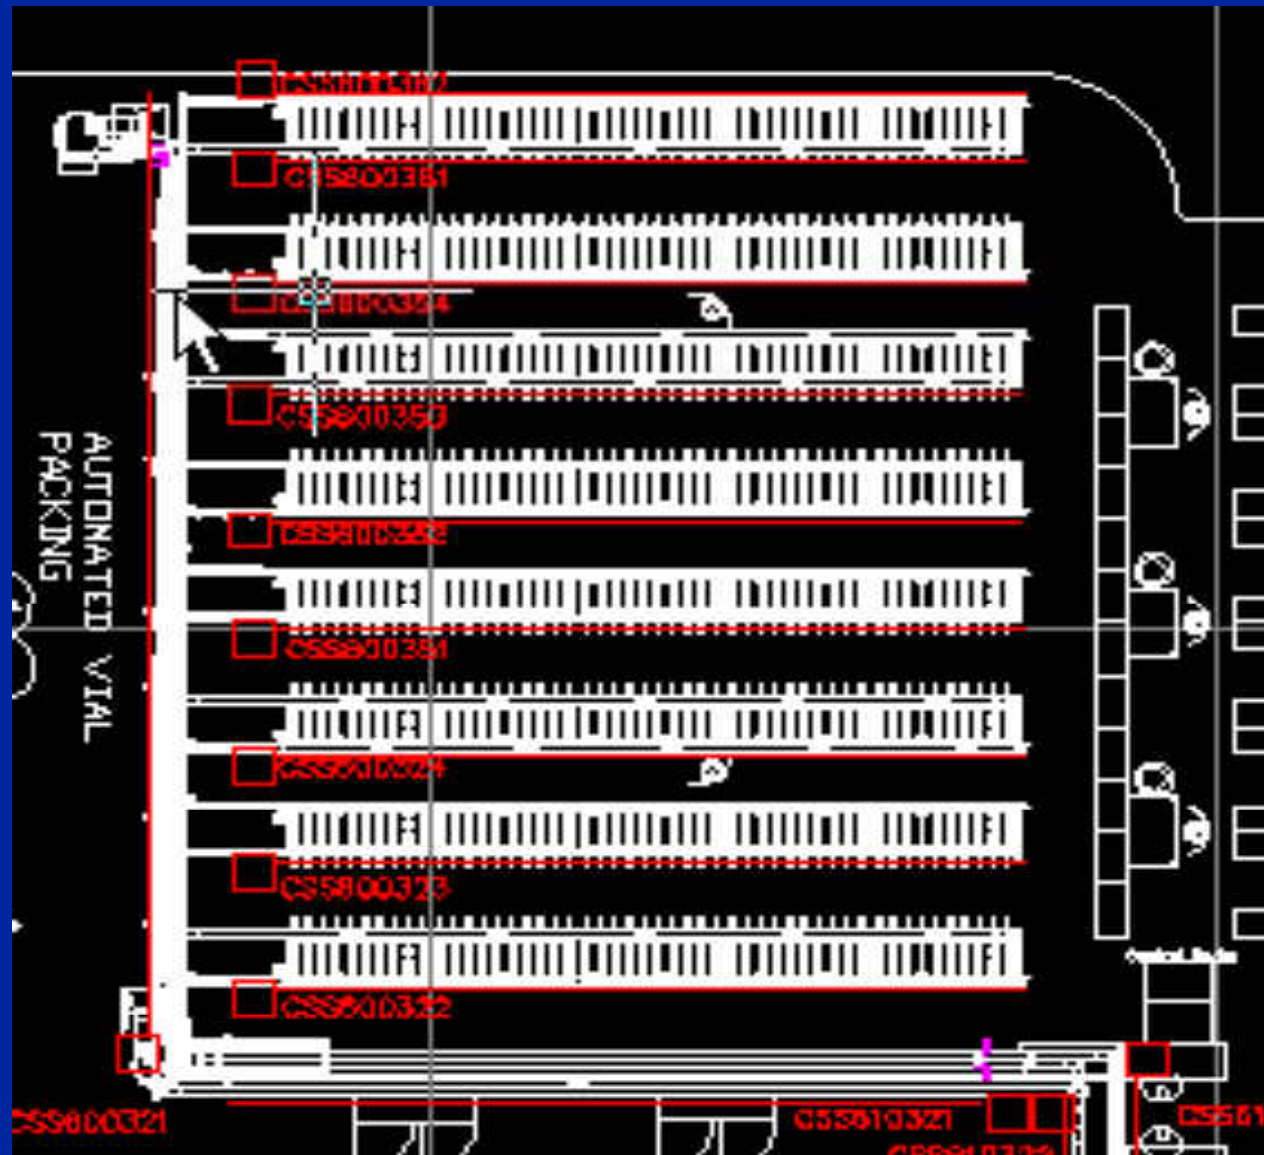
Where do you find the relays?

- When an outage occurs, the PLC and remote IO racks do not necessarily lose power.
 - Control screen is running when the operator shows up to restart the line.
- All of the motor loads do lose power or drop out.
 - This causes the operator to have to press an acknowledge button on his control screen.
 - Once the acknowledge has been pushed, the operator can then restart all of the motors to put the system back online.
 - Something must be dropping out the master control relays (MCR) within the motor panel.

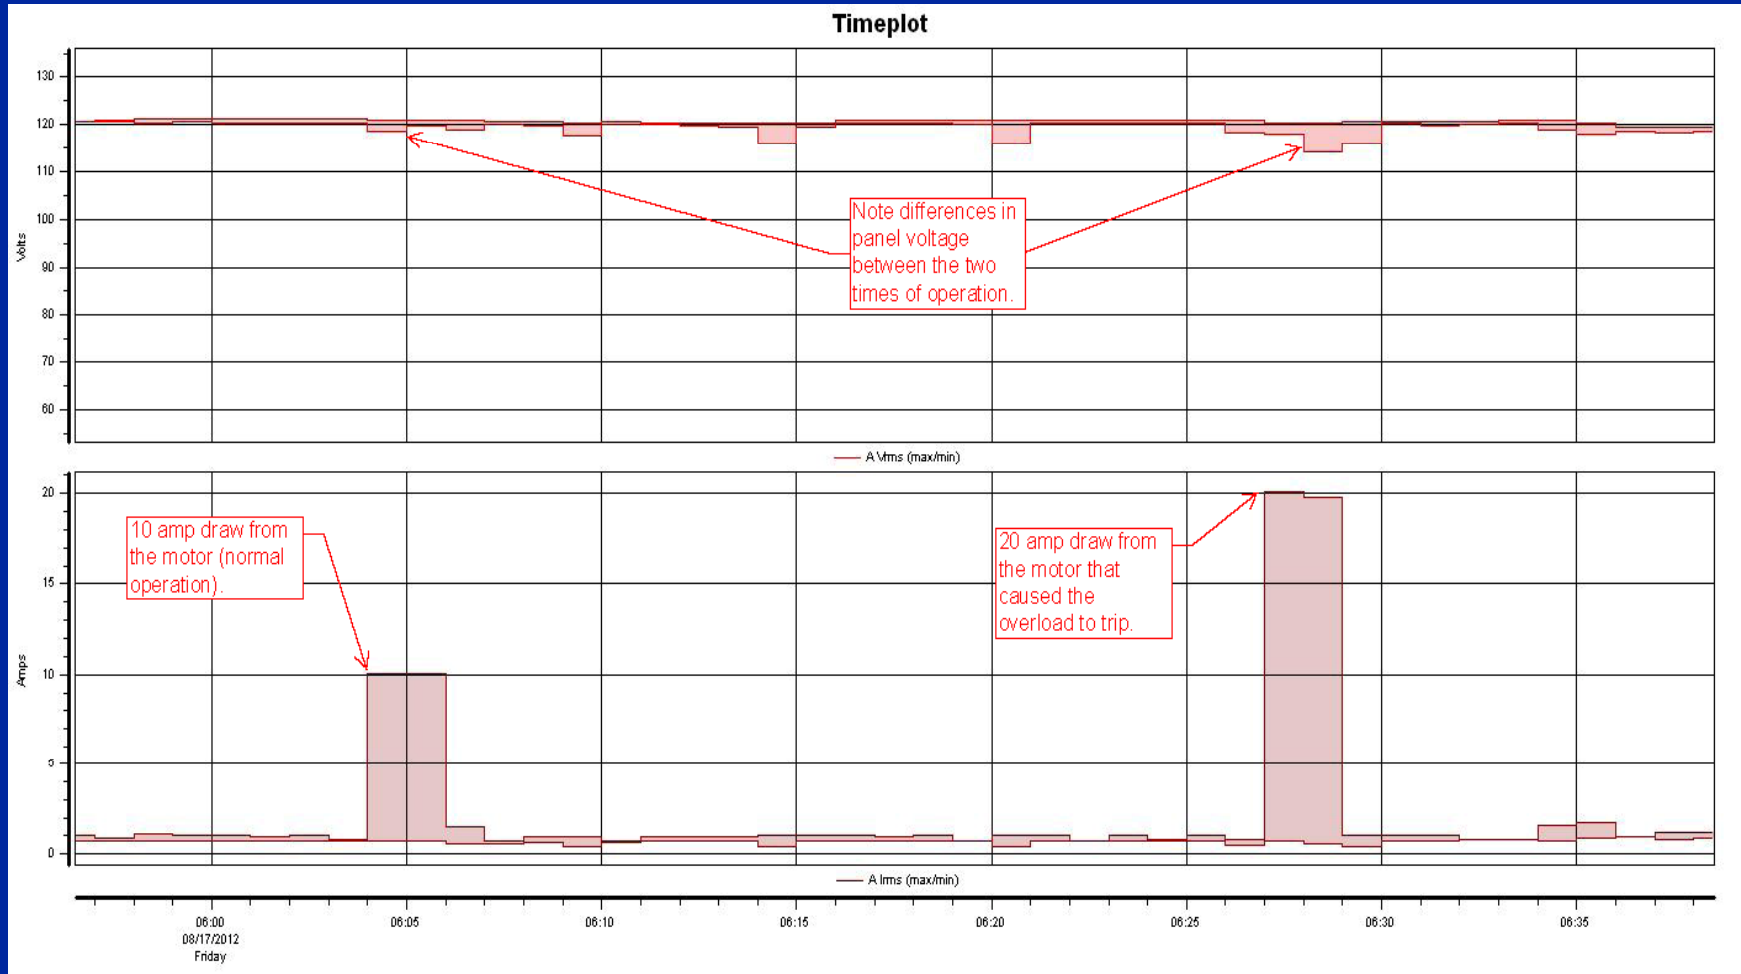
Metered Data at Panel

- Using motor full load values from NEC table 430.250, we can estimate what current trips the overload assuming it's sized at 115%:
 - FLA=9.8A at 115V
 - $9.8\text{A} \times 1.15\% = 11.27\text{A}$
- Our metered data explains why the overload works sometimes and trips at others.

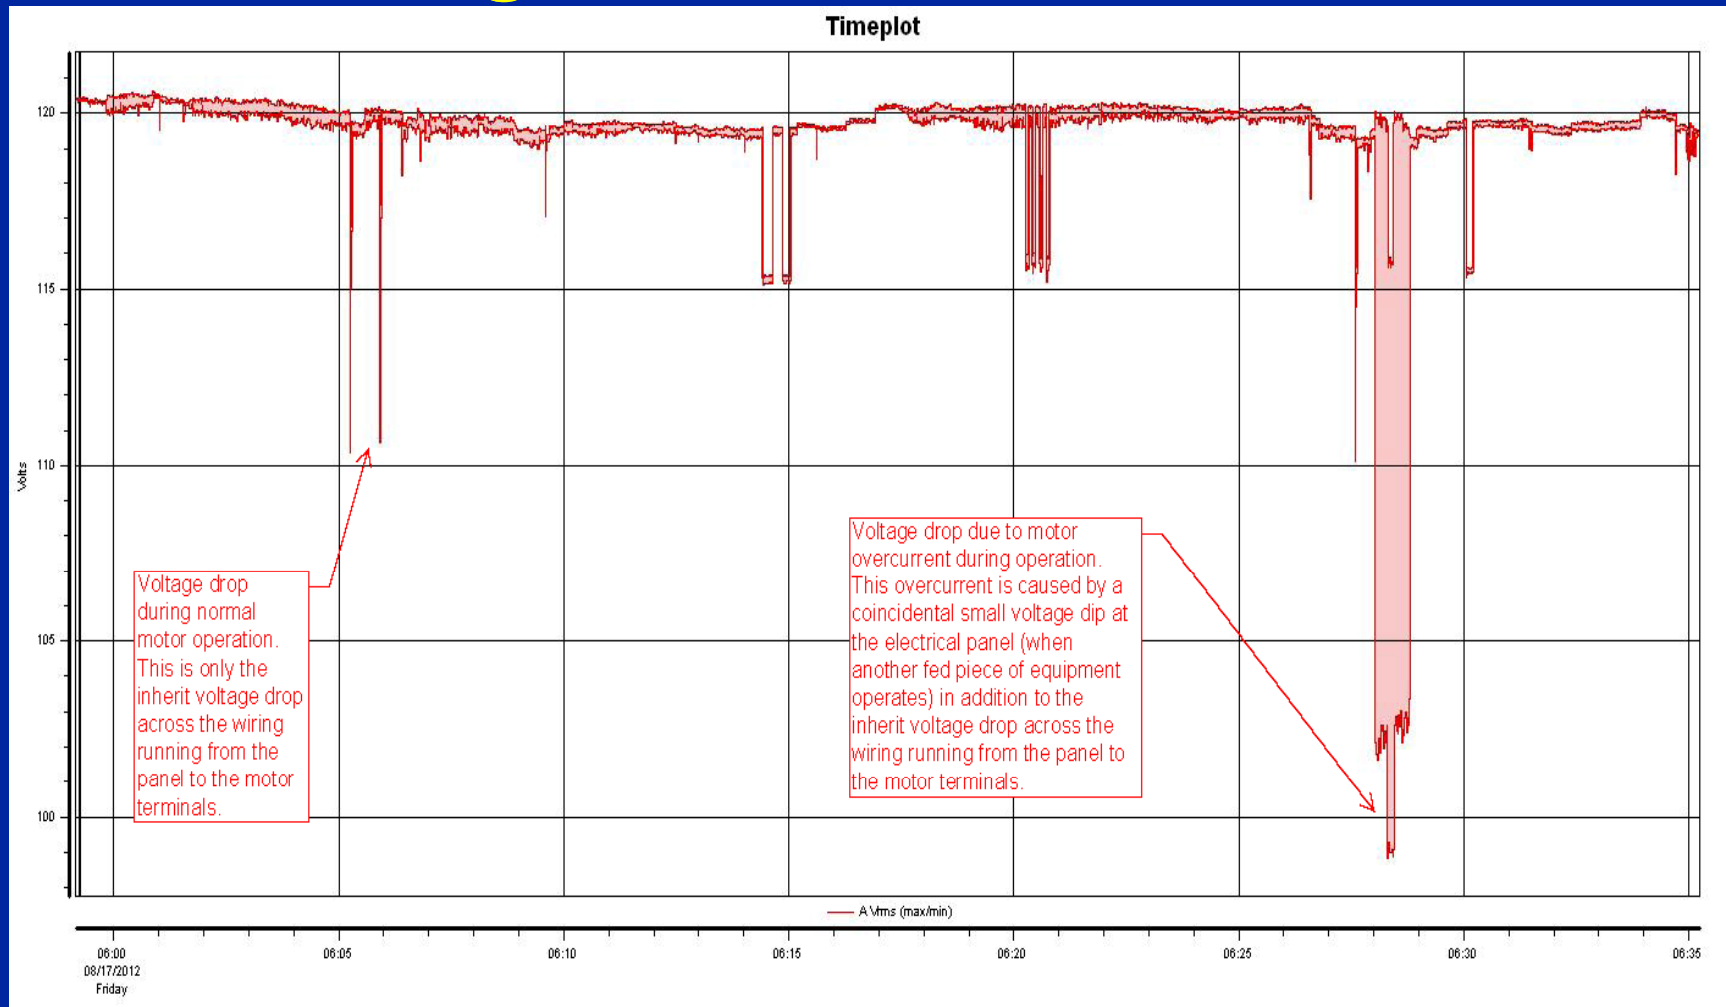
Voltage at Motor Terminals

- NEC recommends no more than 3% voltage drop for either feeder circuits or branch circuits where the maximum total voltage drop on both feeders and branch circuits to the furthest device does not exceed 5%
- Voltage Drop Calculation for our circuit to the motor:
 - $V_{drop} = (2 \times \text{Length} \times \text{Resistance} \times I) / 1000$
 - $V_{drop} = (2 \times 550\text{ft} \times 0.778 \times 9.8\text{A}) / 1000 = 8.39\text{V}$
 - $8.39\text{V} / 120\text{V} = 6.9\% \text{ VD}$

- After substituting in the resistance values (Chapter 9, Table 8 in the NEC) for larger cables, we find that #4 AWG reduces the voltage drop to acceptable levels.
- Voltage Drop Calculation for our circuit to the motor:
 - $V_{drop} = (2 \times \text{Length} \times \text{Resistance} \times I) / 1000$
 - $V_{drop} = (2 \times 550 \text{ft} \times 0.308 \times 9.8 \text{A}) / 1000 = 3.32 \text{V}$
 - $3.32 \text{V} / 120 \text{V} = 2.76\% \text{ VD}$

- We can rip up 550' of pavement to replace the #8 conductors with #4
 - This is because 2#4, #10G will not fit in ½" C per NEC.
- Use a Buck/Boost transformer
 - Need to consider if the contactor is rated to handle a 12% increase in voltage when motor is not running.
- Ask the manufacturer if the motor is dual rated for 240V
 - Need to consider whether the starter is rated for 240V.
- Use the existing #8 conductors to feed a 5 kVA 240:120 transformer set at the gate
 - $5000\text{VA}/240\text{V} = 20.8$ Full load
 - $20.8 \times 1.25 = 26\text{A}$ Needed Ampacity
 - #8, 60 deg C cable ampacity: 40A
 - 40A derated to 40 deg C ambient = $40\text{A} \times .82 = 32.8$
 - $32.8\text{A} > 26\text{A}$ so we're ok.
