# Are snubbers required with Eaton's Cooper Power series liquid-filled hardened transformers?

## Abstract

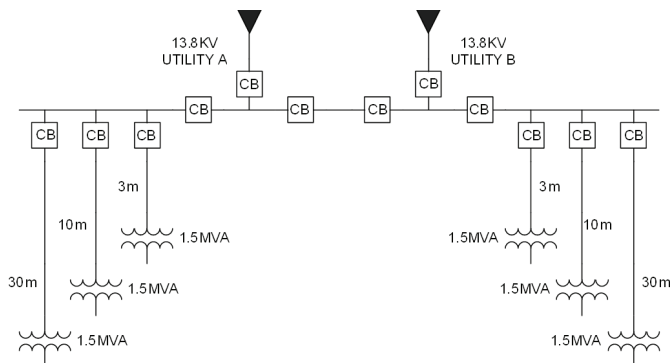
**Figure 1. Typical breakers close-coupled to transformers in a data center**

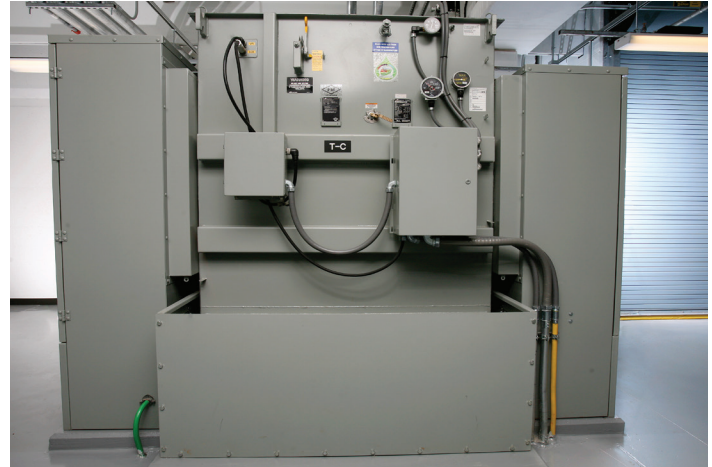
Center (HDC) transformer, as a solution for the primary switching transient problem occurring in data centers. (See Fig. 2.) The HDC transformer is a more robust distribution transformer design that includes specially insulated coils and leads and is based on years of experience with applications that require high reliability.

**Figure 2. Eaton's Cooper Power series HDC transformer**

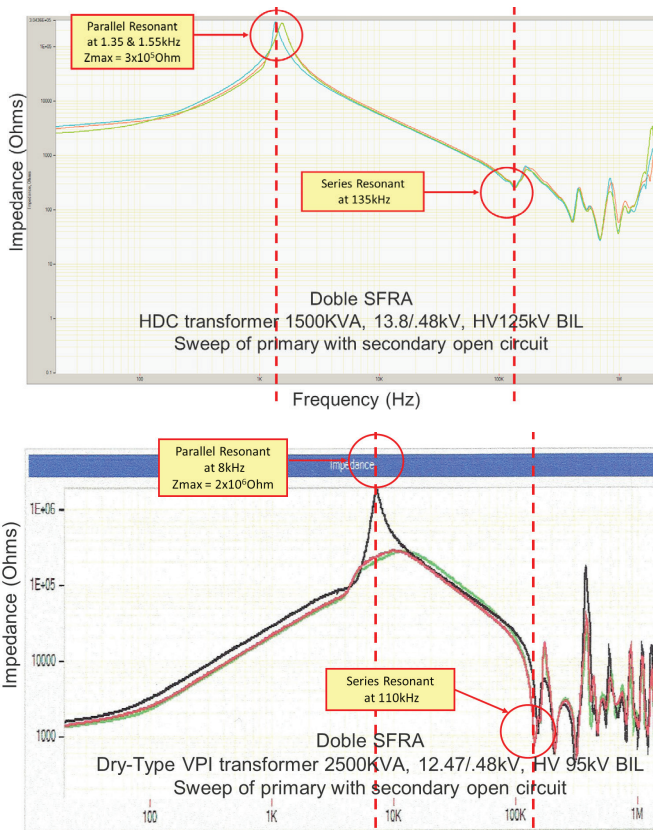
**Figure 3. Sweep Frequency Response Analysis SFRA for HDC and dry-type transformers**

A close look at these 2 SFRA graphs is revealing. An estimate of the internal transient voltage amplification factor can be approximated by looking at the ratio of –

$$\text{Amp. F} = Z_{\text{max}}/Z_{60}$$

Where Zmax is the SFRA impedance at desired frequency (all transformers will have a switching frequency impedance) compared to its 60 Hz impedance (Z60). Assuming a typical switching frequency of 8kHz:

- HDC transformer             $\text{Amp F} = 8 \times 10^9 / 4500 = 1.78$
- Dry-type transformer       $\text{Amp F} = 2 \times 10^6 / 1600 = 1250$

If a transformer is excited at or near its resonant frequency, the internal voltage will be amplified many times, resulting in failure. Of particular observation, is how much lower the amplification factor is for the specially designed HDC transformer compared to dry-type transformers. The transient voltage amplification factor of the HDC

transformer is more than 700 times lower. Also note that the first parallel frequency is much lower than in dry-types. For most power systems, the frequencies that would be prevalent impinging on the transformer, are above the parallel resonant frequency and way below the next higher series resonant frequency.

3. The Doble SFRA showed the first internal modes in the range of 1200 Hz followed by the next mode at 100 kHz when excited from the medium-voltage side. The frequency of this first mode is much lower compared to a dry-type of the same kVA rating that may have 8-10 kHz for the first mode (see Fig. 3). This is significant because switching frequencies for 13.8 kV cable systems typically range from a few kHz to 50 kHz. It is important that the switching frequency avoids the natural mode(s) of the transformer. During the switching, none of the breaker-cable combinations excited internal resonance.

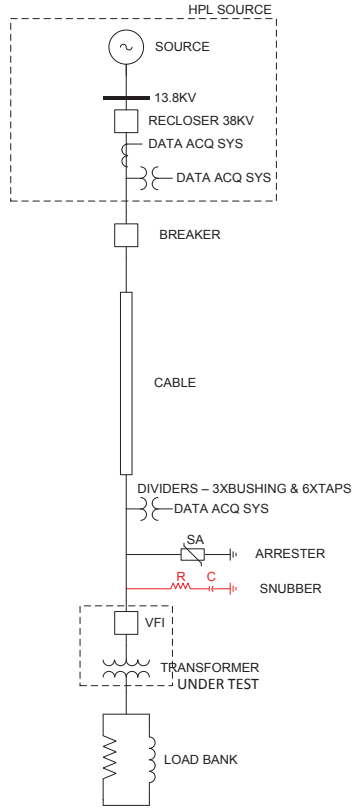
After completion of the switching transient study of the HDC transformer, Eaton conducted staged switching transient tests and transient measurements in the high-power lab at its A2KA-accredited Thomas A. Edison Technical Center in Franksville, WI. using the 500 MVA short circuit generator. The tests quantified the magnitude and frequency of transient line-to-ground voltages at the 13.8 kV primary of the HDC transformer during primary vacuum circuit breaker or internal VFI openings and closings. Specialized direct measurements at 13.8 kV captured the waveforms at the transformer winding produced during switching of the primary vacuum circuit breaker or VFI internal to the HDC transformer tank (with primary bushings and special taps at 1/3 and 2/3 of it). The test circuit consisted of the source, breaker, transformer, cable and load bank as shown conceptually in Fig. 5a. The prototype HDC transformer under test is shown in Fig. 5b.

Figure 5. A. Test circuit replicating a data center application

The performance test consisted of 1) closing a vacuum circuit breaker or VFI to energize the transformer without load, 2) applying a highly inductive light load consisting of a load bank to the secondary, 3) opening the vacuum breaker or VFI to de-energize the transformer after some time had elapsed, and 4) repeating steps 1 through 3 varying the X/R ratio of the light load. This test was conducted for switching of the vacuum breaker or VFI.

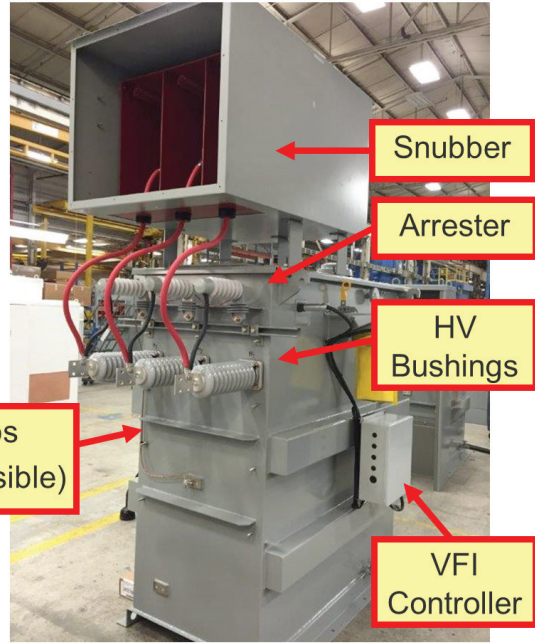
Figure 5. B. Eaton's Cooper Power series HDC transformer (prototype for testing purposes)

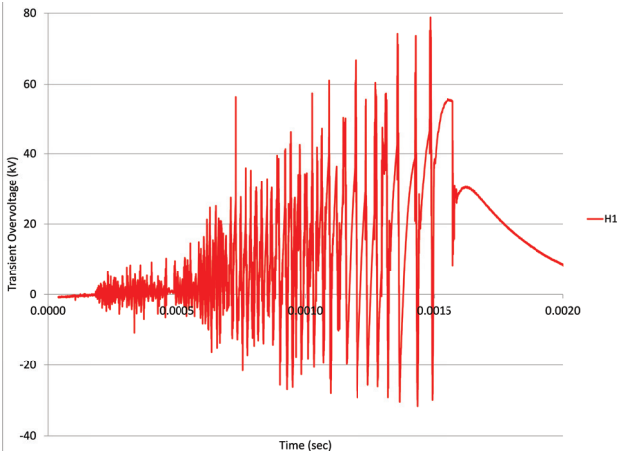
The switching transients captured at the HDC transformer primary winding terminals and taps exhibited the characteristics of switching a highly inductive current, i.e., multiple reignitions followed by voltage escalation. When a prestrike or reignition occurs, there is a very abrupt change in voltage magnitude as shown in Fig. 7 by the near vertical lines in the voltage measurement. This creates a very high rate of rise of voltage, or high dv/dt.

**Figure 7. Reignition followed by voltage escalation common in data center switching (Trace#156)**

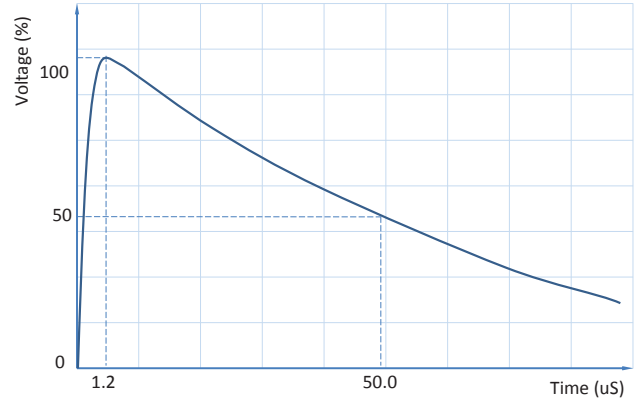
Transformers are not rated expressly for dv/dt. However, they do have a Basic Impulse Level (BIL) rating. As shown in Fig. 8, the lightning impulse test is a high voltage, steep wavefront test that is common for most electrical equipment. The test applies a voltage waveform with a rise time of 1.2µs and decays to 50% magnitude in 50µs. Maximum voltage varies with equipment rating.

**Figure 8. Lightning impulse test waveform (1.2x50µS)**

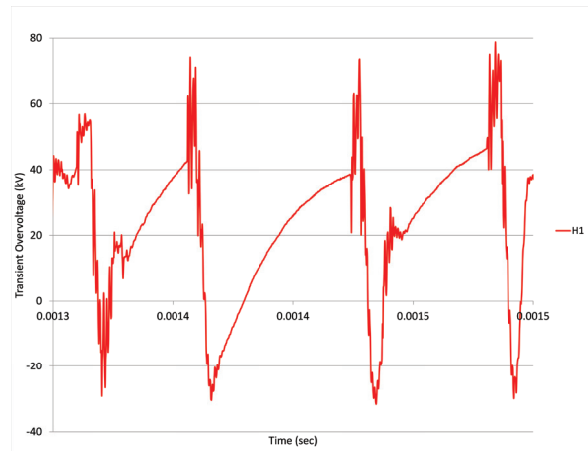
The HDC transformer tested was rated 125 kV BIL. From the BIL rating, a dv/dt rating can be estimated by dividing the maximum voltage by the rise time. The BIL rating of 125 kV produces a dv/dt rating of 104.2 kV per microsecond. As shown in Fig. 9 for trace #156, the magnitude of 78.8kV with rise time of 0.91µs gives dv/dt of 86.6kV/µs.

**Figure 9. Calculating dv/dt from reignition transient of test (Trace#156)**

The measured dv/dt values were then compared to the estimated withstand based upon the BIL rating of the transformer. As the measured dv/dt values approach the estimated withstand, damage due to dv/dt is possible, even likely. A failure would be expected to occur, depending on how frequent the dv/dt events occur.

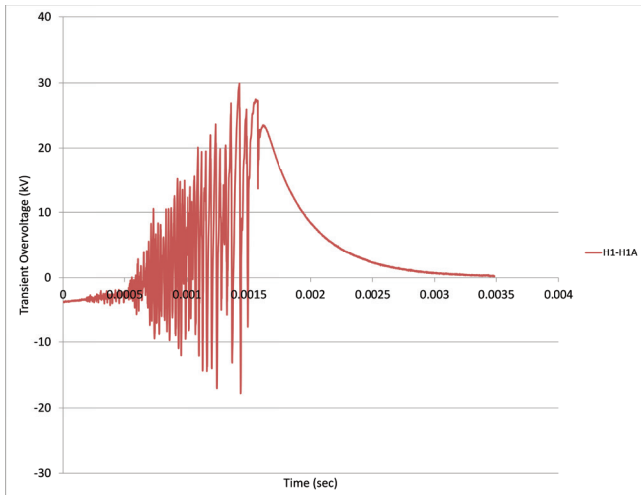
The voltage across the portion of the winding from the primary bushing to the 1/3 tap (or 2/3 tap) is of interest because the transient voltage is not evenly distributed across the entire winding. The voltage across this portion of the winding can be calculated from the measured transient overvoltage waveforms at the primary bushing and 1/3 tap. Below is the calculated voltage across H1 (primary bushing) to H1A (1/3 tap bushing). The dv/dt on this portion of the winding can be calculated as explained above.

**Figure 10. A. Typical voltage between primary bushing and 1/3 tap**

Another reason for looking at the 1/3 to 2/3 points in the windings is that these are typical points internally where the resonant voltages will be highest if the impinging waveform happens to match one of these resonant frequencies.

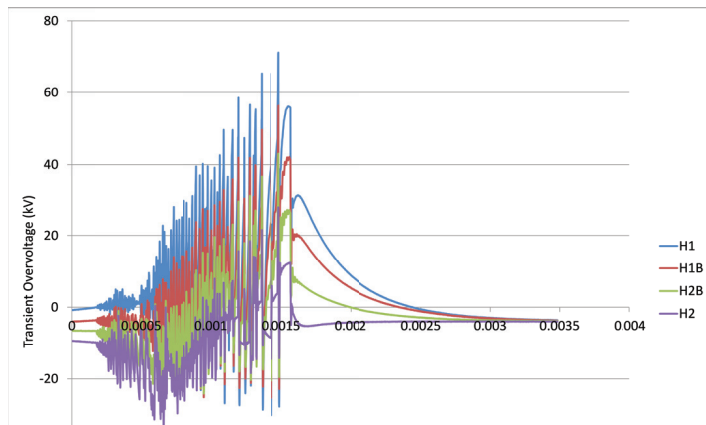
**Figure 10. B. Typical voltage across the entire winding referenced to ground (H1B = 1/3 of B C)**
