Troubleshooting and Lessons Learned Using Protective Relay Event Analysis

GE Digital Energy Multilin

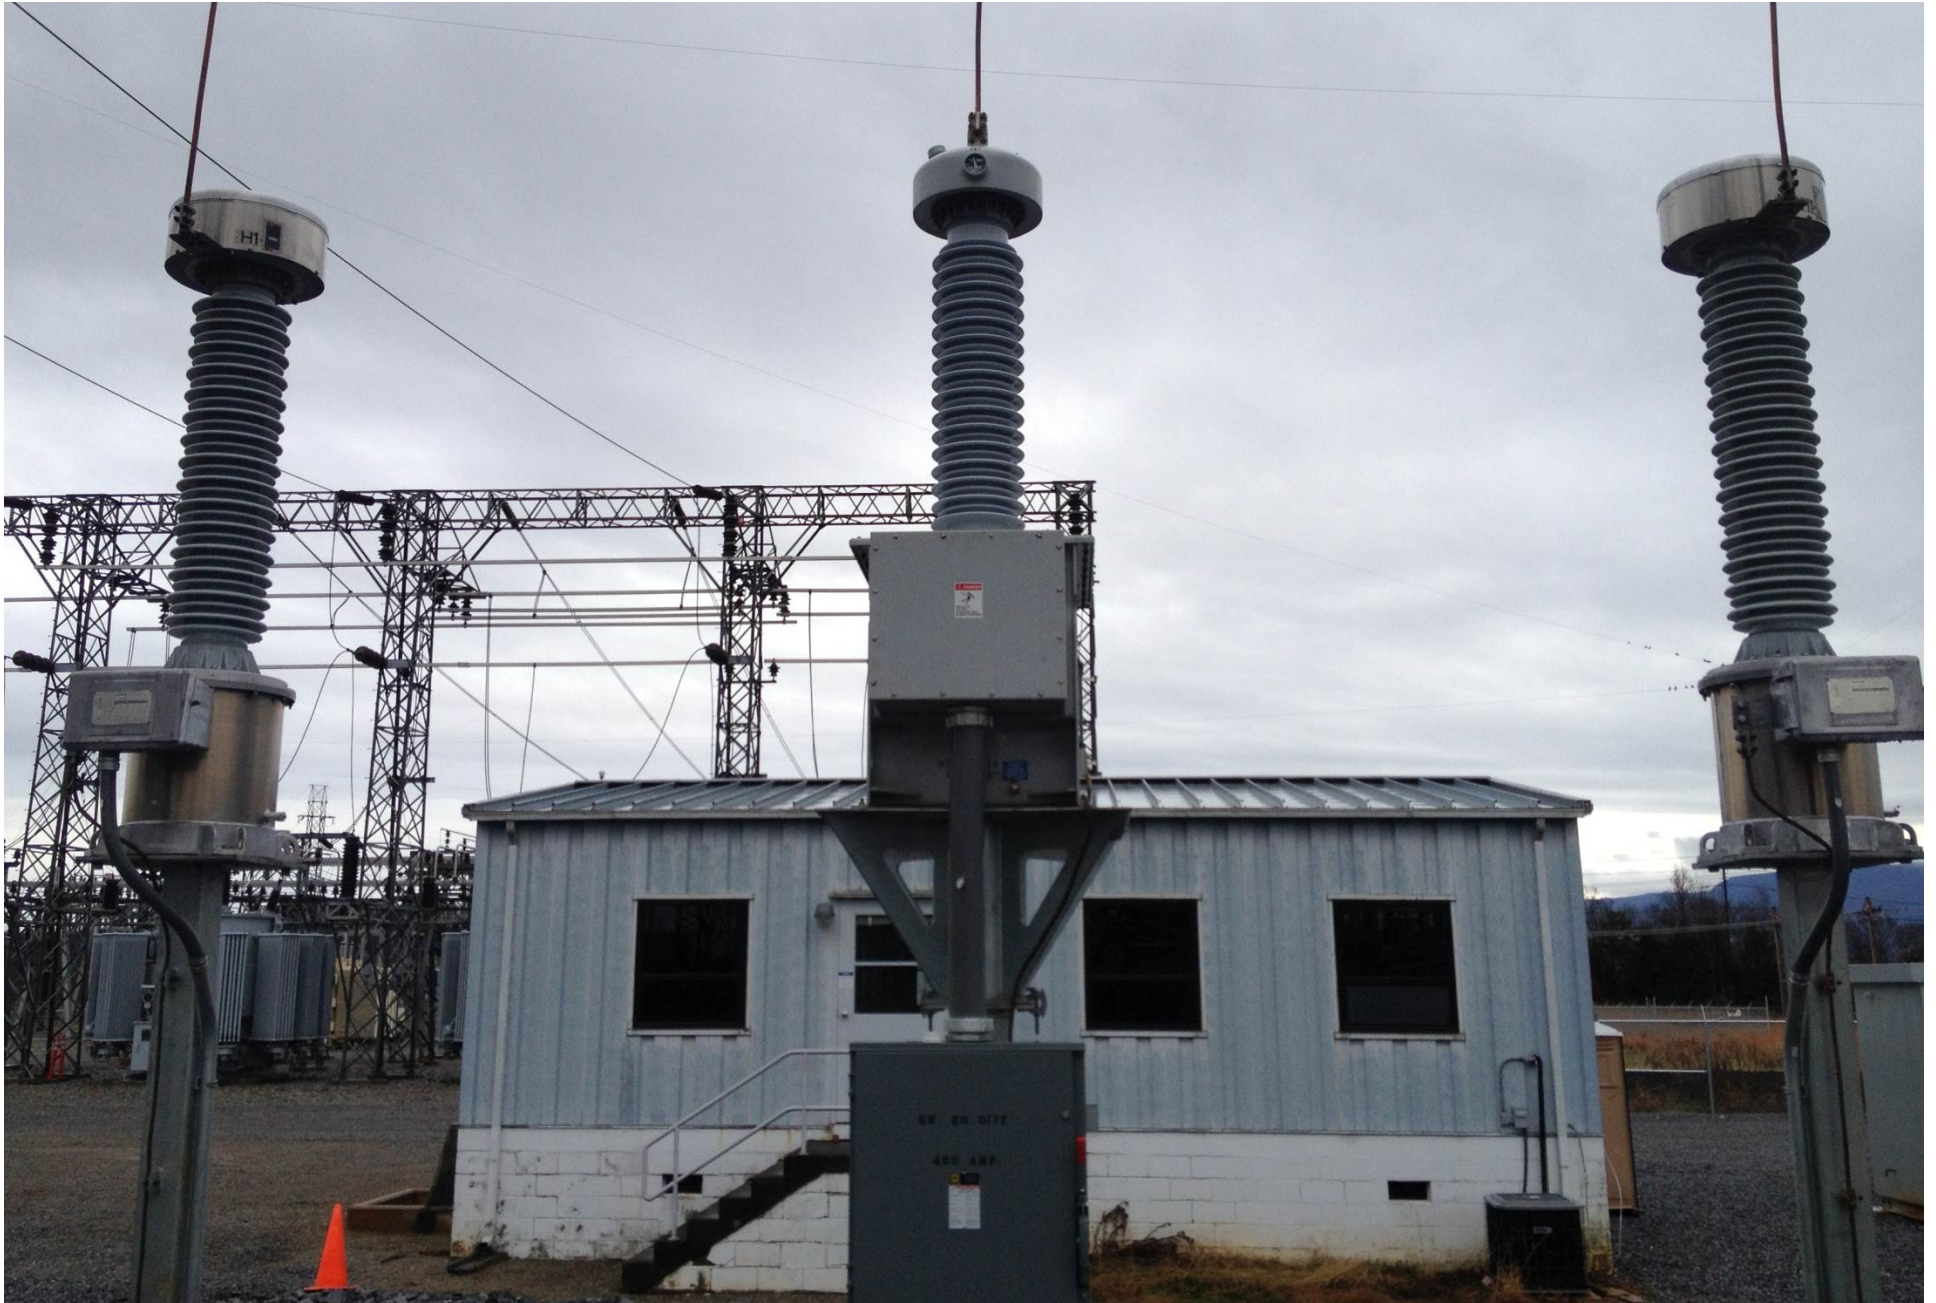
One of these things isn't like the others!
